## Dipole Impedance Measurement

Equipment Location	Equipment Name	Model Name	Date of Verification
UL Verification Services Inc. 47173 Benicia Street Fremont, CA 94538, U.S.A.	Dipole Antenna	D3700V2-1039	October 2, 2023

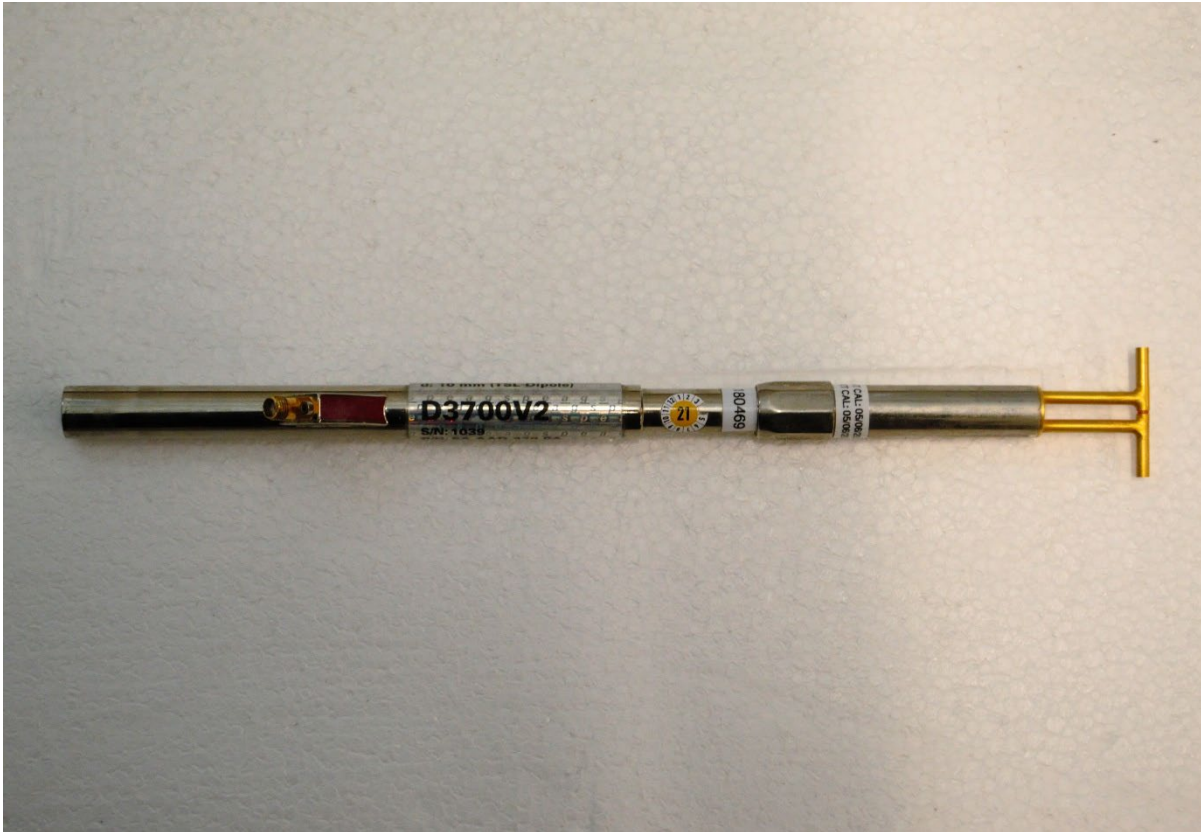
### 1) Photo of Dipole

- The connector of dipole contains no abnormalities.

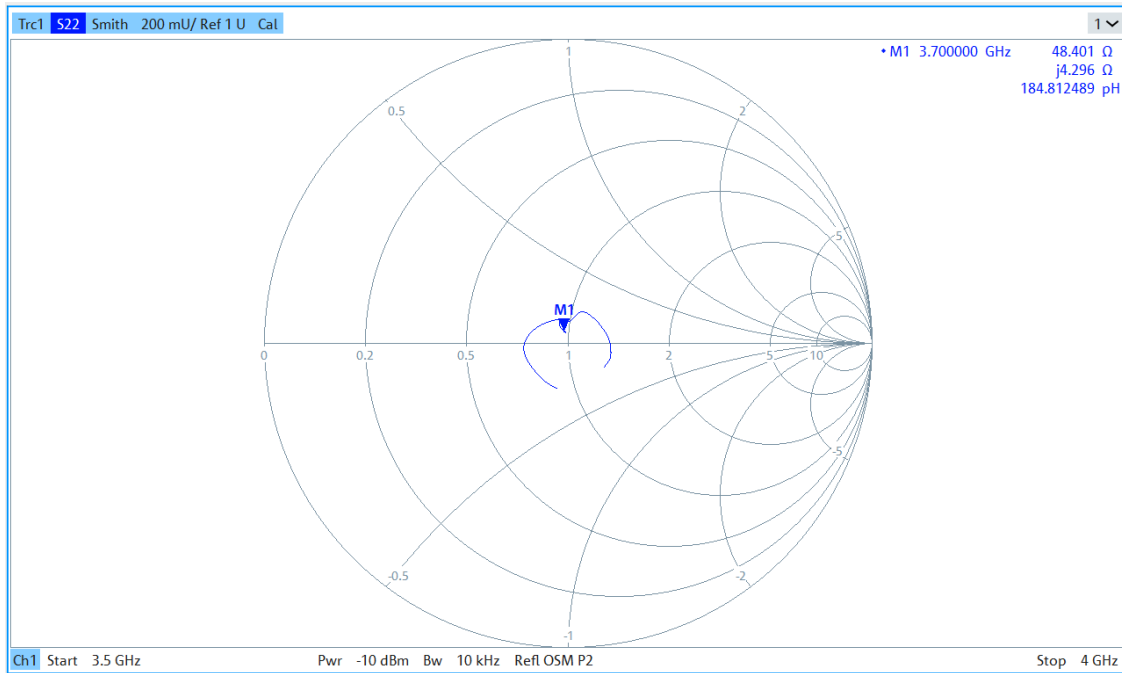
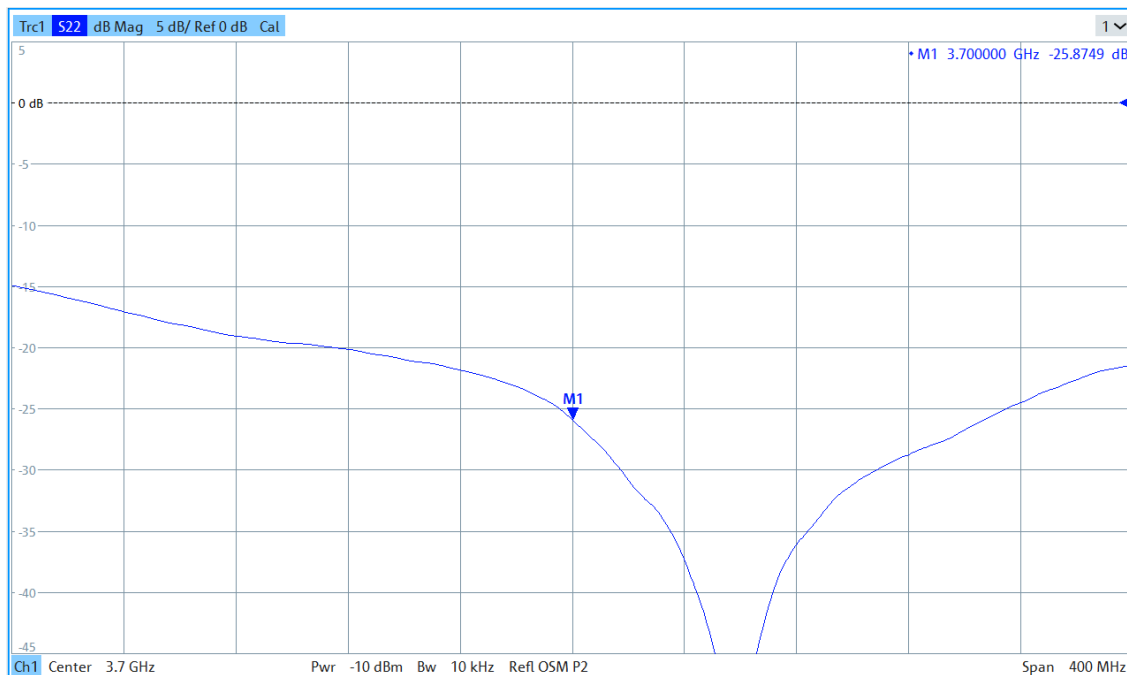
### 2) Impedance and Return/Loss

- Return/Loss is greater than the -20 dB cutoff and Impedance is within 5  $\Omega$  of previous value.

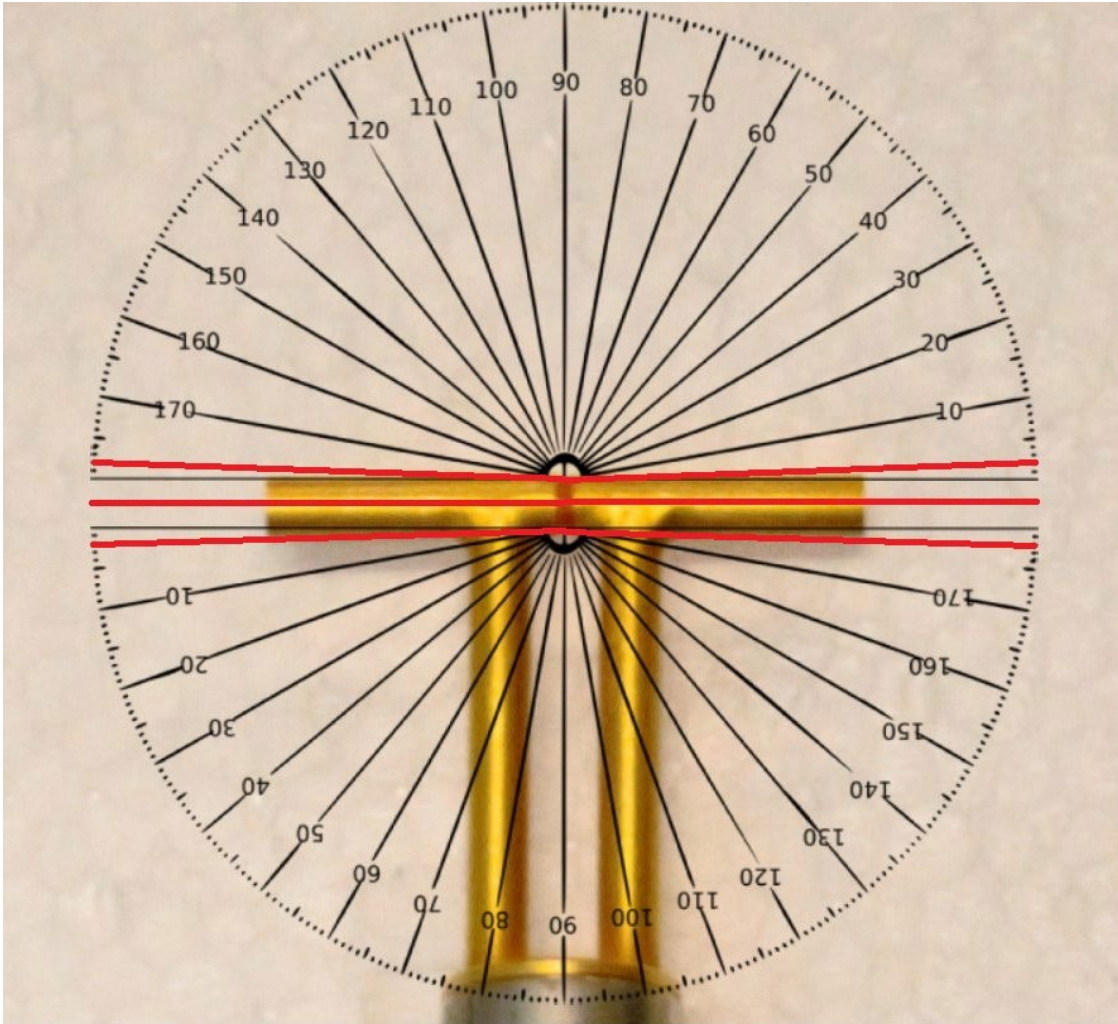
### 3) Dipole Arms

- The center red line indicates that the arms of the dipole fall within  $\pm 2^\circ$
