## Dipole Impedance Measurement

Equipment Location	Equipment Name	Model Name	Date of Verification
UL Verification Services Inc. 47173 Benicia Street Fremont, CA 94538, U.S.A.	Dipole Antenna	D750V3-1019	April 13, 2023

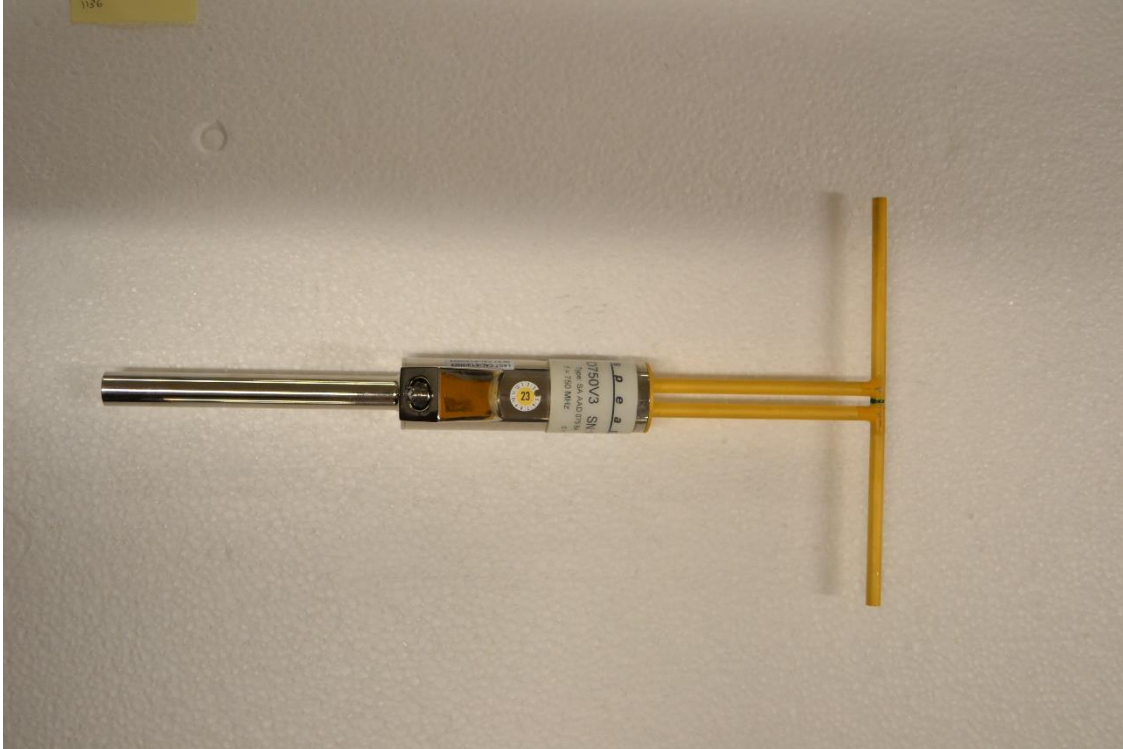
### 1) Photo of Dipole

- The connector of dipole contains no abnormalities.

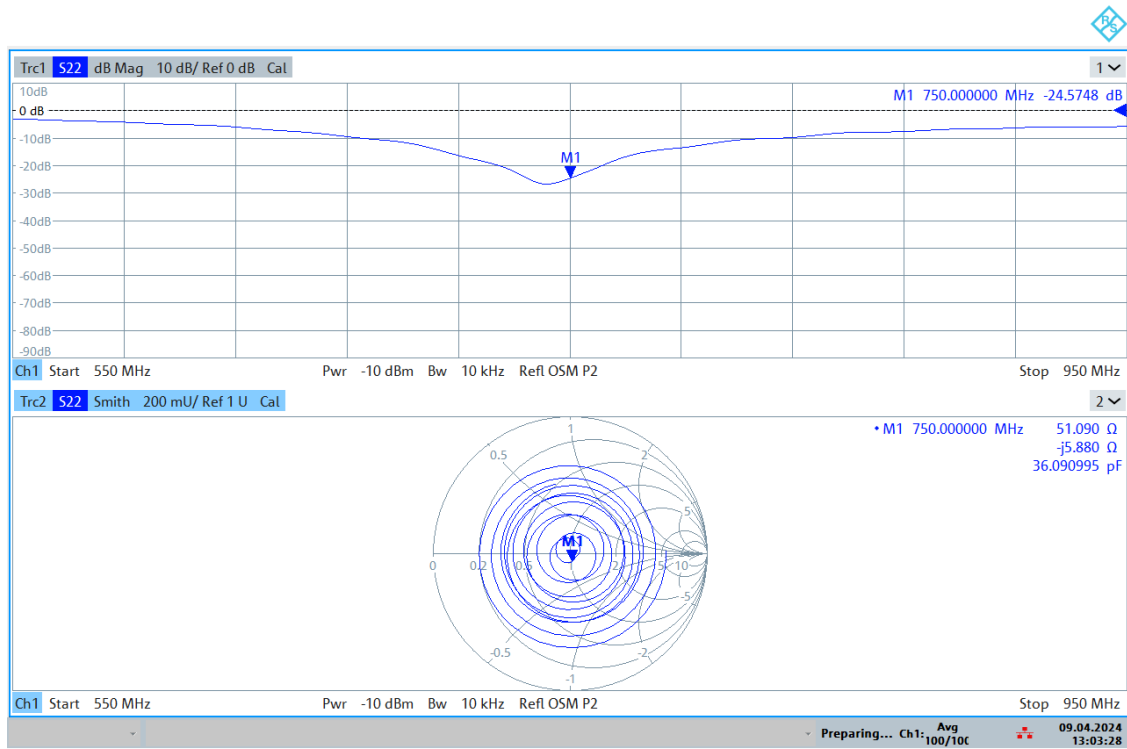
### 2) Impedance and Return/Loss

- Return/Loss is greater than the -20 dB cutoff and Impedance is within 5  $\Omega$  of previous value.

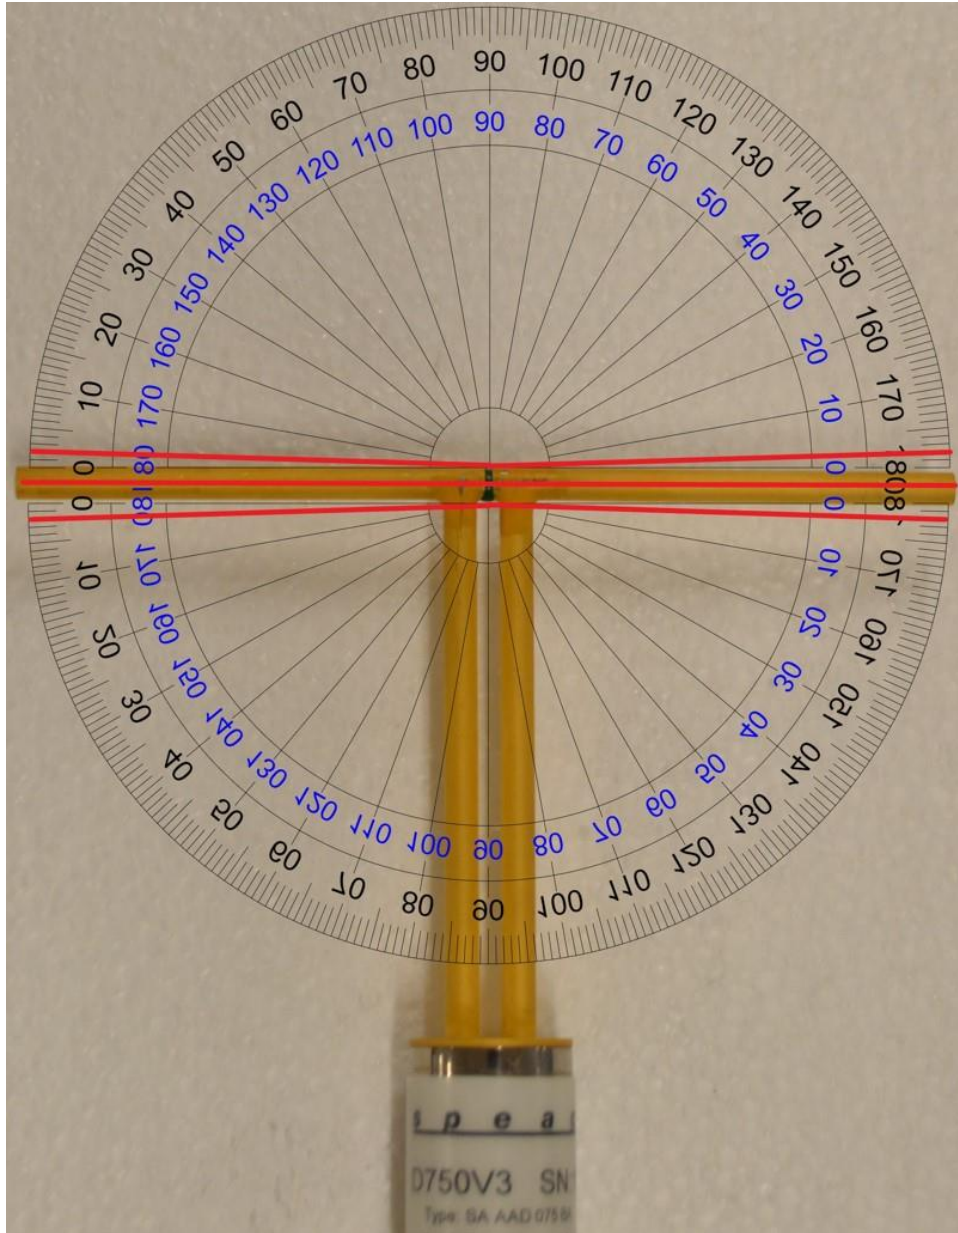
### 3) Dipole Arms

- The center red line indicates that the arms of the dipole fall within  $\pm 2^\circ$

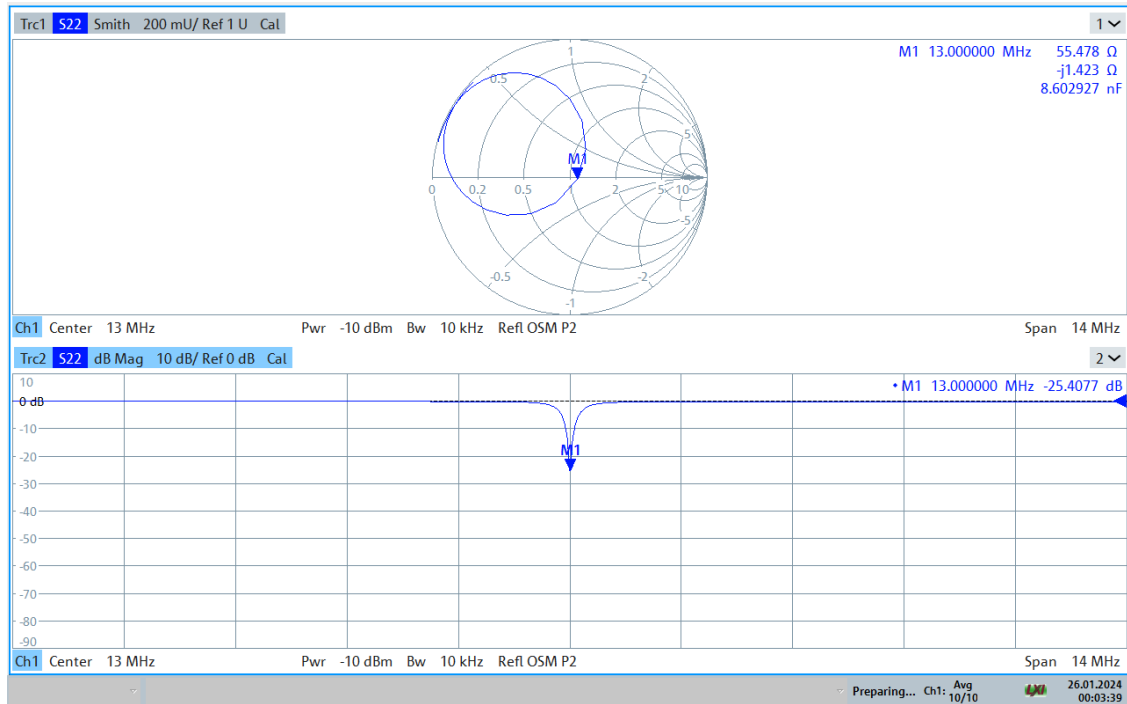
### 4) Impedance and Return/Loss

- Return/Loss is greater than the -20 dB cutoff and Impedance is within 5 Ω of previous value.

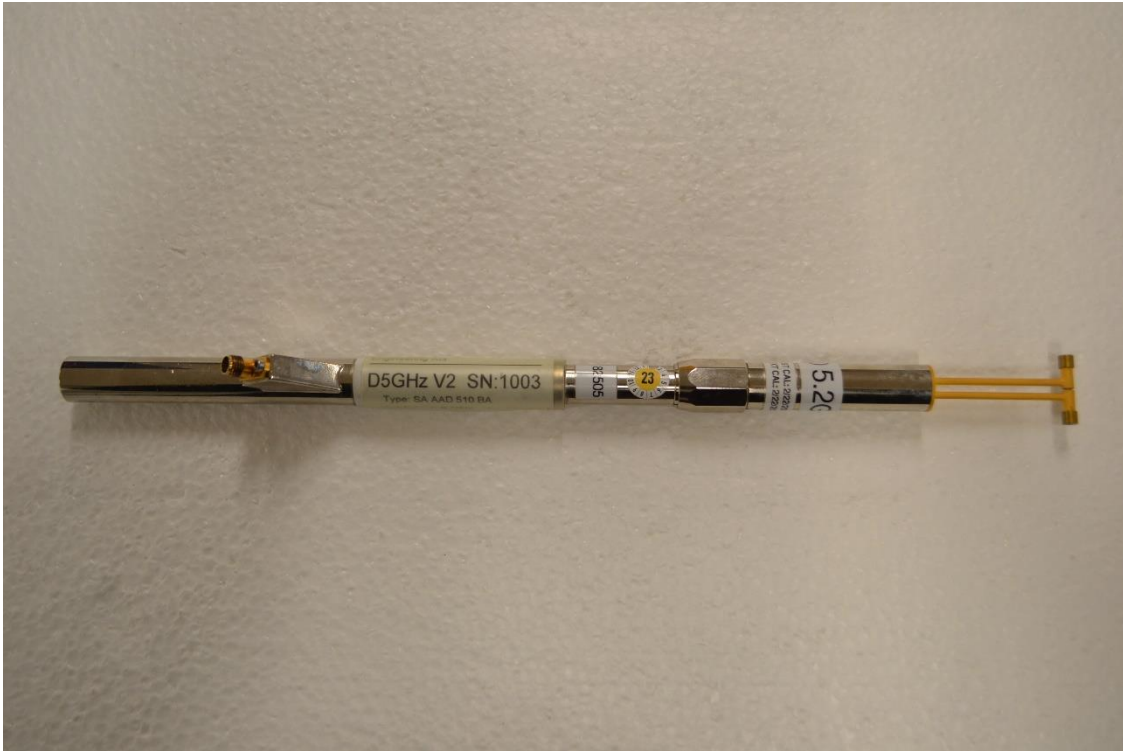
### 5) Photo of Dipole

- The connector of dipole contains no abnormalities.

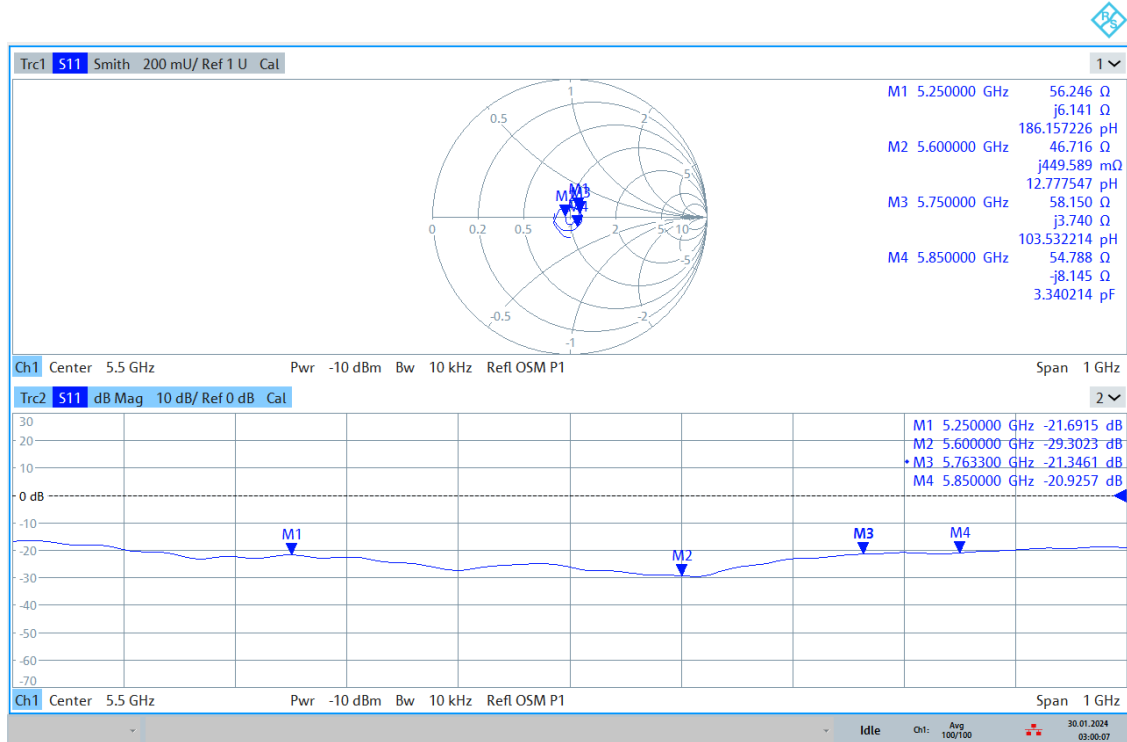
### 6) Impedance and Return/Loss

- Return/Loss is greater than the -20 dB cutoff and Impedance is within 5  $\Omega$  of previous value.

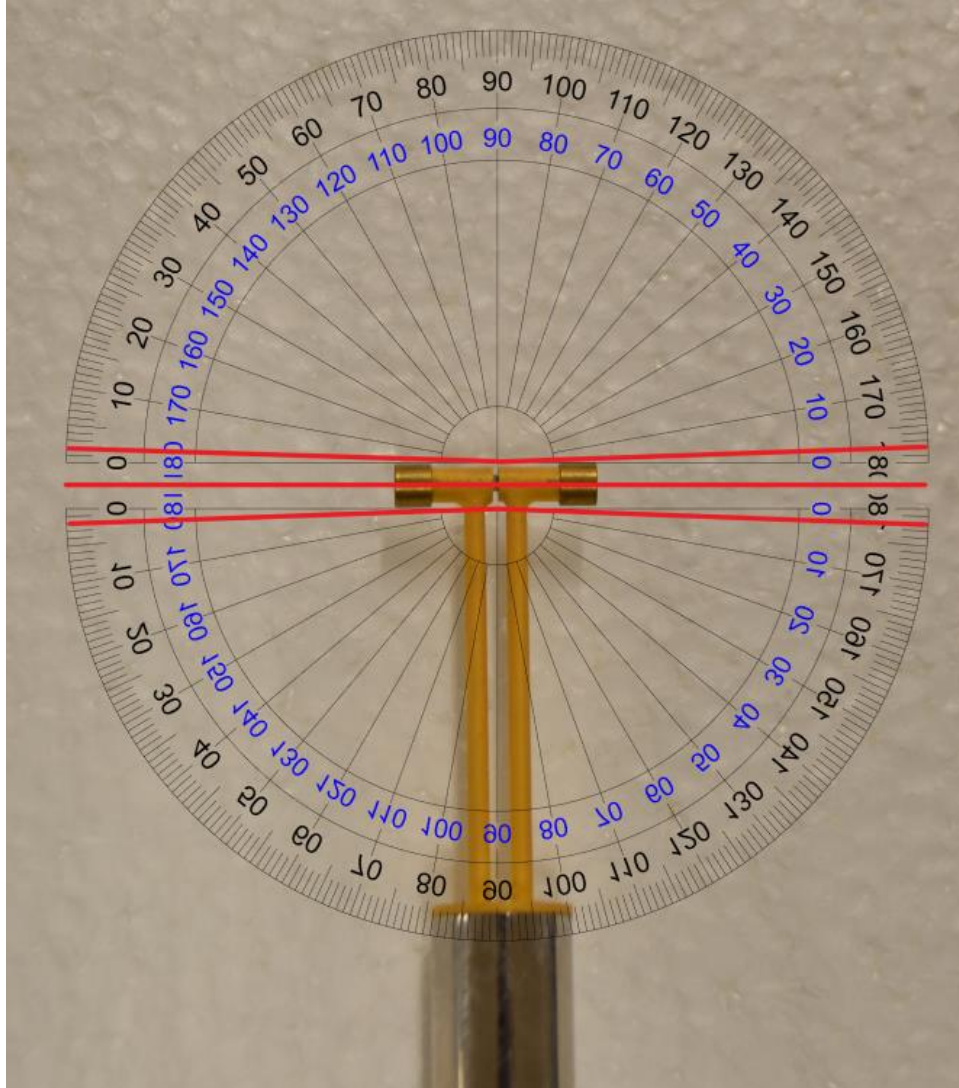
### 7) Dipole Arms

- The center red line indicates that the arms of the dipole fall within  $\pm 2^\circ$

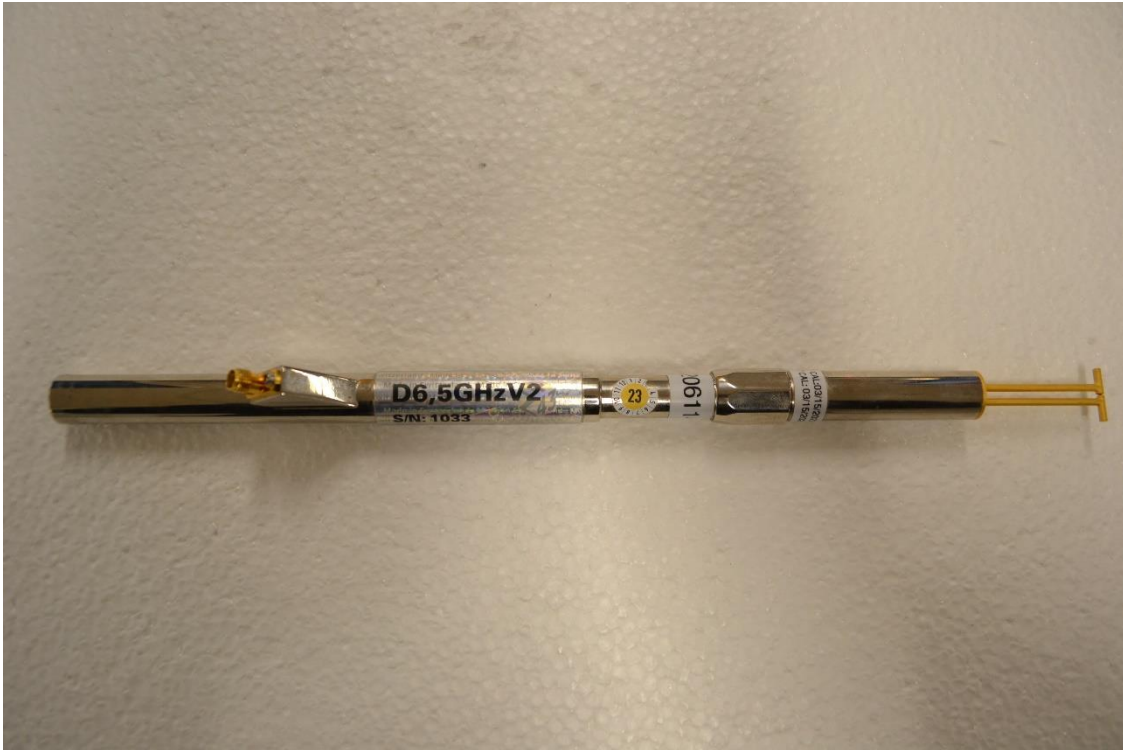
### 8) Photo of Dipole

- The connector of dipole contains no abnormalities.

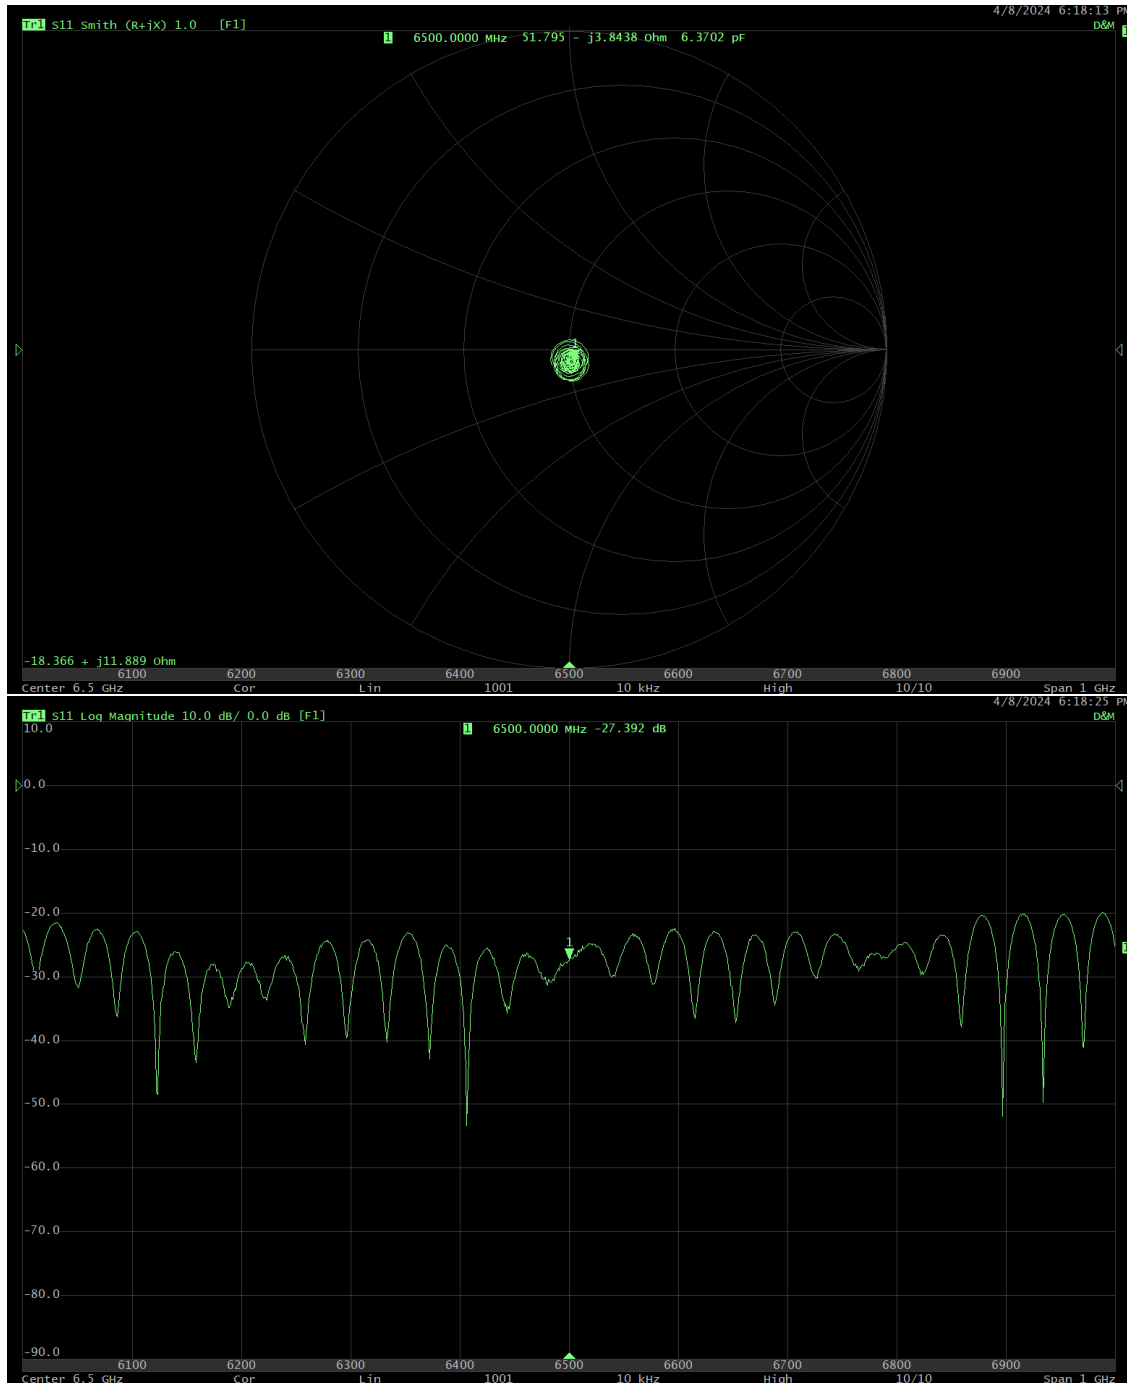
### 9) Impedance and Return/Loss

- Return/Loss is greater than the -20 dB cutoff and Impedance is within  $5 \Omega$  of previous value.

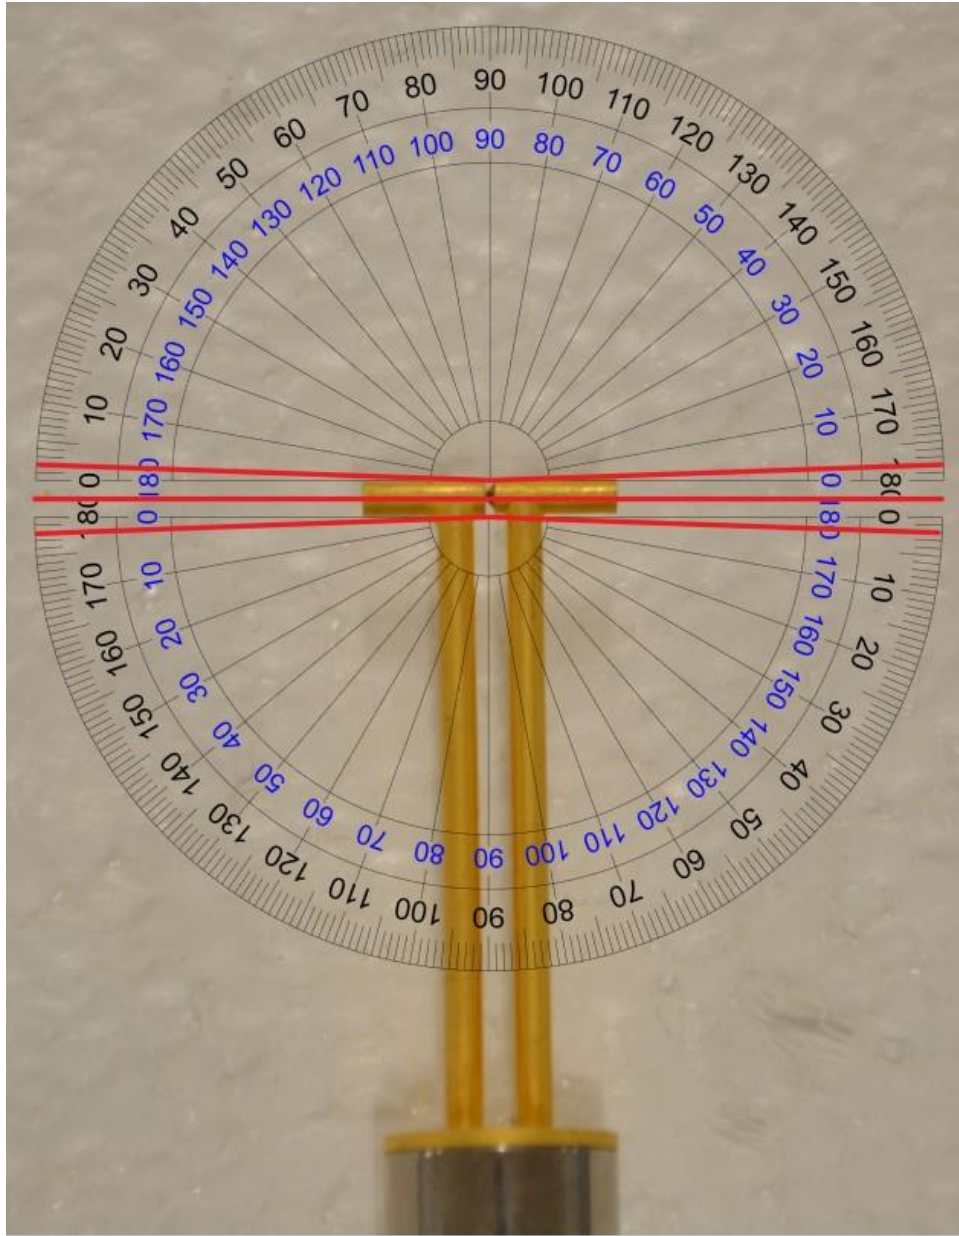
### 10) Dipole Arms

- The center red line indicates that the arms of the dipole fall within  $\pm 2^\circ$

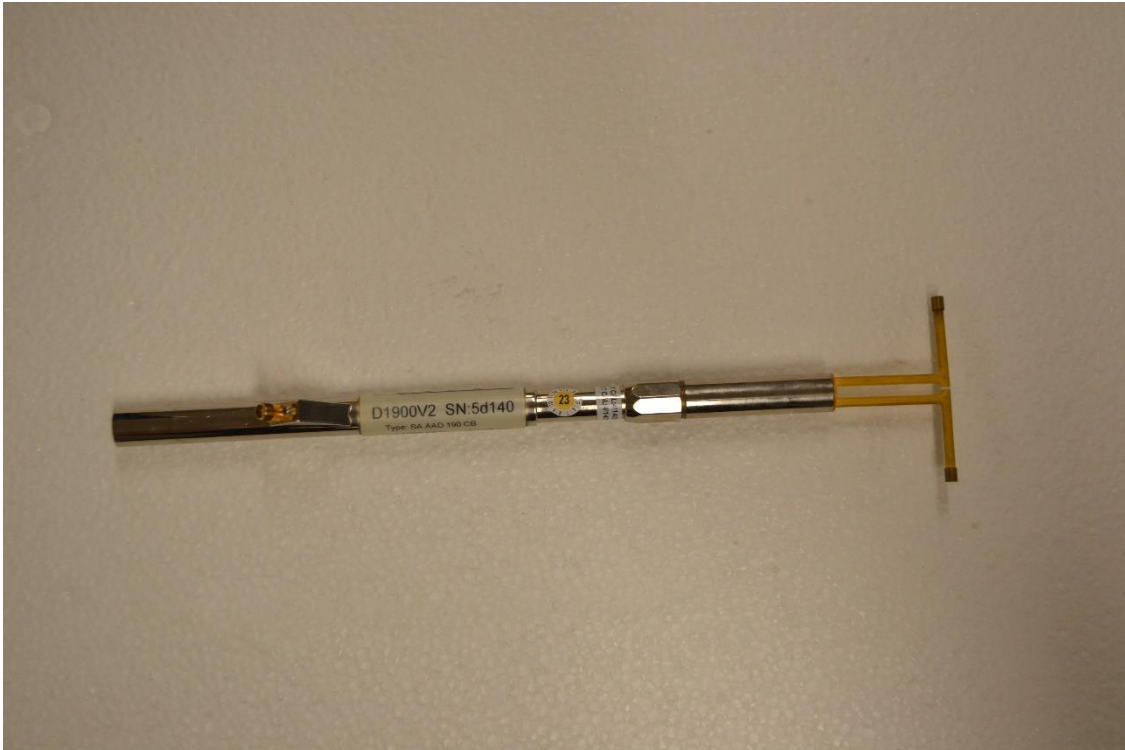
11) Photo of Dipole

- The connector of dipole contains no abnormalities.

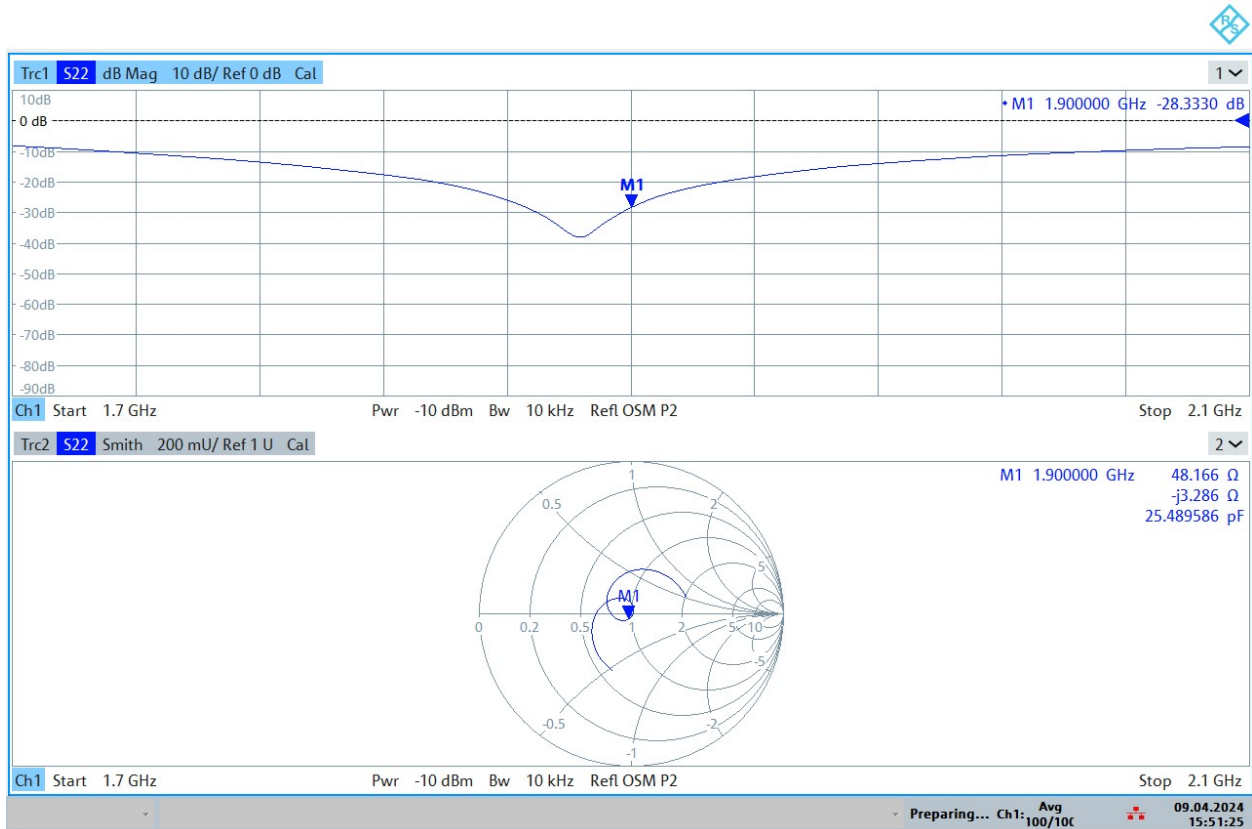
### 12) Impedance and Return/Loss

- Return/Loss is greater than the -20 dB cutoff and Impedance is within 5 Ω of previous value.

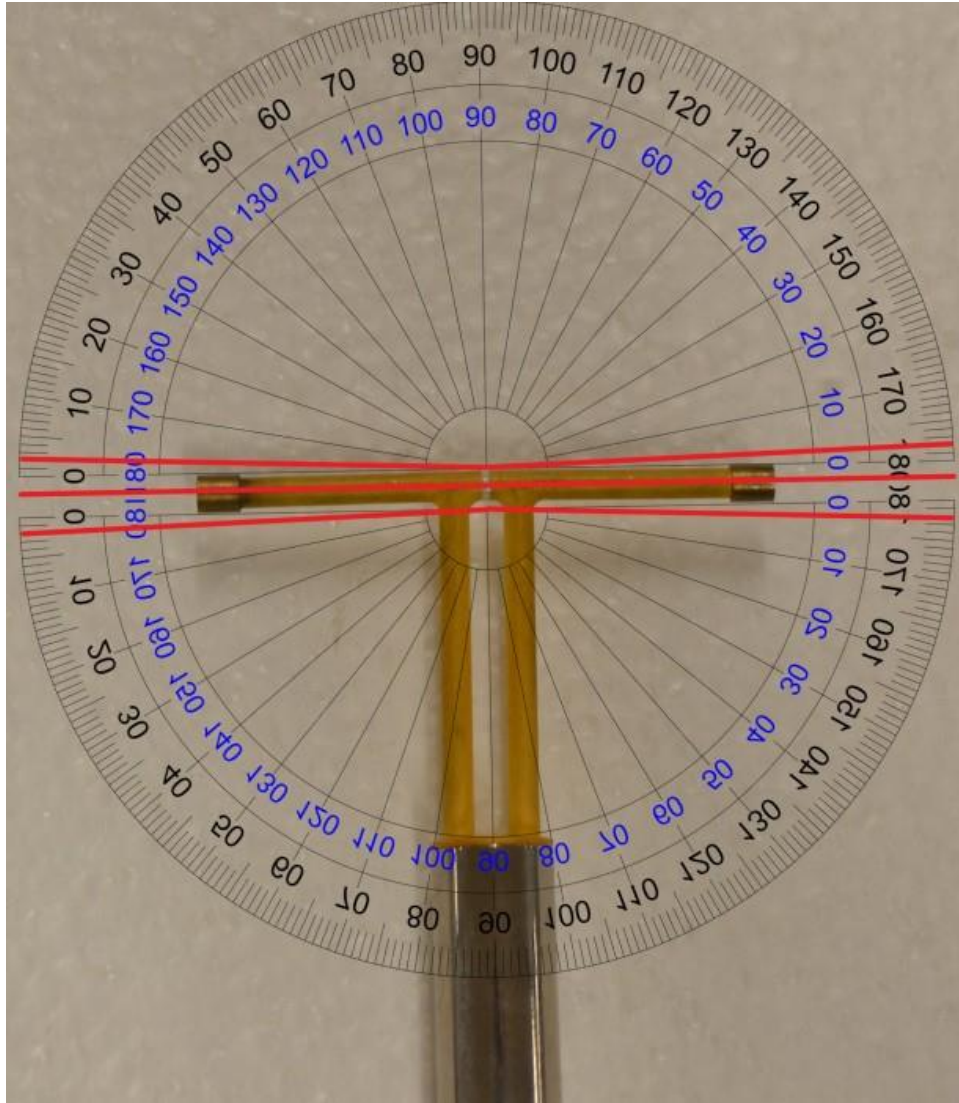
### 13) Dipole Arms

- The center red line indicates that the arms of the dipole fall within  $\pm 2^\circ$

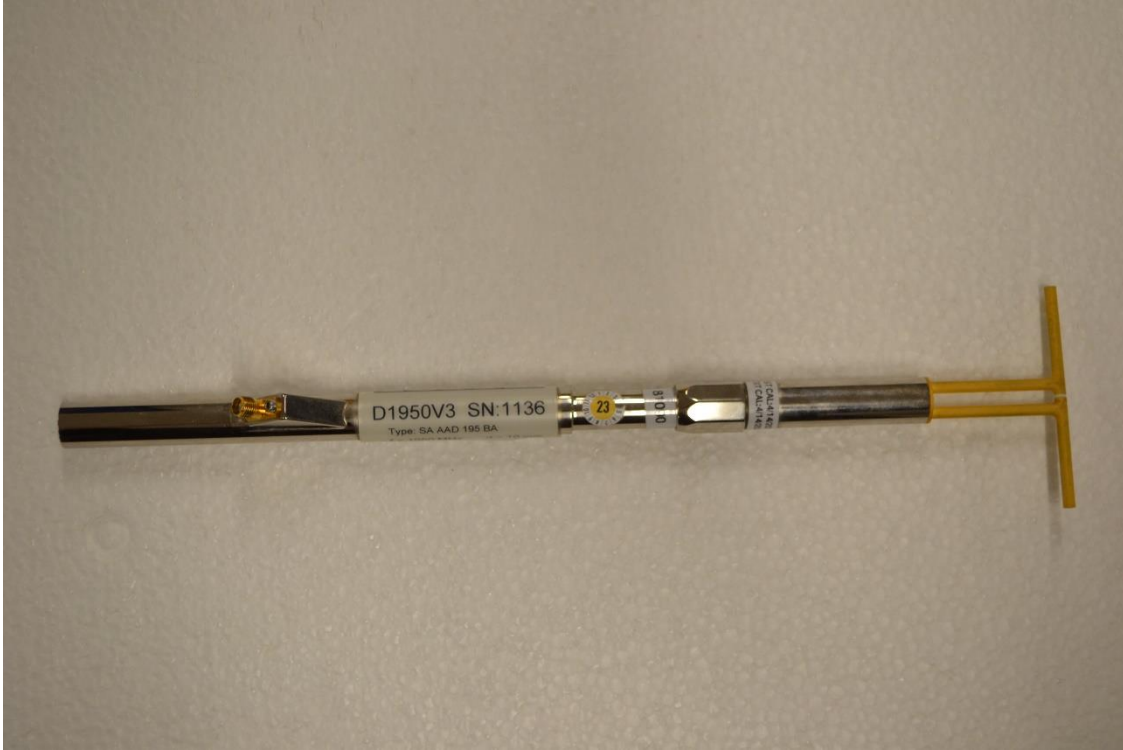
14) Photo of Dipole

- The connector of dipole contains no abnormalities.

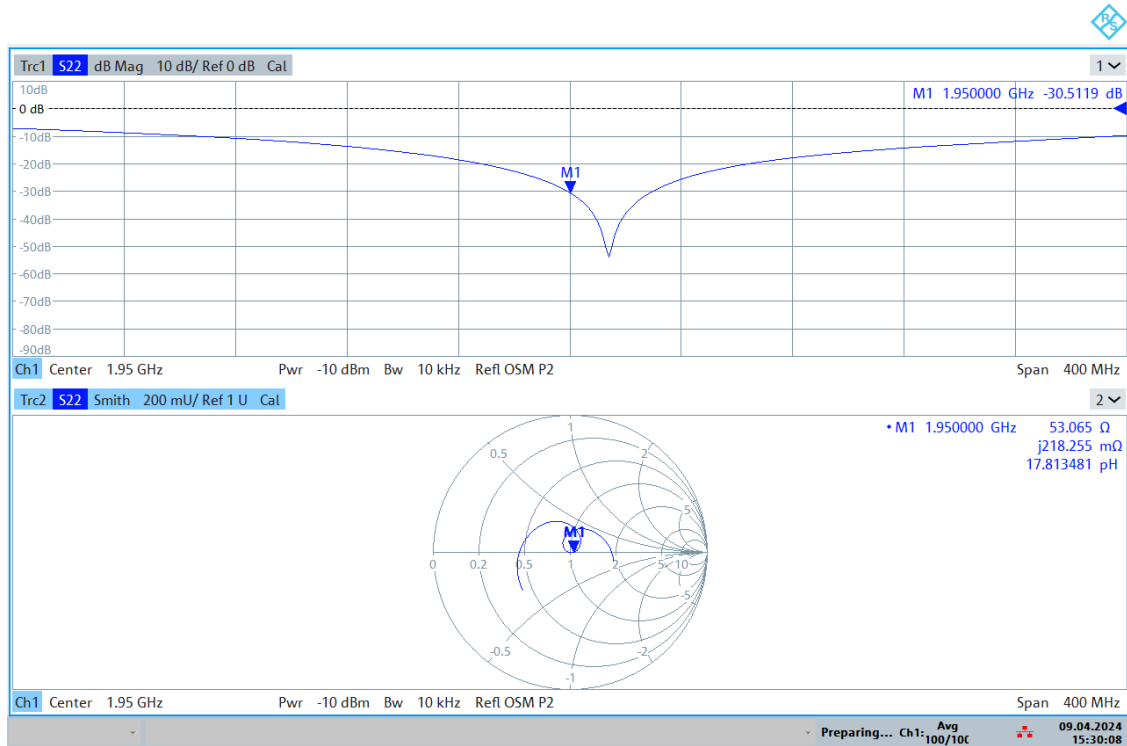
### 15) Impedance and Return/Loss

- Return/Loss is greater than the -20 dB cutoff and Impedance is within 5 Ω of previous value.

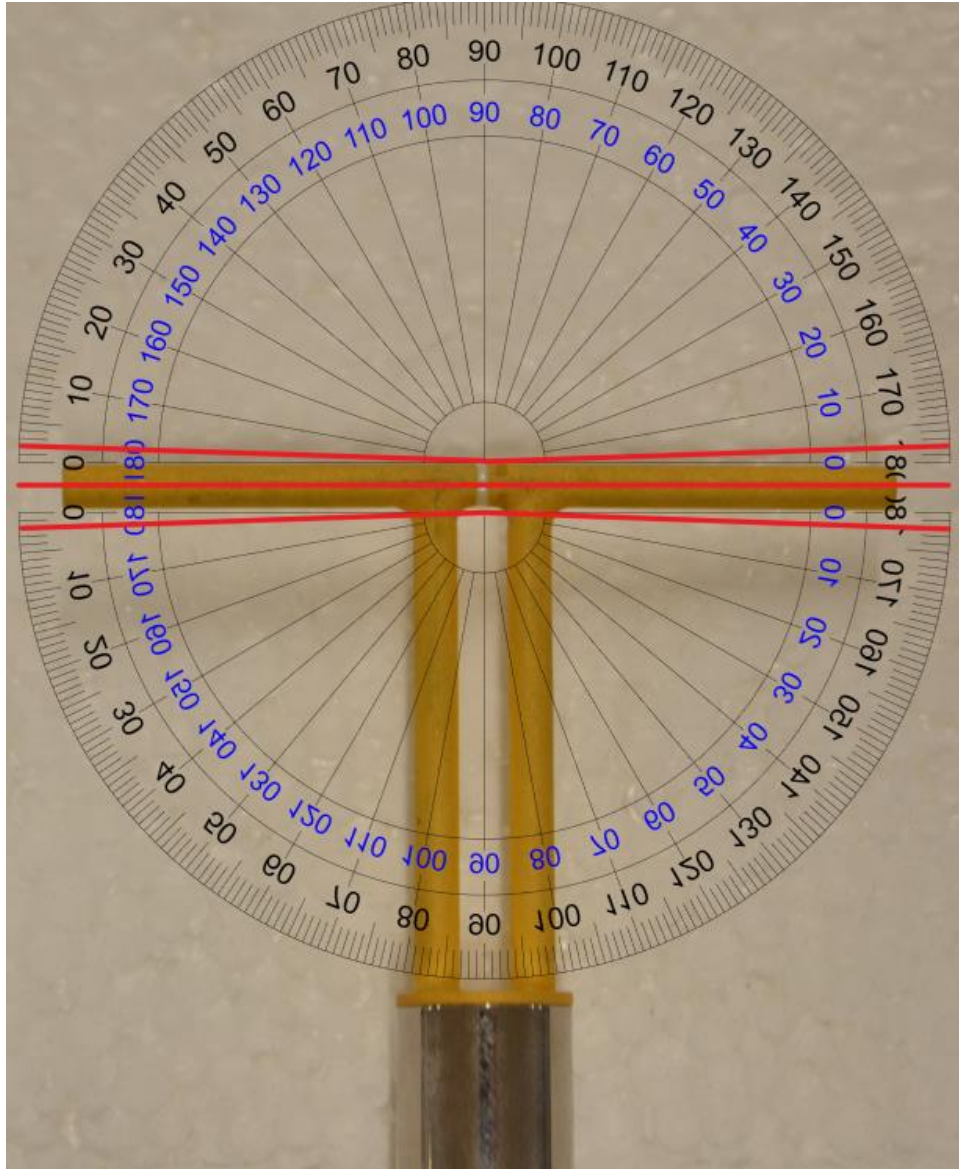
### 16) Dipole Arms

- The center red line indicates that the arms of the dipole fall within  $\pm 2^\circ$

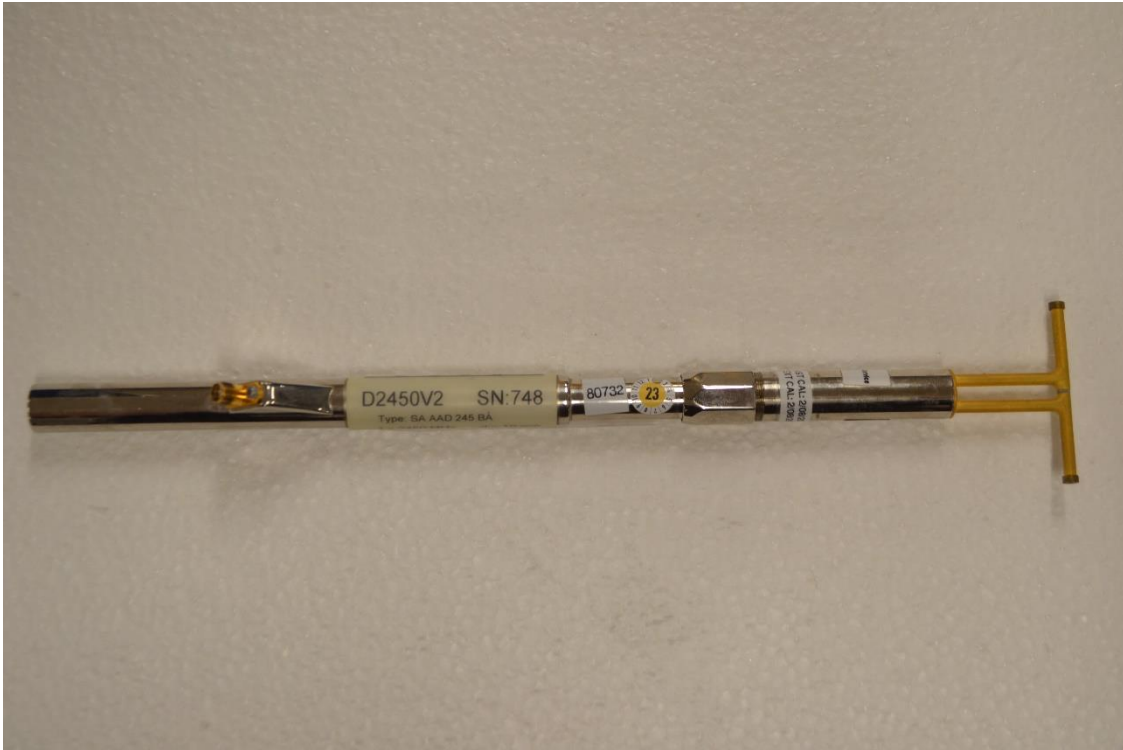
17) Photo of Dipole

- The connector of dipole contains no abnormalities.

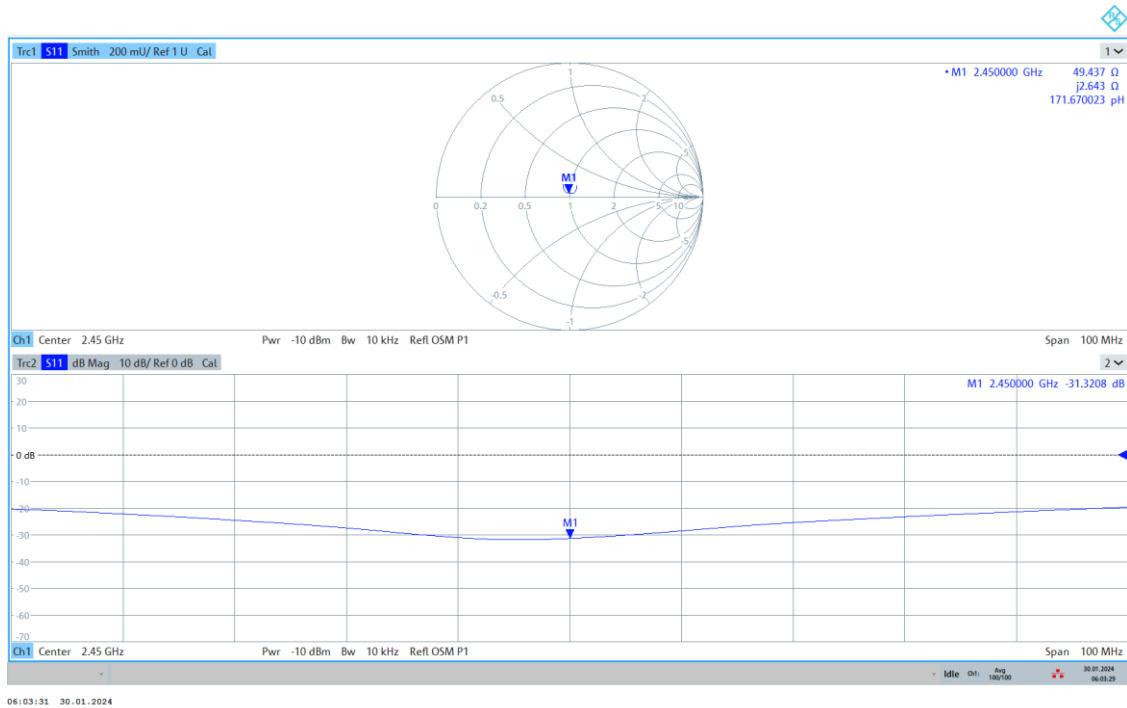
### 18) Impedance and Return/Loss

- Return/Loss is greater than the -20 dB cutoff and Impedance is within  $5 \Omega$  of previous value.

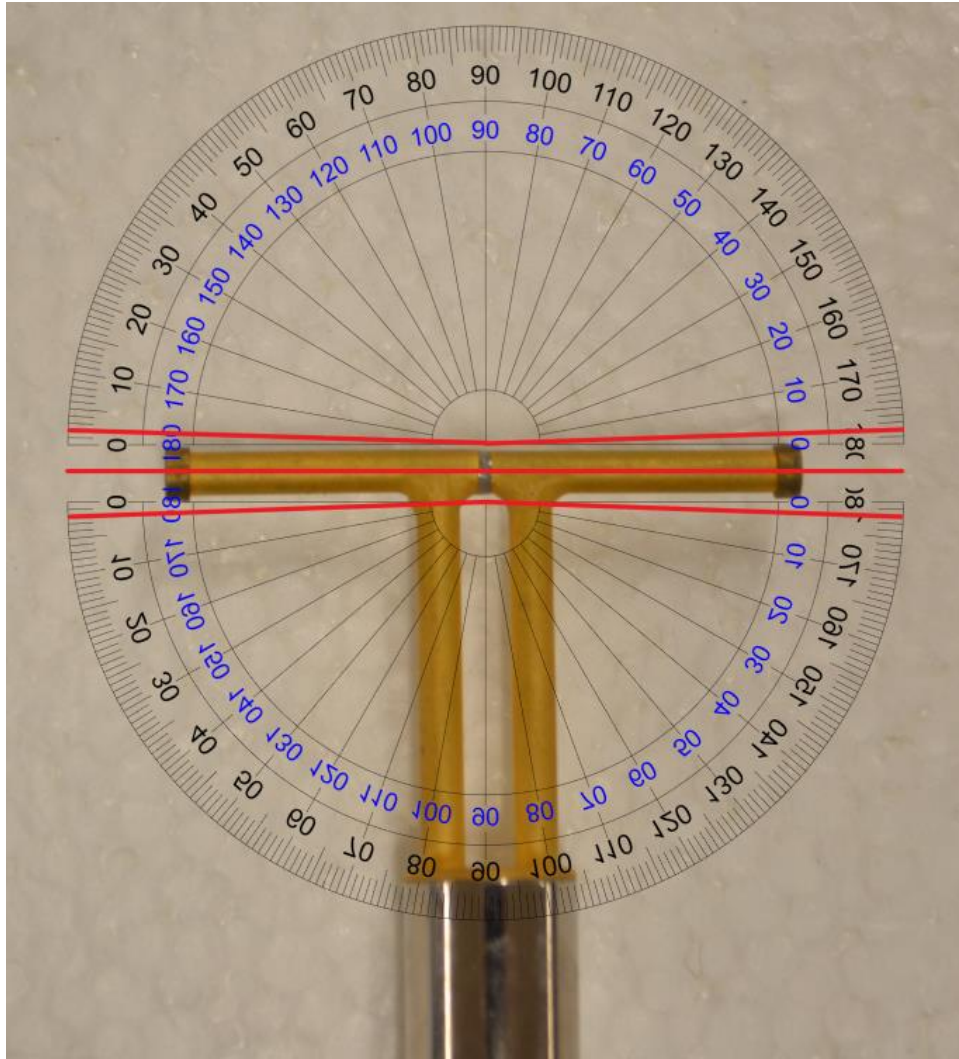
### 19) Dipole Arms

- The center red line indicates that the arms of the dipole fall within  $\pm 2^\circ$

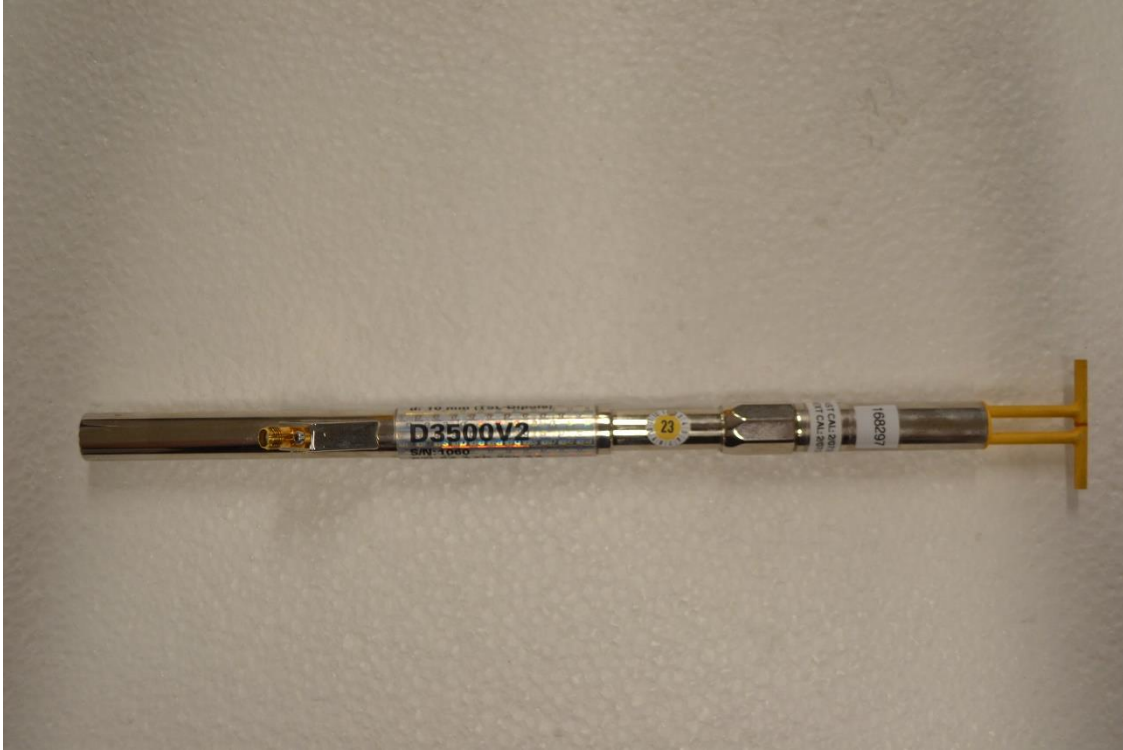
20) Photo of Dipole

- The connector of dipole contains no abnormalities.

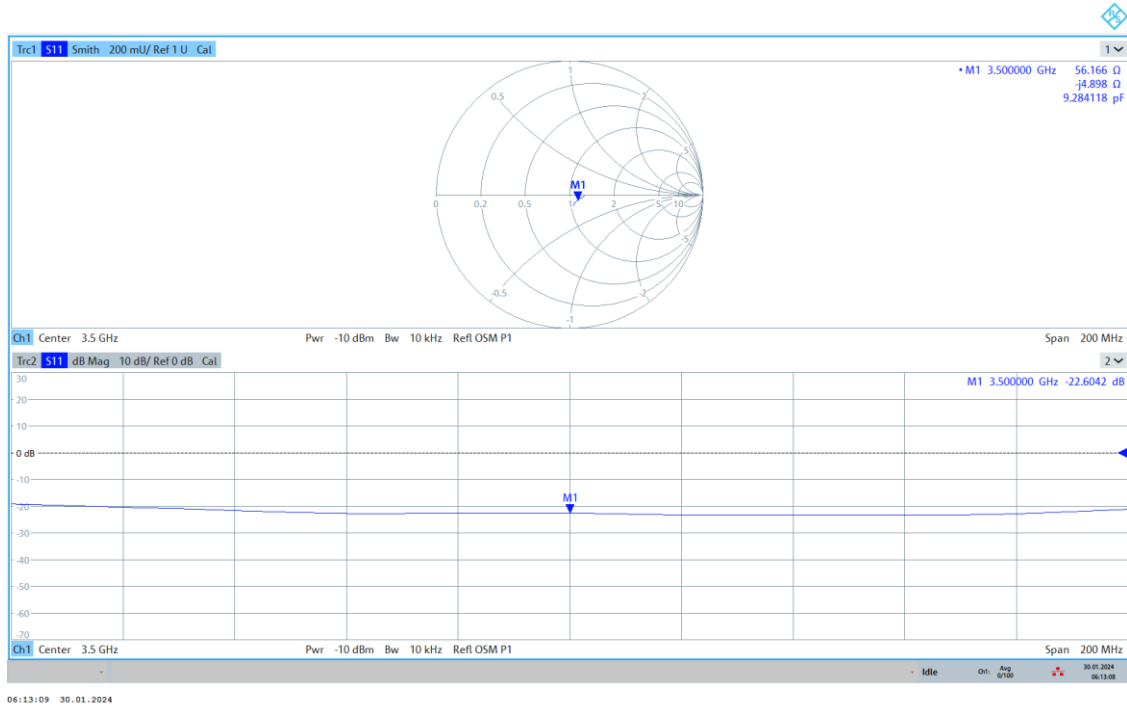
### 21) Impedance and Return/Loss

- Return/Loss is greater than the -20 dB cutoff and Impedance is within 5  $\Omega$  of previous value.

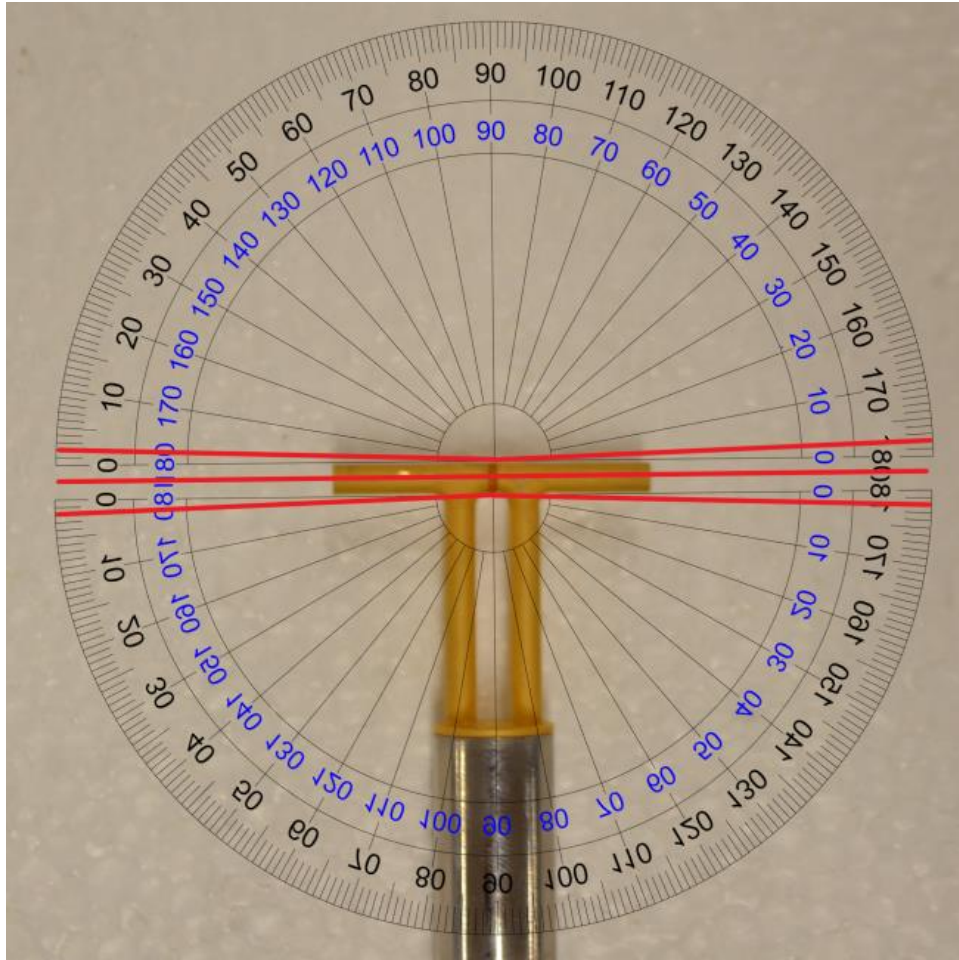
### 22) Dipole Arms

- The center red line indicates that the arms of the dipole fall within  $\pm 2^\circ$

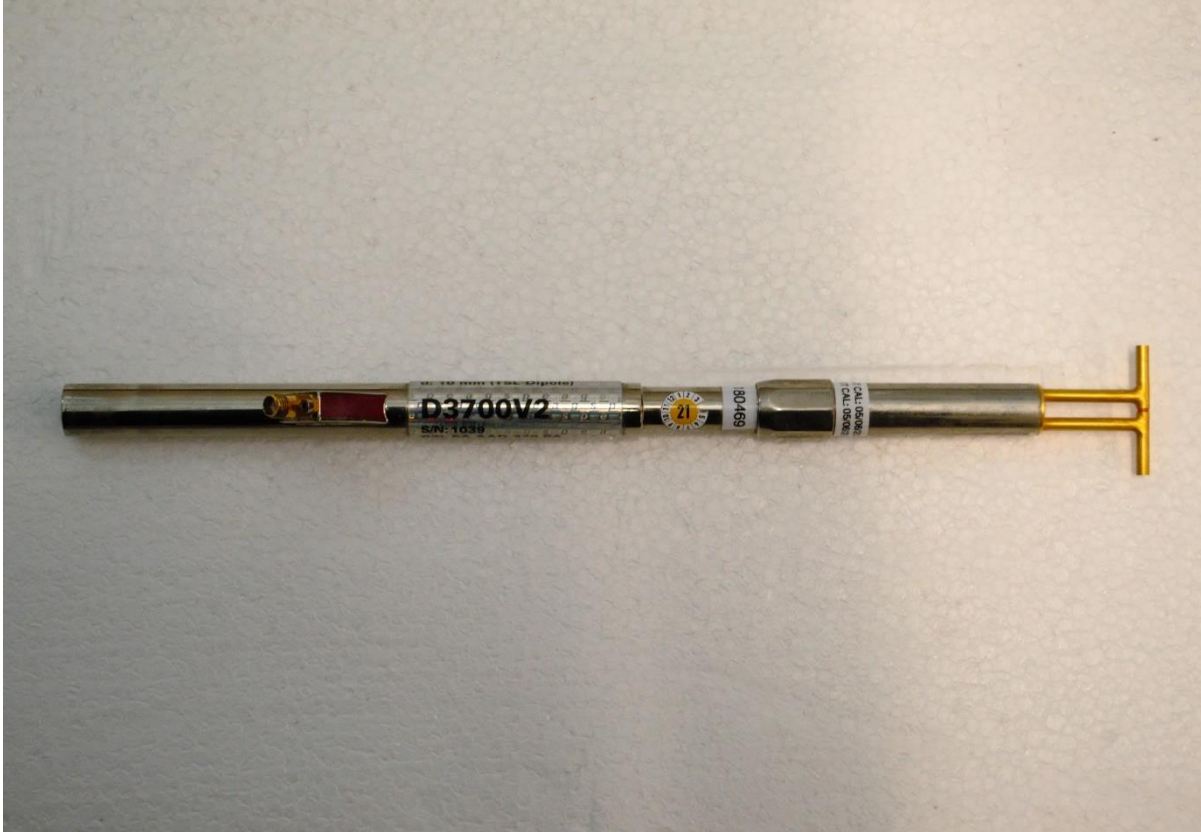
23) Photo of Dipole

- The connector of dipole contains no abnormalities.
