## Dipole Impedance Measurement

Equipment Location	Equipment Name	Model Name	Date of Verification
UL Verification Services Inc. 47173 Benicia Street Fremont, CA 94538, U.S.A.	Dipole Antenna	D750V3-1019	April 13, 2023

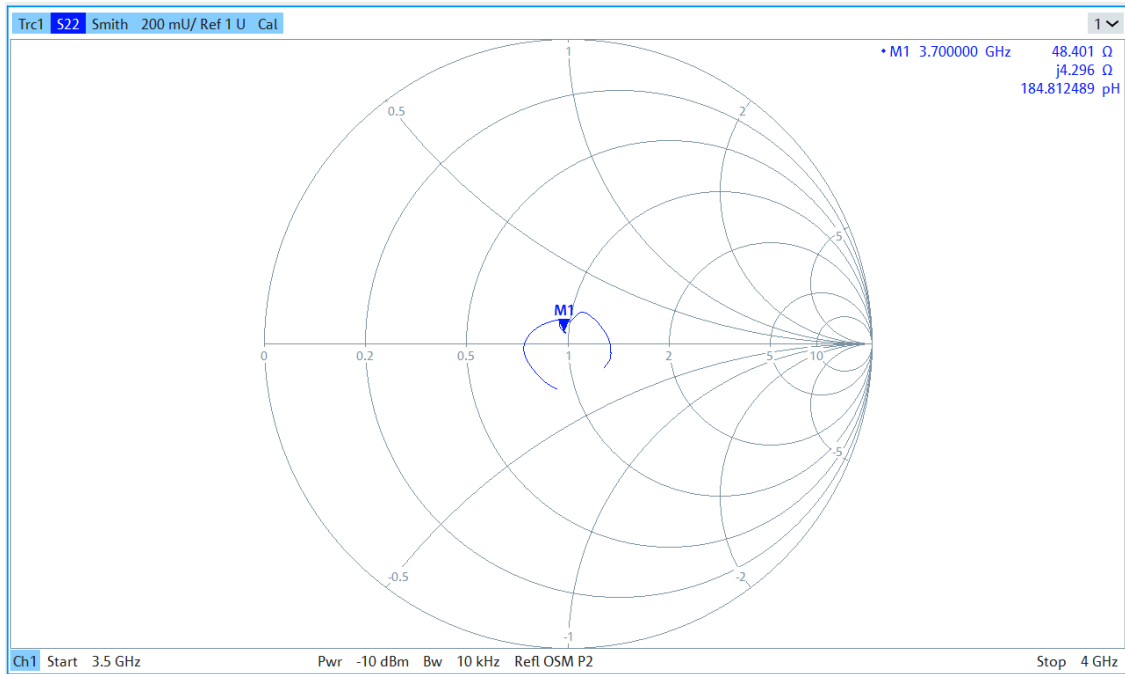
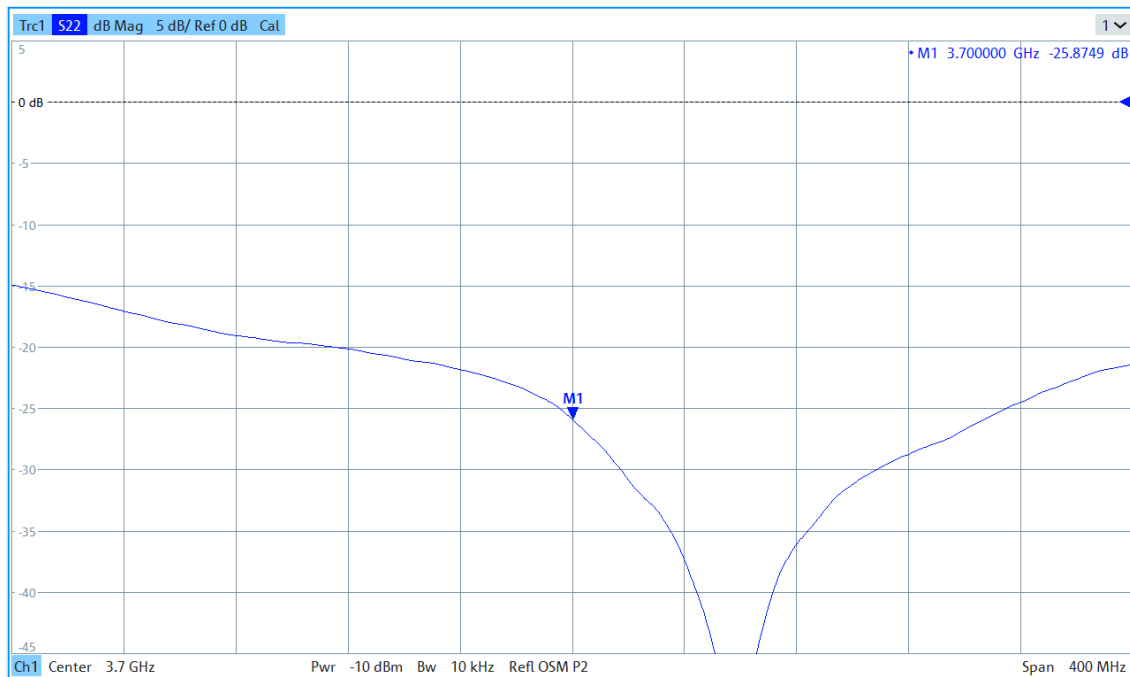
### 24) Impedance and Return/Loss

- Return/Loss is greater than the -20 dB cutoff and Impedance is within 5  $\Omega$  of previous value.

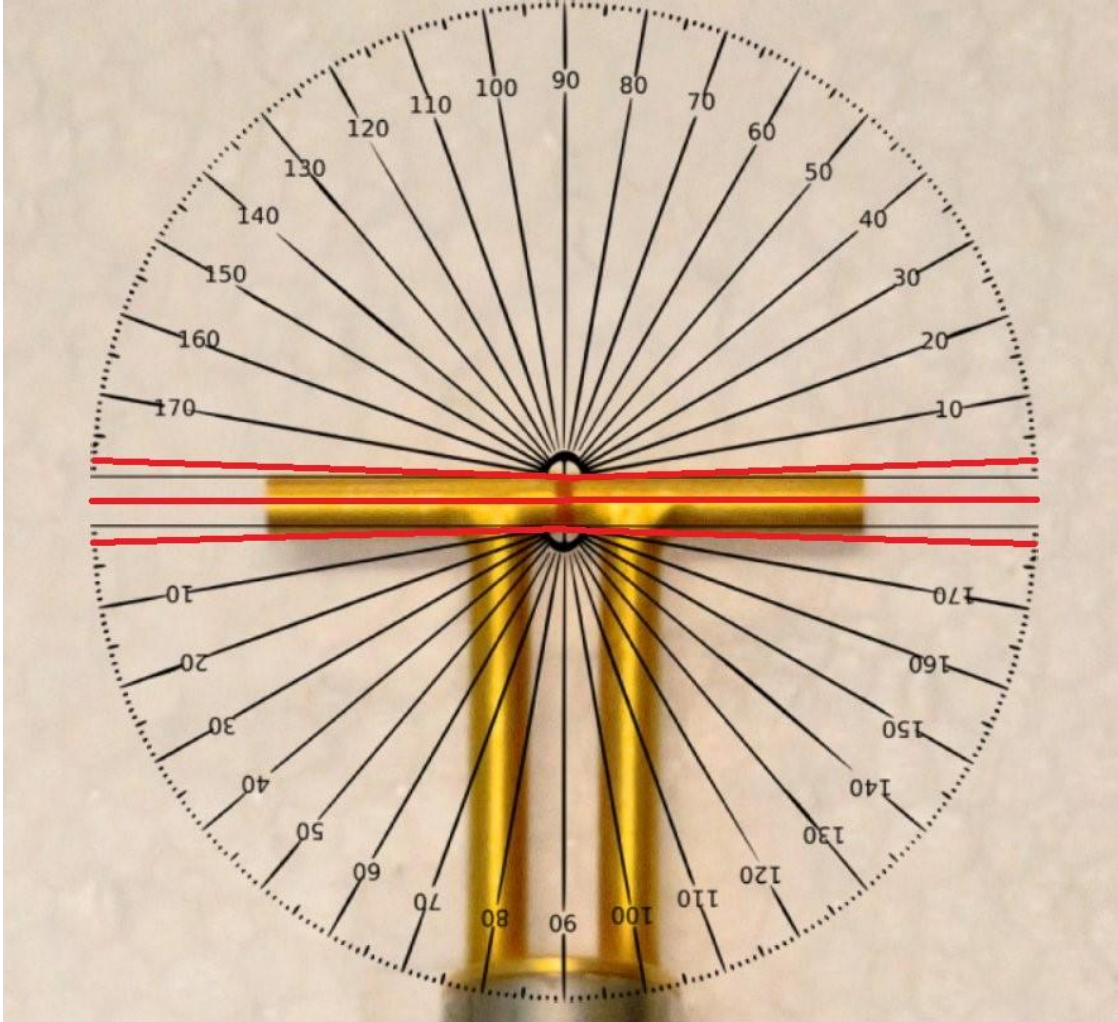
### 25) Dipole Arms

- The center red line indicates that the arms of the dipole fall within  $\pm 2^\circ$
