August 12, 2010

**Request for RF Register change – WMCU Firmware Version TP6 to TP7
(2010 Wireless DJ Turntable Controller – XBOX 360)**

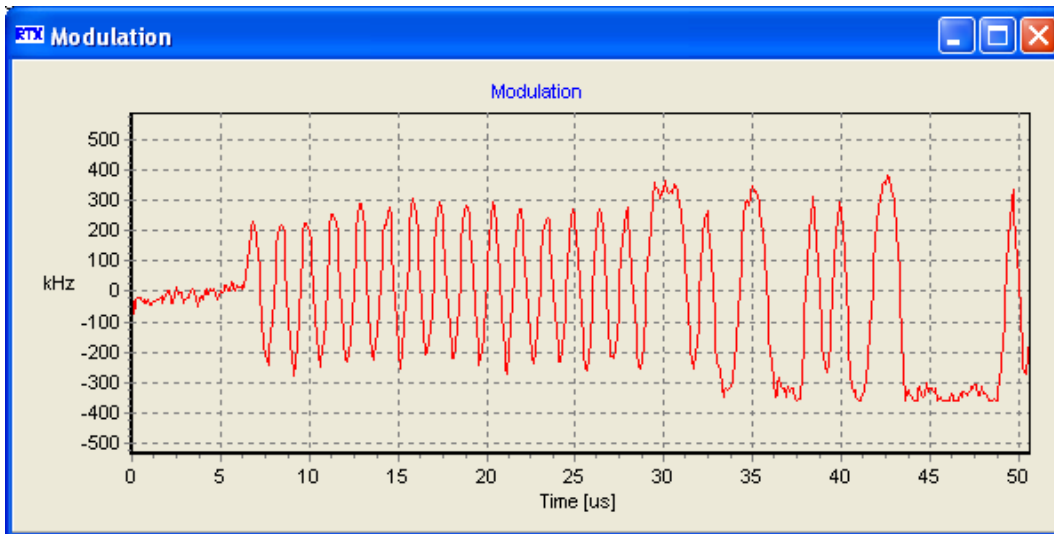
TP7

VCO stability improvement is made by turning on driver stage prior to PA turn on by 2.5us. Previously some frequency offset failures on production line were encountered due to open loop modulation format. Change compliance impact NIL was verified by band-edge analysis (see below).

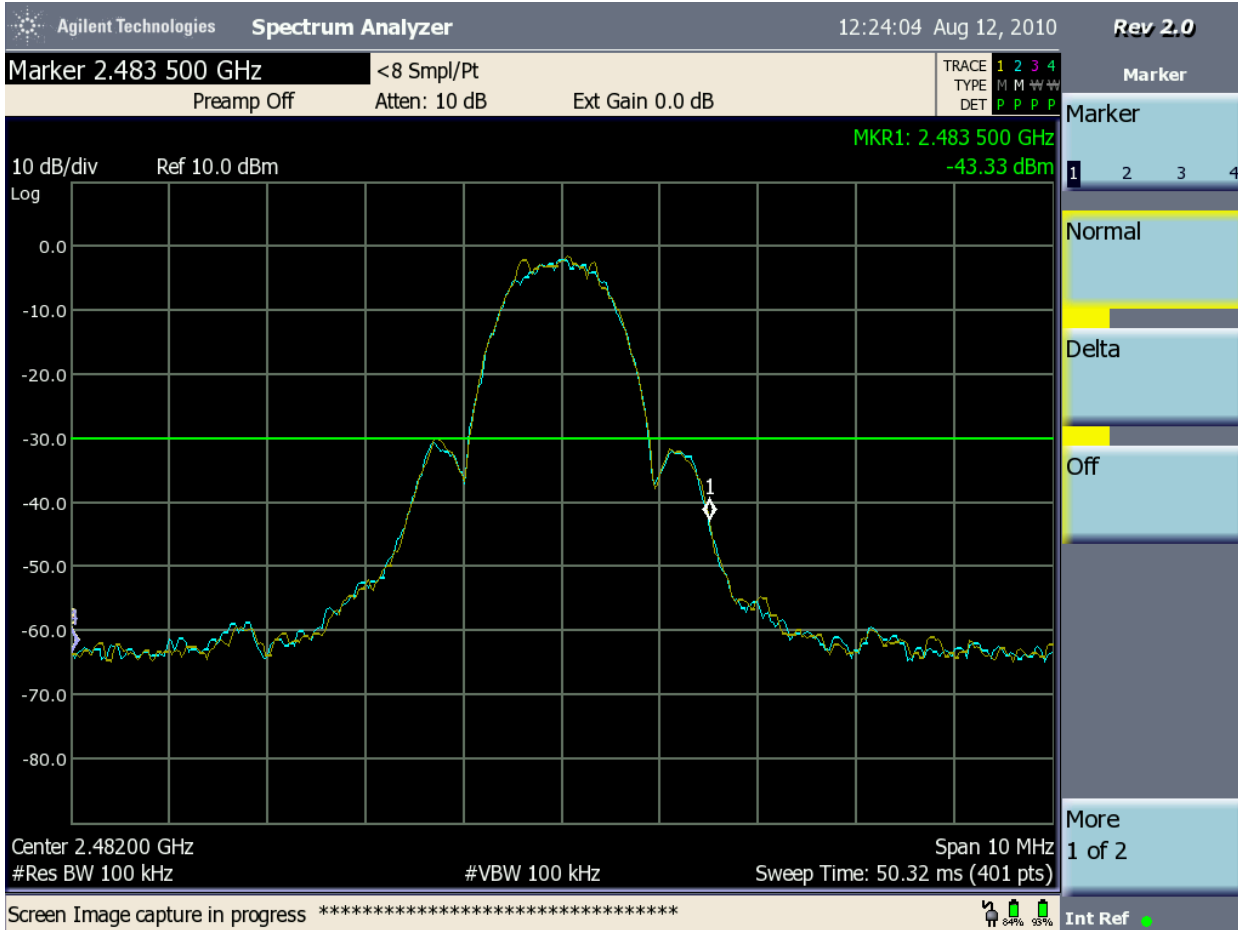
Upper band-edge Pre-change (YELLOW) and Post-change (BLUE)
