SDIS1 HW Change Document

Product: SDIS1
Author: Vivian Kill-Tollnek, Emil Schuster, Tobias Cremer
Approver: CTC Advanced
Date: 28.09.2016
Version: v2.3
Status: Draft
Location: P:\SDIS1\05_SW08_Certification\TCF

1 Introduction of HW42

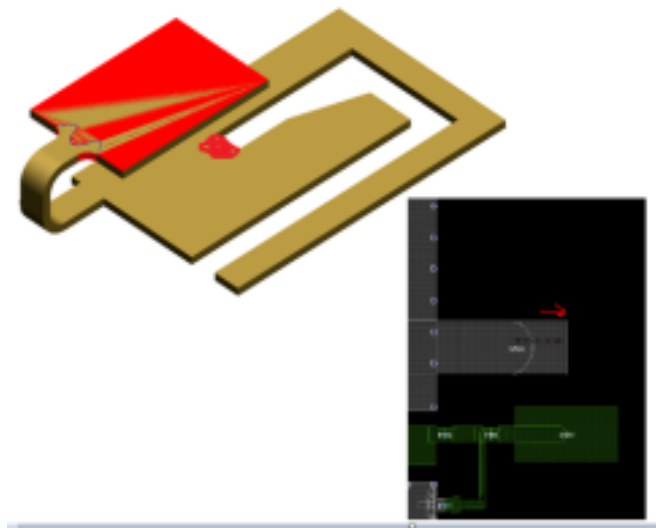
1.1.2.1.1 WiFi antenna 5GHz

Due to mechanical changes, the antenna was de-tuned. The tuning was adapted accordingly.

Pattern tuning + move C-Clip on PCB

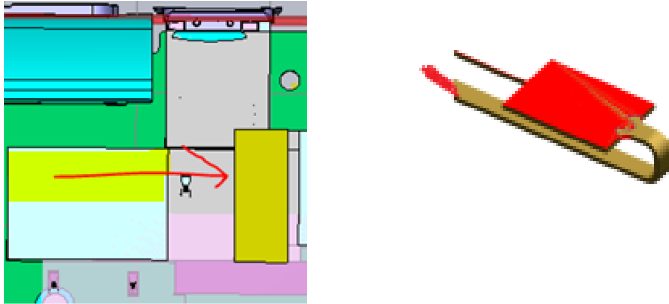
1.1.2.1.2 BT antenna

Pattern tuning + move grounding on audio shielding

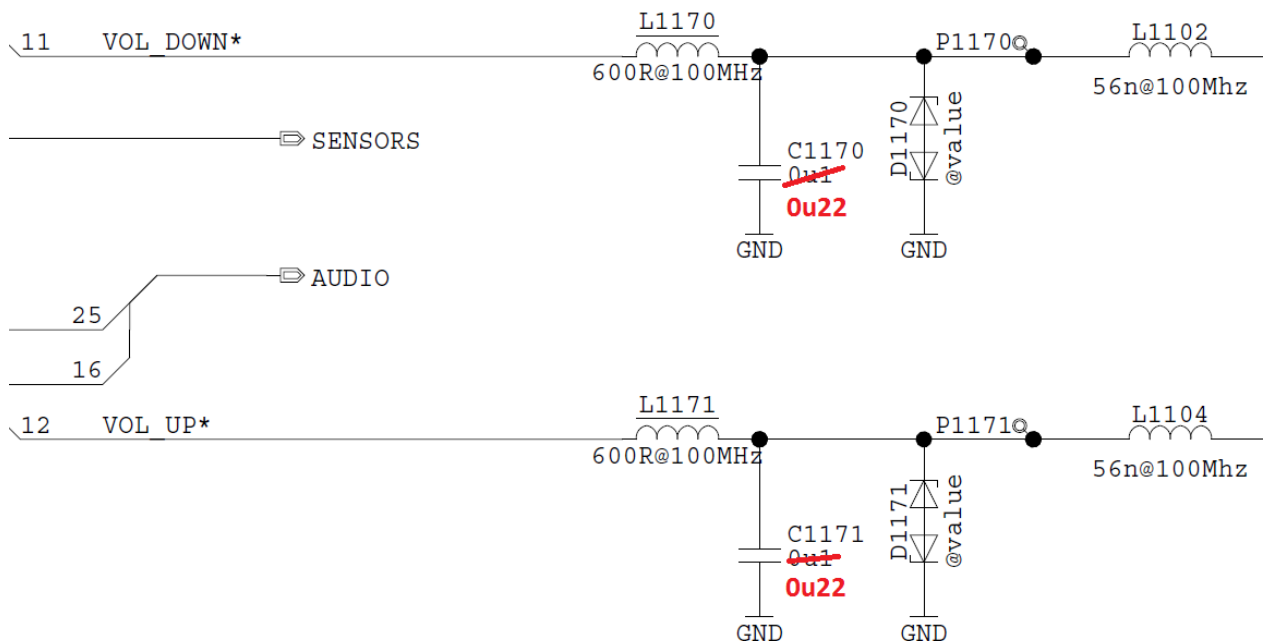
Figure 1 Schematic drawing of change for voltage undershoot correction

Description: Change to Engine PCB to avoid damage of processor

Reason: Signal undershoot at falling edges of VOL_UP* and VOL_DOWN* exceeding absolute maximum ratings of -500mV according to NVIDIA datasheet.

Changes: Increase value of capacitors C1170 and C1171 from 0u1 to 0u22 (1100254 Capacitor 0402 0u22 +/-10 % 16Vdc Murata GRM155R71C224KA12D)

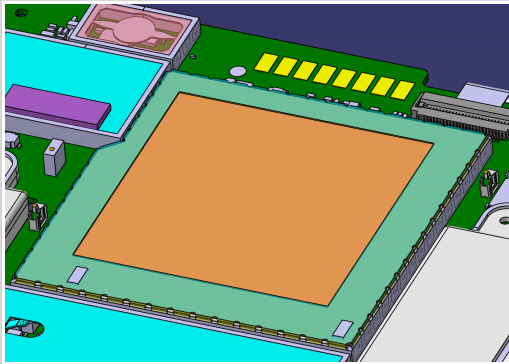
Figure 2 Copper foil before change

Added holes to copper foil to avoid air trapped in under foil in gluing process.

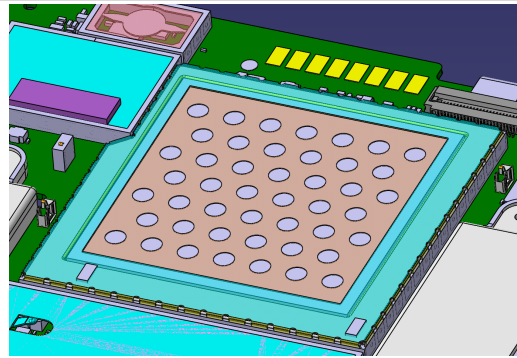
Figure 3 Copper foil after change

Copper foil is still attached to entire metal surface of processor with electrically conductive glue, thus holes do not affect EMI performance.

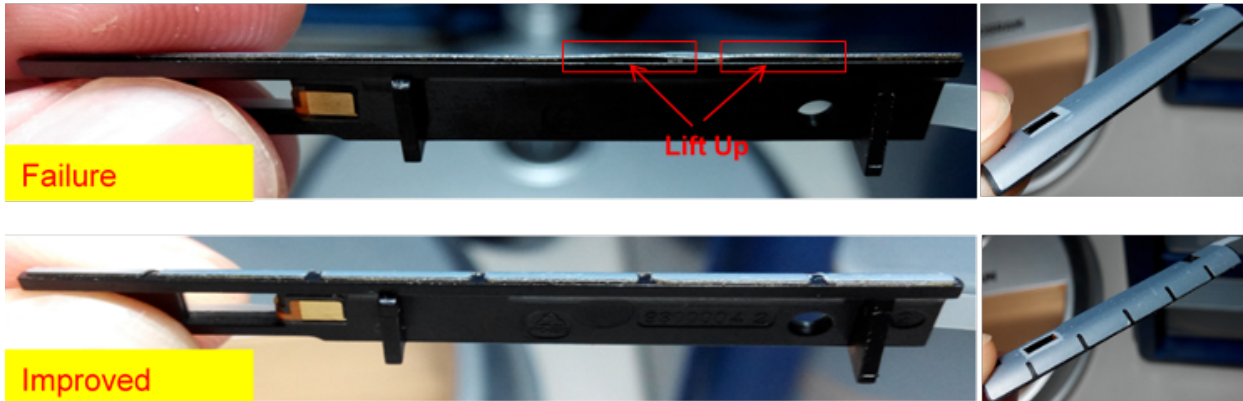
Figure 5 Image of antenna flex change, before and after

Radius of GPS antenna flex is too tight, added cutting lines to improve reliability and keep performance.

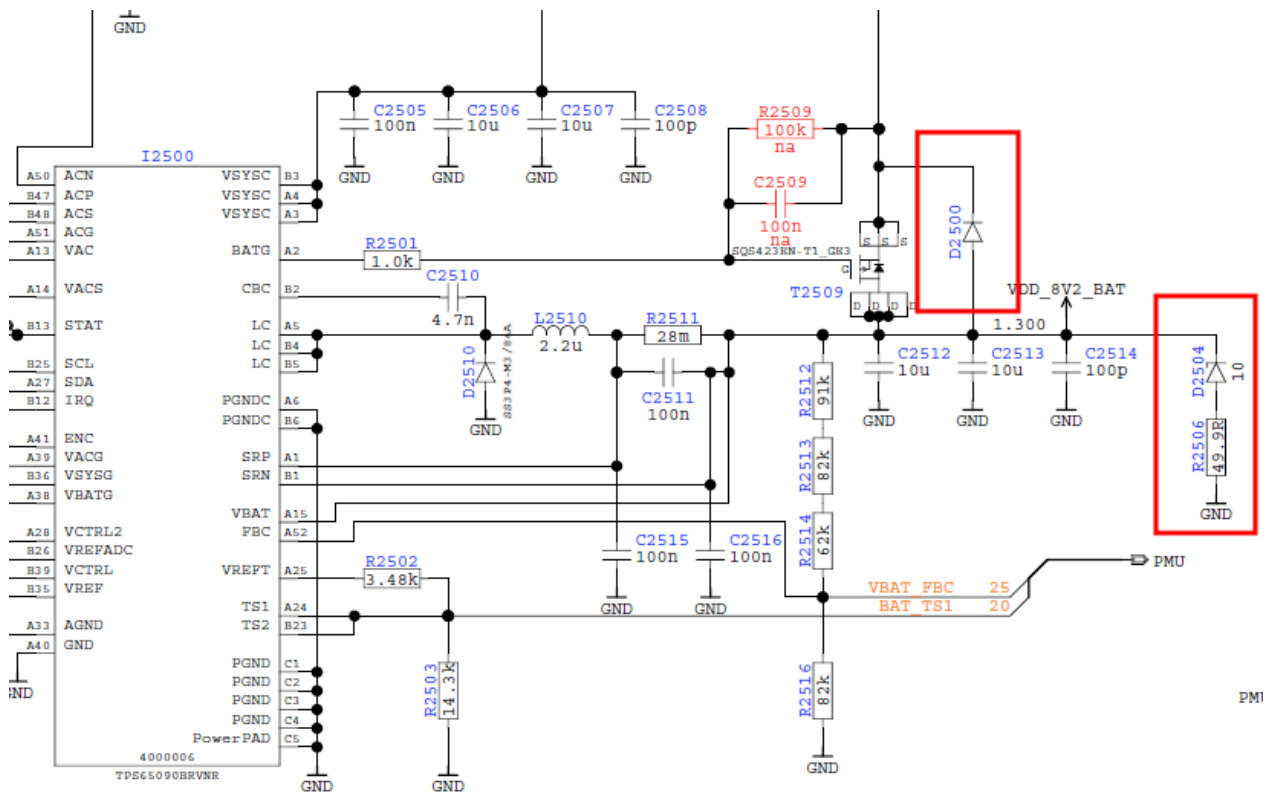
Figure 10 Components added for system crash prevention

Added Schottky-diode and leakage compensation to avoid that system crashes under certain conditions.

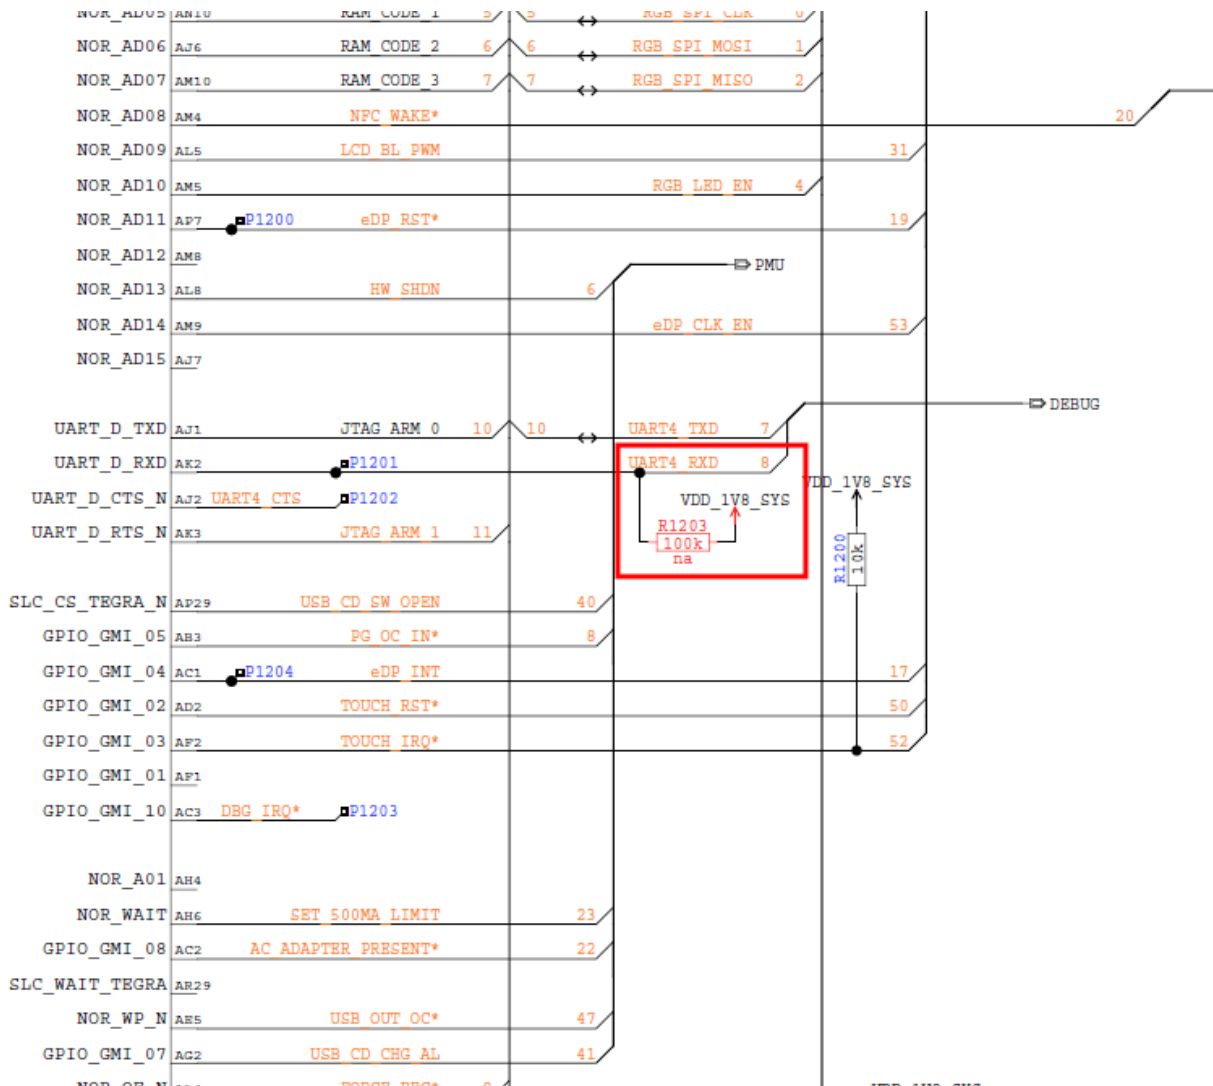
Figure 11 Component added for RX line termination

Rx (signal to VCM) line of internal debug connector is currently floating and needs to be terminated to avoid false input signals.

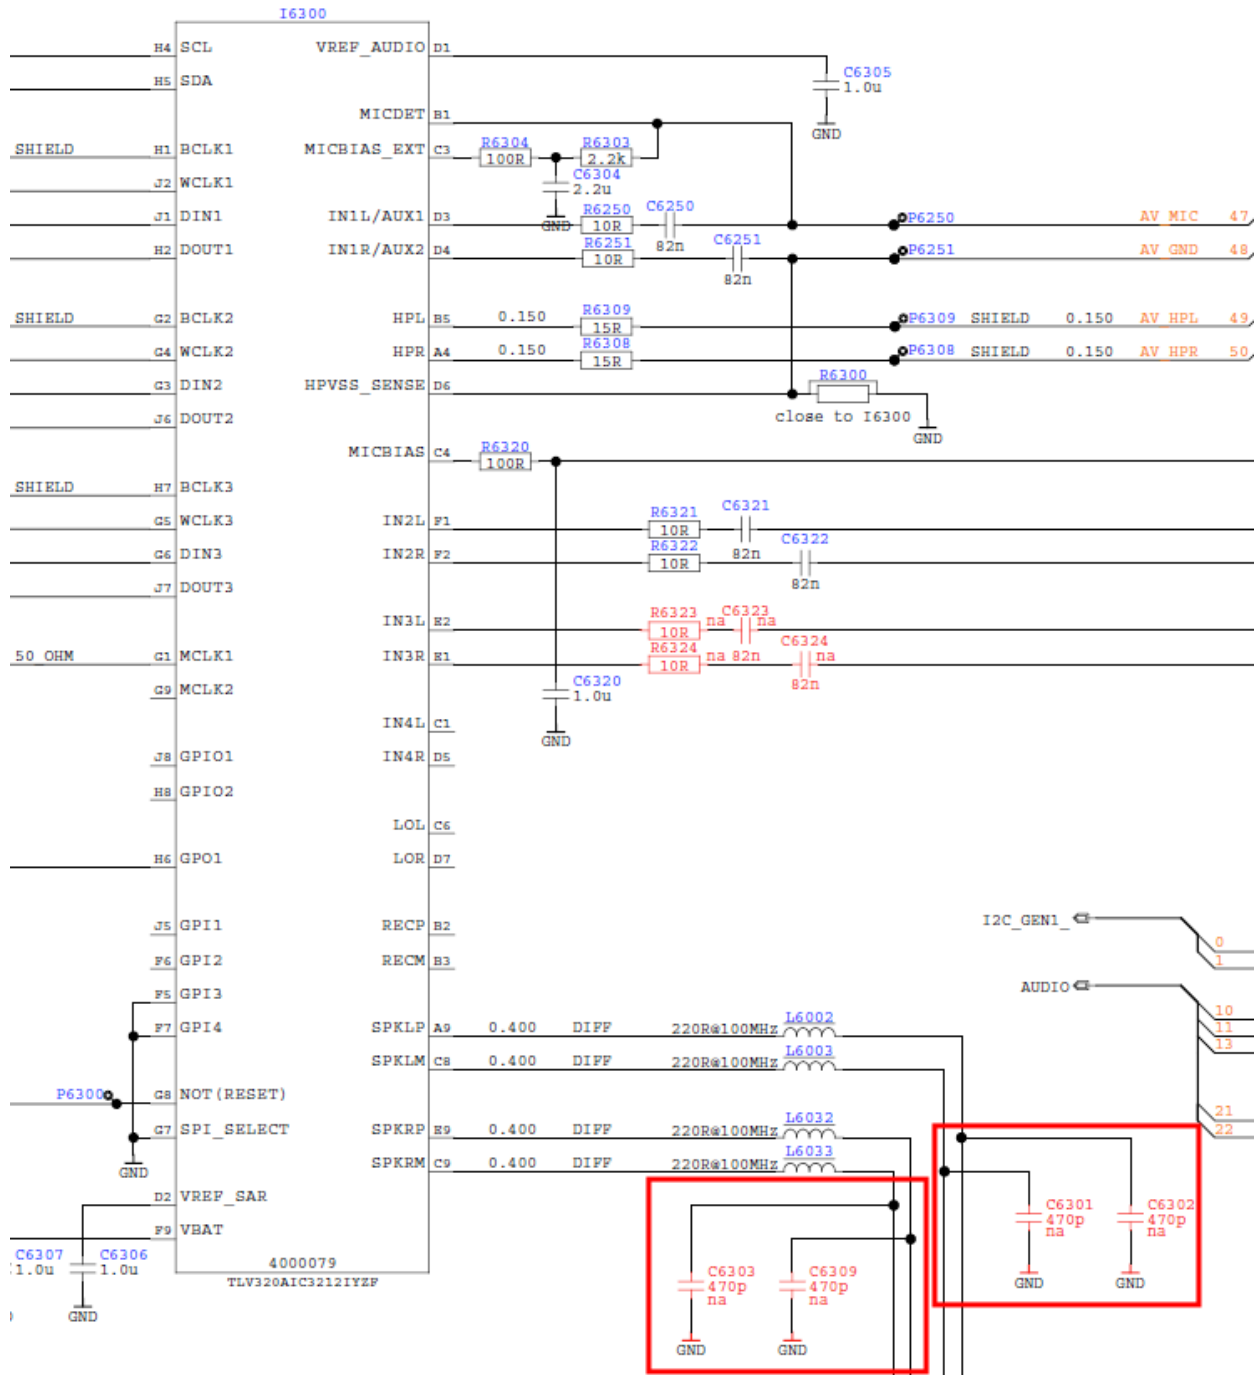
Figure 12 Components added for EMC correction at 750kHz

1.1.2.9 EMC correction for radiated emissions at 750kHz

Added one capacitor to ground at each audio output line of the audio codec I6300. Capacitors to be placed after ferrites L6002, L6003, L6032, L6033 to ground. Parts to be set to not assembled.

Description of the capacitor: Capacitor 0402 470p +/- 5% 50Vdc AEC-Q200

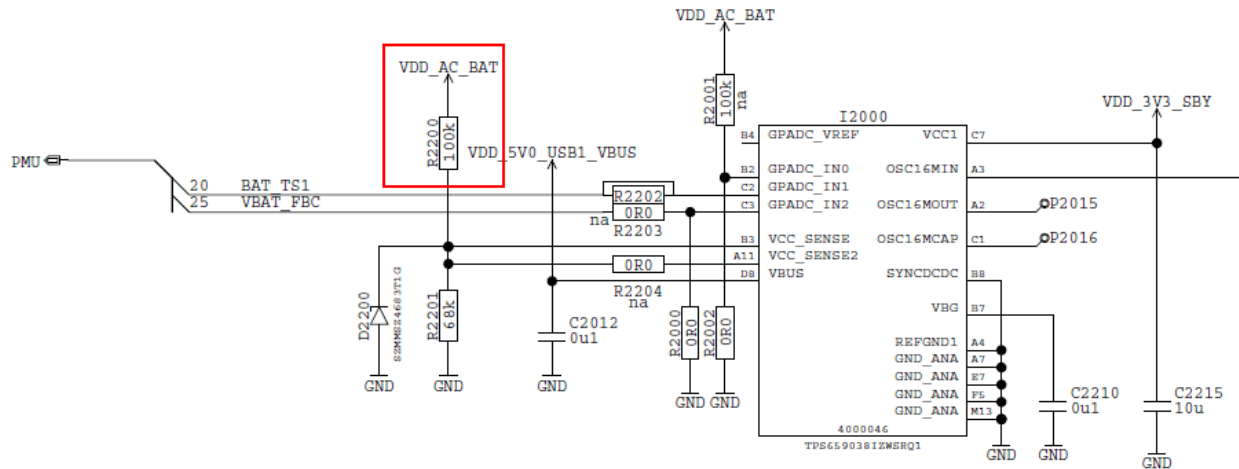
Figure 13 Schematics before change

Debouncing circuit to improve user experience by decreasing response time of power button press while device is being started in charger/hidden mode.

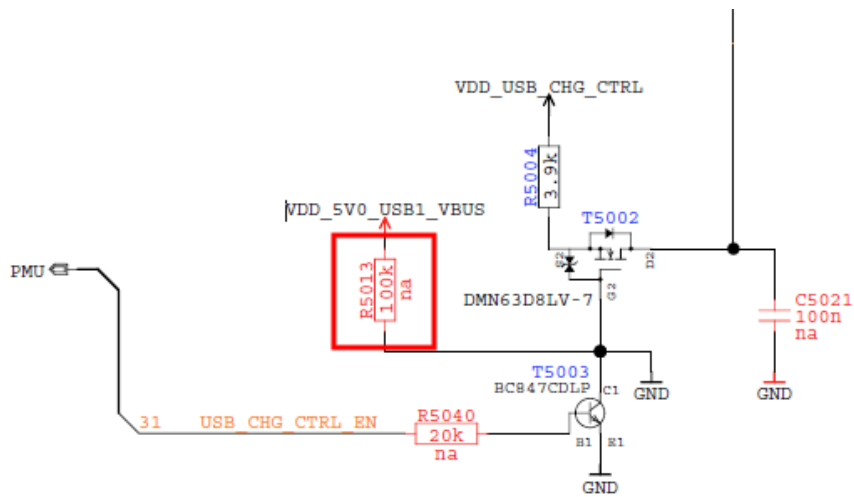
Figure 15 Schematic drawing of component added for USB-charging stabilisation

Reason: Corrects a potential malfunction in USB charging mode, to allow for reliable charging with 500mA

Technical solution: One additional ground connection (via) on engine PCB.

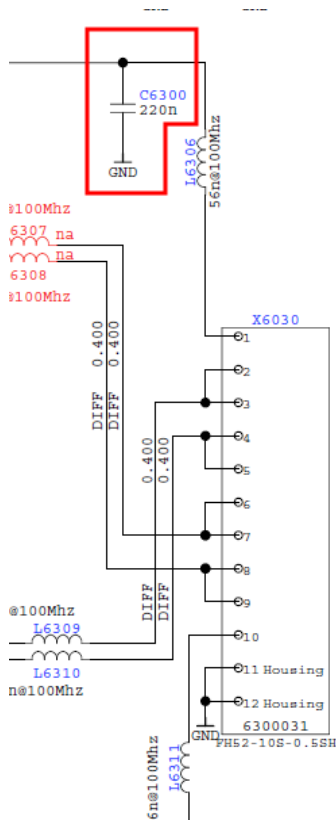
Figure 16 Voltage undershoot correction: change in schematics

Current circuitry creates unwanted voltage-undershoot, which is not allowed (could harm application processor)
 Solution: Implementation of one additional capacitors on engine PWB.

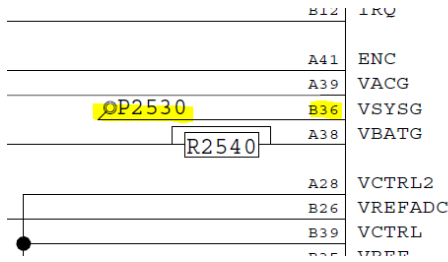
Figure 18 Schematic before change

In case of unexpected system-power-cut to PMIC, the component must be shutdown via HW trigger (NSLEEP), to prevent potential damage of the component.

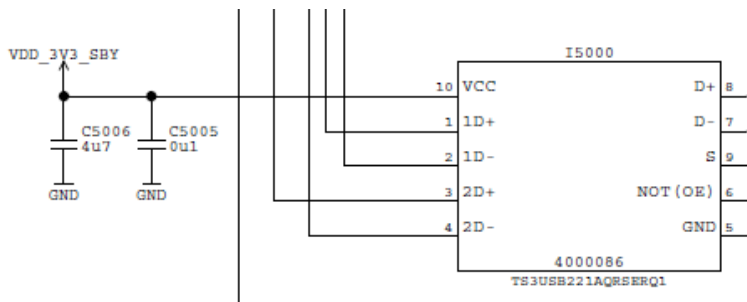
Figure 20 Schematics before change

Power supply for USB-Mux (I5000) needs to be re-assigned from VDD_3V3_SBY to VDD_5V_USB1_VBUS, correct supply voltage needs to be set by resistive voltage-divider and one zener-diode.

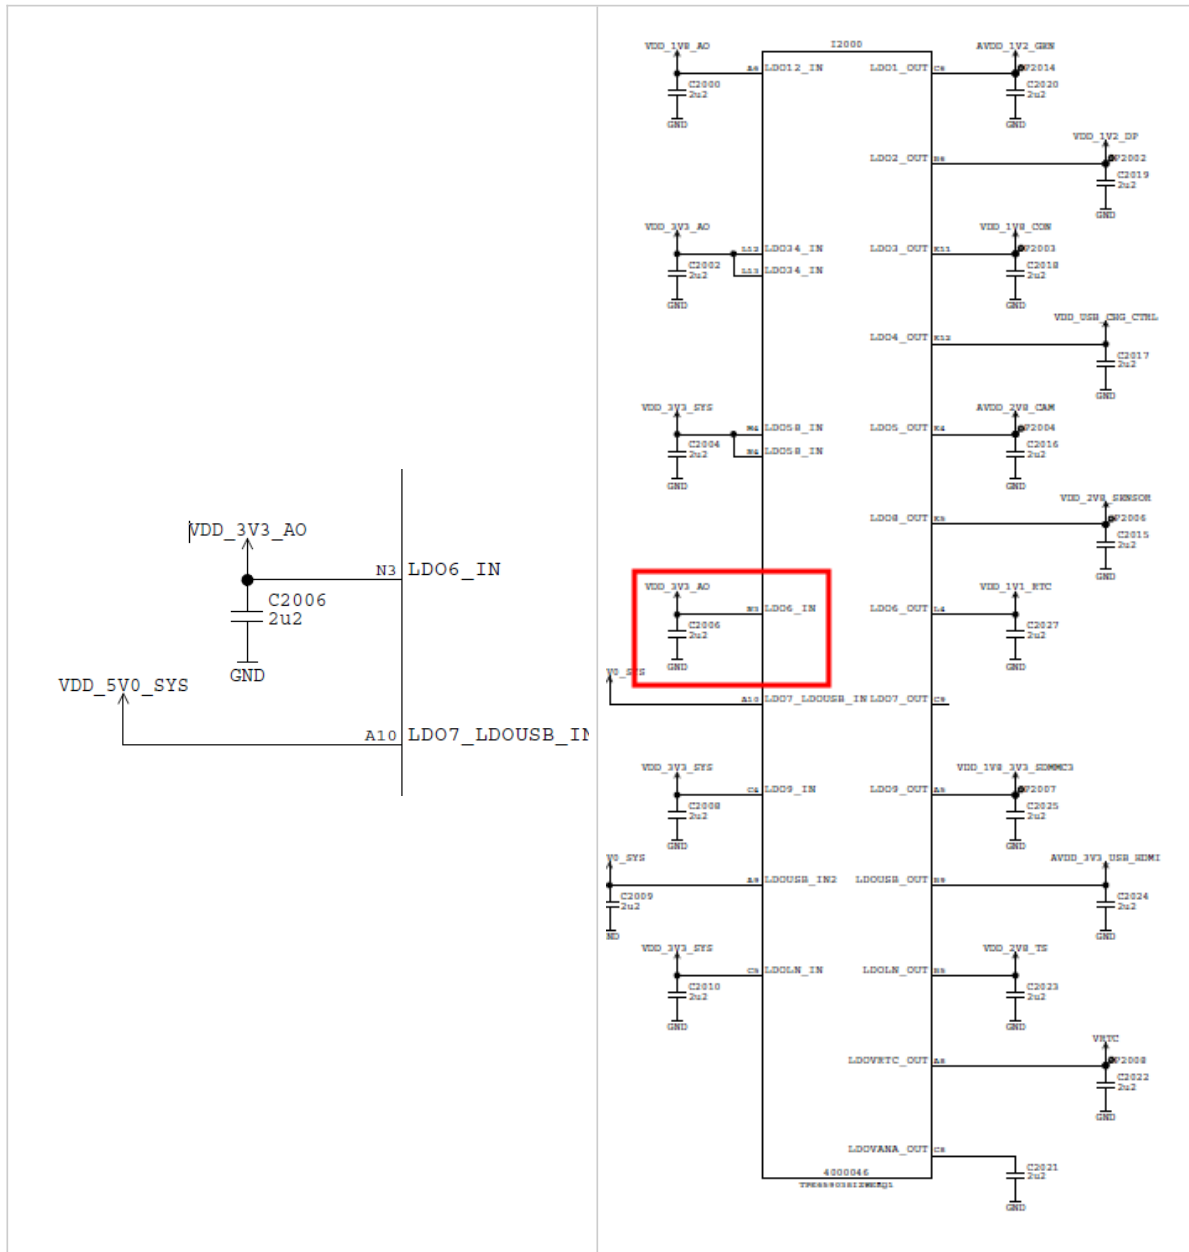
Figure 25 Detailed schematics before change

Power sequence for LDO6 input needs to be modified, in order to prevent PMIC deadlock under rare condition.

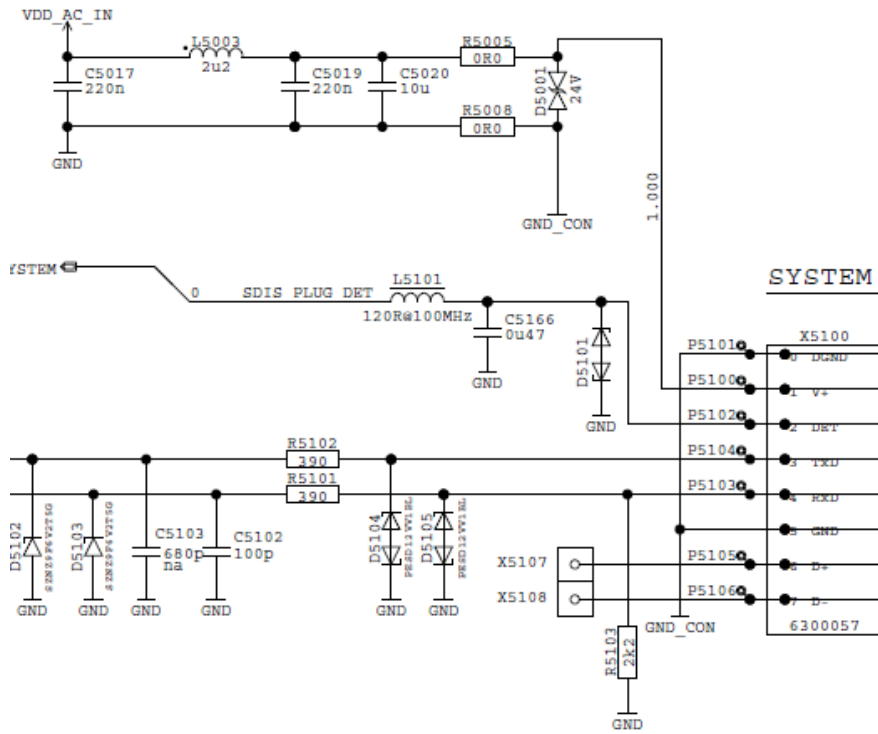
Figure 27 Schematics before change

1.1.2.19 EMI correction for emission at 156MHz, radiated by harness

Changes to Engine PCB required to add a 2n2 50V 0603 capacitor to the V+ Supply close to the system connector. Removal of 0 Ohm Resistors in Supply Lines.

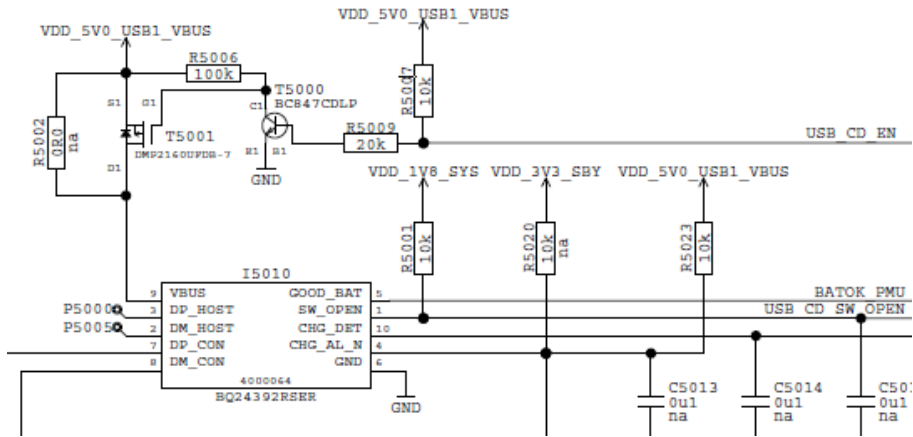
Figure 29 Schematics before change

Update for PCB and components. in order to avoid non-deterministic behaviors of GPIOs after boot up and damage of VCM after ~60k boot cycles.

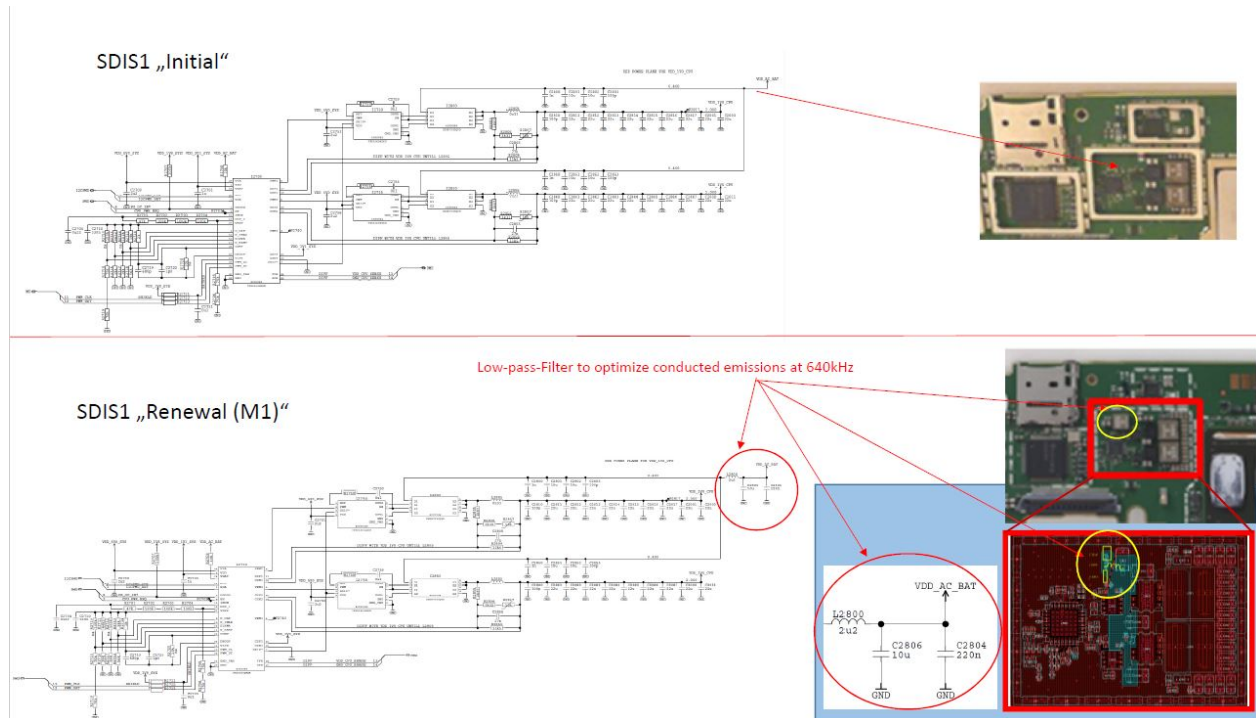
Figure 31 Comparison of schematics

1. The modifications shown in “M1” are incorporating a low-pass-filter, in order to optimize the conducted emissions behavior at 640 kHz
2. The low pass filter is comprising
 - a. Shielded power inductor: Coilcraft XAL4020-222ME 2.2.uH
 - b. Capacitor: Murata GCM188R71E224KA55D 220nF
 - c. Capacitor: Murata GRM21BC81E106KE11 10uF
3. The SDIS1 passed official testing at CETECOM including this low-pass-filter

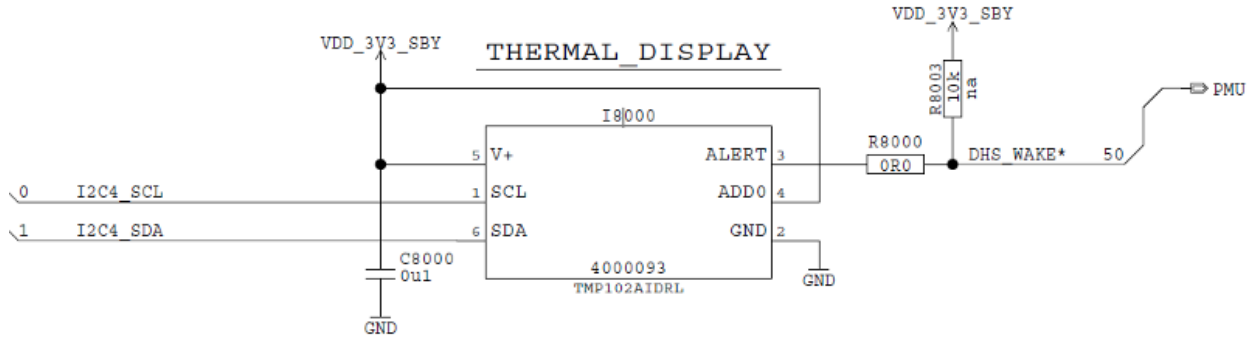
Figure 33 Schematics of Thermal Display before change

Reason: Wake-up the system when battery power comes back with temperature decreasing after interruption at 80°C, so that TMP102 can be reconfigured via software after POR.
