Re: *DIRECTV Enterprises, Requests for Special Temporary Authority*  
*File No. SAT-STA-20050414-00083*  
*File No. SAT-STA-20050427-00091*  
*File No. SAT-STA-20050517-00104*

***Background on "Tin Whisker" Failures***

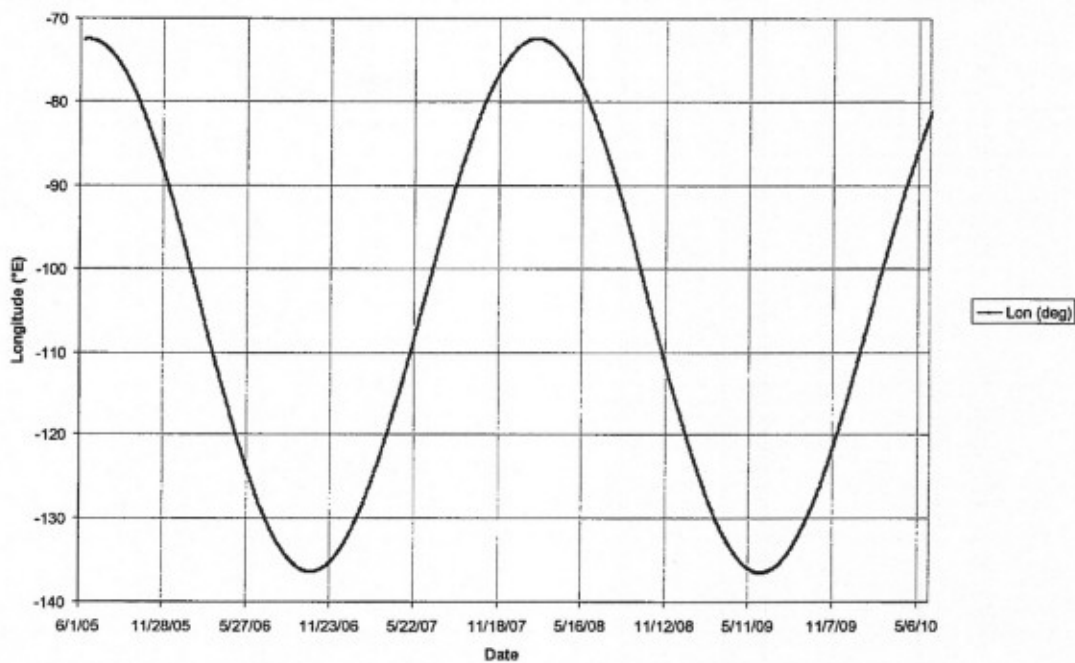
**Figure 1. Longitude vs. Time  
(5 years)**

If both SCPs on a satellite become disabled, it is no longer possible to control the satellite position. Figures 1 through 4 show the change in orbit longitude (east-west) and inclination (north-south) and apogee/perigee (radial) over time for such a case, assuming the failure occurred at 72.5 WL. The possibility of contact with another satellite diminishes over time. Figure 2, which is an expansion of the data in Figure 1, shows that although the eccentricity and therefore east-west longitudinal movement begins immediately, the satellite is still within the 0.05 degree station keeping constraints shown by the horizontal lines for about three weeks. This, interestingly, is one advantage of moving a satellite susceptible to SCP failure away from a crowded orbit position such as 101° WL, where six satellites currently operate. As Figure 3 depicts, the inclination of the orbit is also growing linearly at about one degree per year and the apogee and perigee

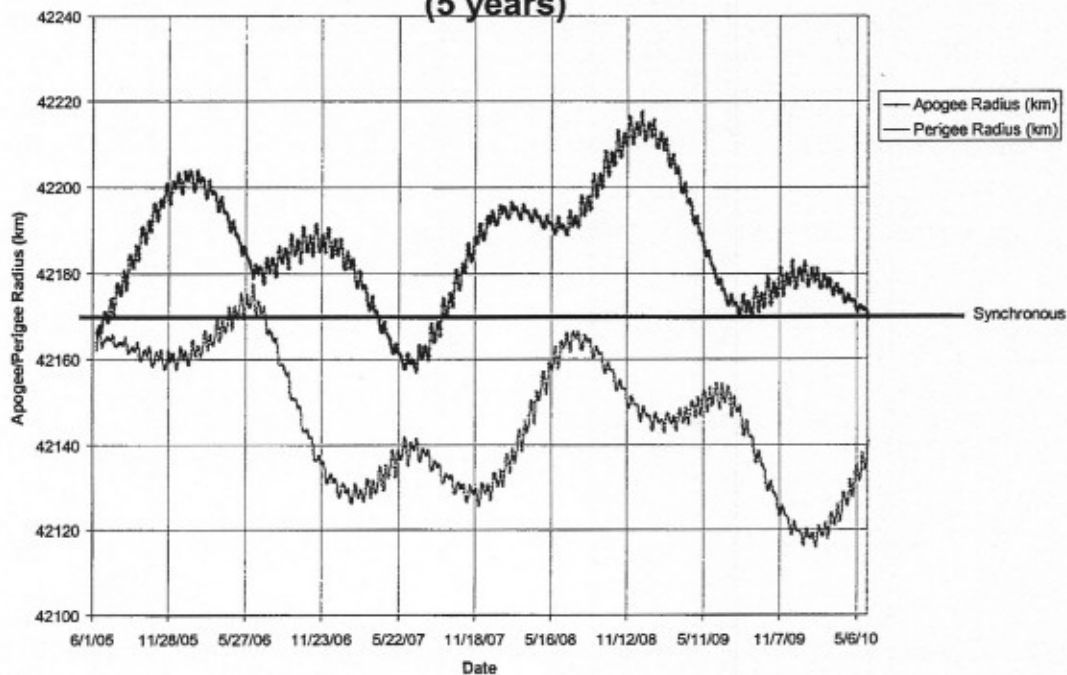
**Figure 4. Apogee and Perigee vs. Time  
(5 years)**

also diverge from synchronous as shown in Figure 4. The three measures of position (east-west, north-south, and radial) all diverge from the geosynchronous arc, and although the satellite will pass through the equatorial plane, the crossings are displaced from the geosynchronous arc. This is somewhat analogous to a satellite in transfer orbit passing through the equatorial plane. Therefore, although the satellite would remain near the geosynchronous arc, it is clear that as time passes the chance of contact with another satellite diminishes.
