Internal photos

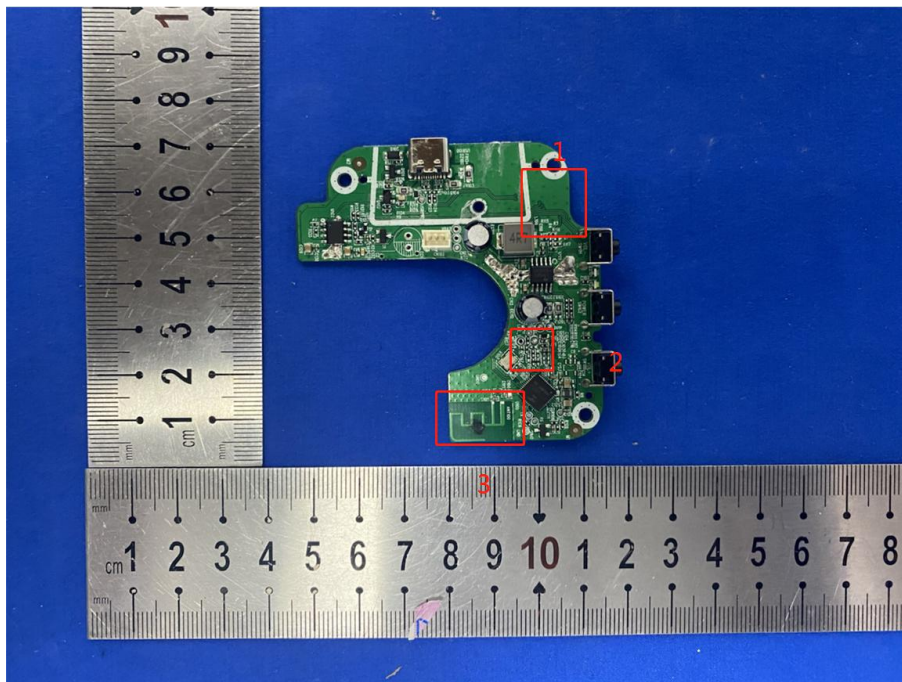
The solder joint test was cancelled at position 1, the line layout was optimized at position 2, and the antenna was lengthened at position 3
