Document number  
BGLI08:494  
Date  
2008-06-05  
Remarks

## HW change description for

**Mobile Station Type:**  
**AAD-3252041-BV W760i**  
**HW (B)**

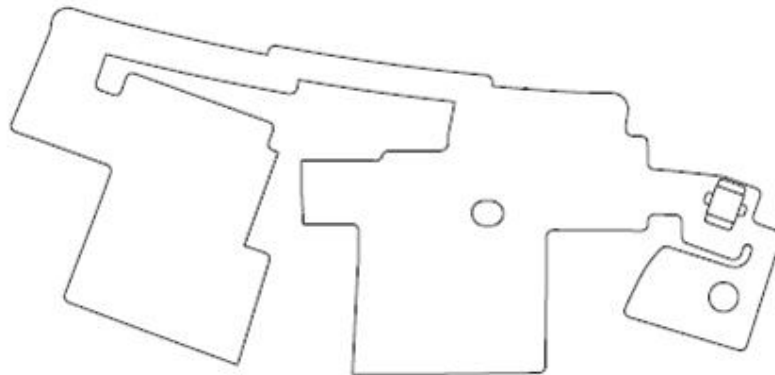
#### HW-B

For HW-B, the element shape has changed and the pre-distortion matching circuit has been eliminated.

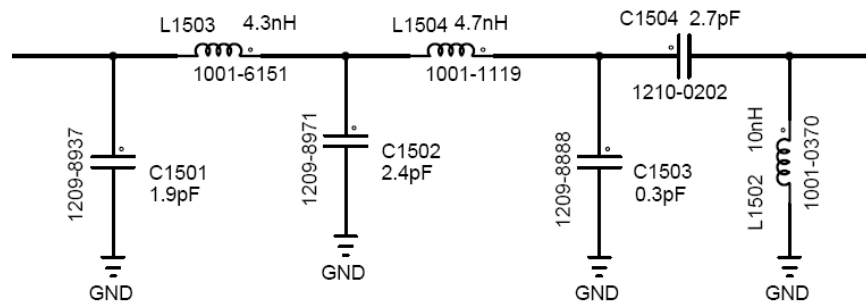
**HW-A**

HW-A used a 7 component LCCLCLC matching circuit. HW-B uses only a 2 component CL circuit. For HW-B, C1501 through C1503 are no-mounted (<NM>) and L1503 and L1504 are replaced with 0 ohm resistors. C1504 is replaced with a 2.2nH inductor and L1502 is replaced with a 0.5pF capacitor.
