American Telecommunications Certification Body Inc.  
6731 Whittier Ave, McLean, VA 22101

RE: Cisco-Linksys, LLC

FCC ID: Q87-WGA54AG

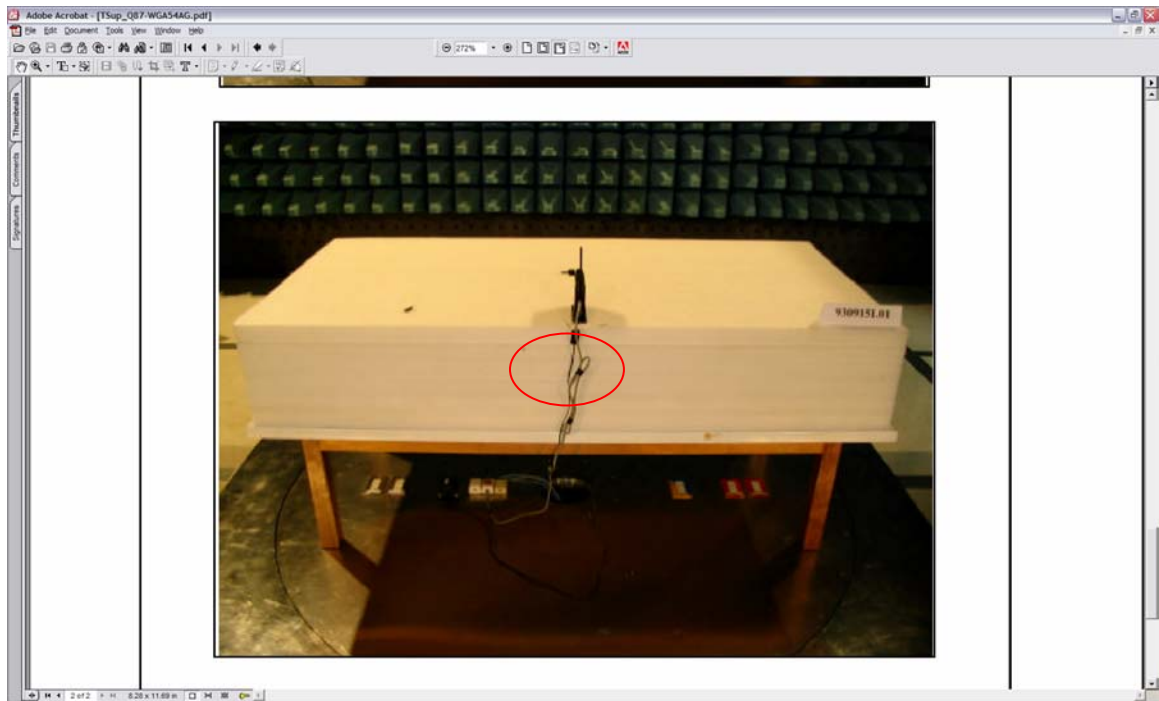
- 1) The users manual appears to be missing the information required by 15.21. Please correct.
- 2) Please confirm if the AC power line contains a ferrite. There appears to be a ferrite on this cable in the test photographs, but the test report (page 11) states no core was present. Please explain and correct as necessary.
