**Engineering Change Request (ECR) Okt-2018 – DT750 BLE
TCN015 + 5103A-015**

Modification of antenna pcb

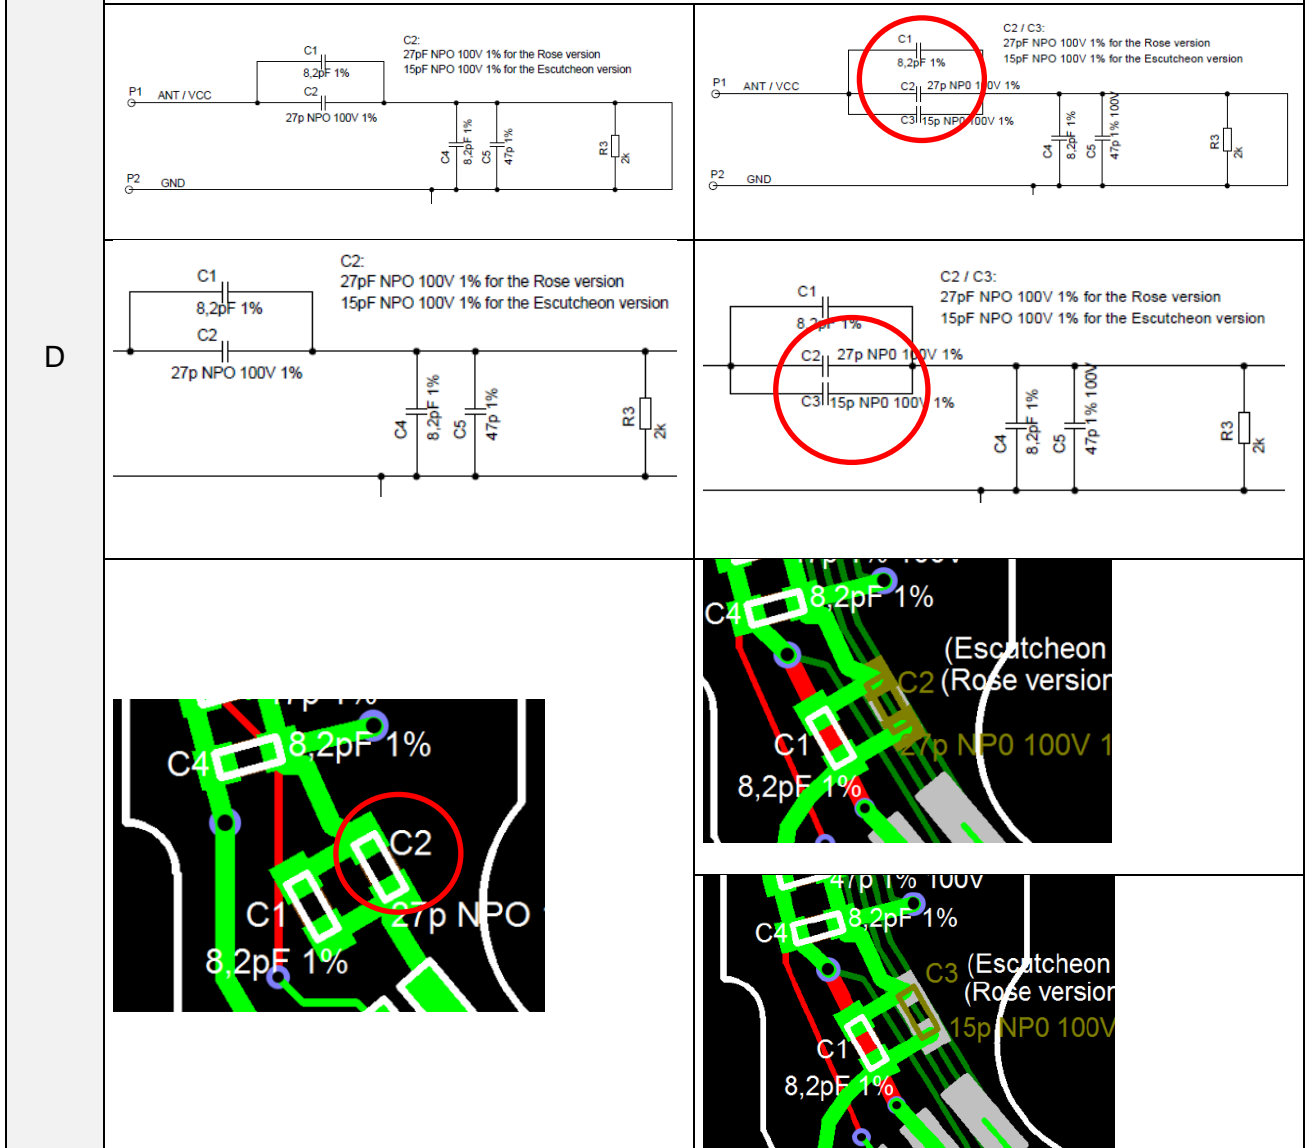
C3 for Escutcheon version added. C2 and C3 share the same pcb position. It is not possible to place both at the same time.

This change results in two different BOMs:

- 3.164.022.60c BOM SHS-92 V1.4 (Rose version)
 - C2 included
 - C3 not included
- 3.164.022.60c BOM SHS-92 V1.4 (Escutcheon version)
 - C2 not included
 - C3 included

Cause of modification: Optimization of BOM handling

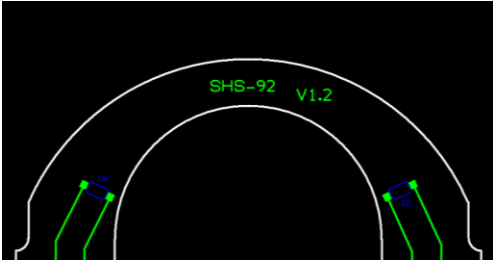
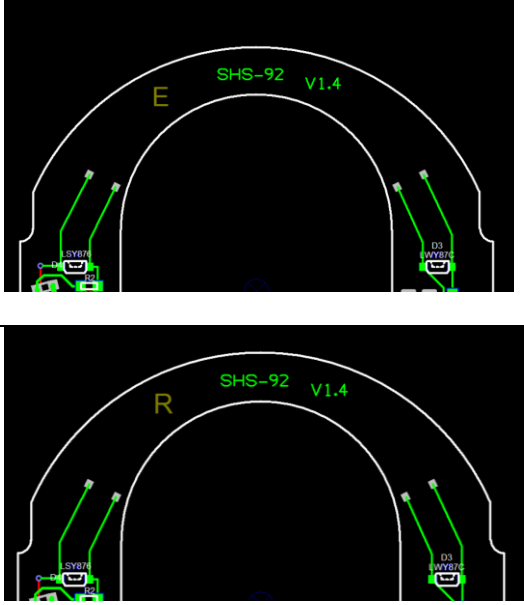
E	added "E" / "R" in the silkscreen layer of the pcb Cause of modification: Optimization of pcb handling in production
