A.4 POWER SPECTRAL DENSITY

UTTR-RF-RSS247-V1.1

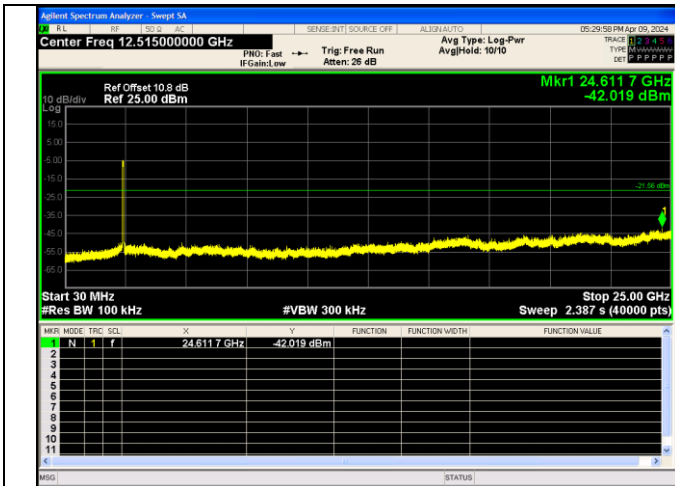
Spurious Emission
IEEE 802.11ax Channel 3 40MHz Antenna 0 RU&Index SU

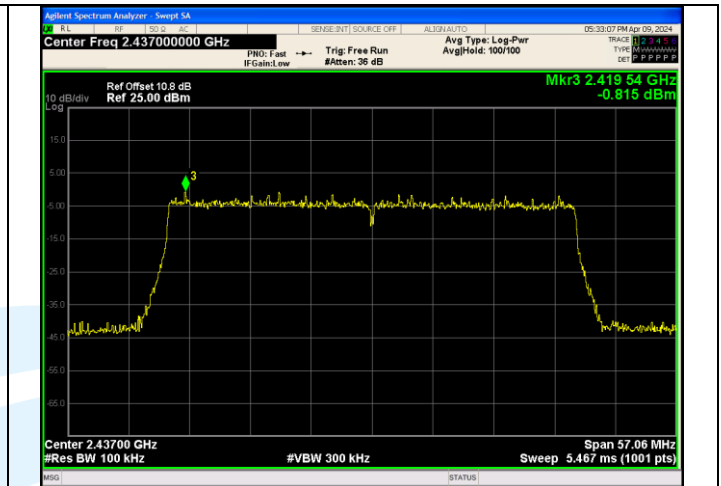
In-Band Reference Level
IEEE 802.11ax Channel 6 40MHz Antenna 0 RU&Index SU

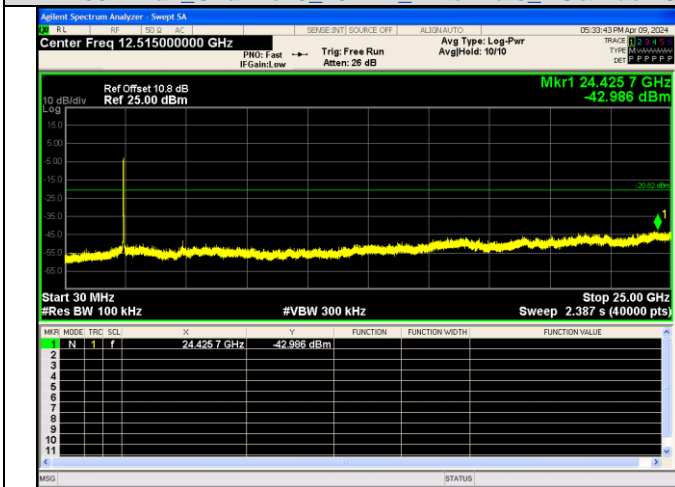
Spurious Emissions
IEEE 802.11ax Channel 6 40MHz Antenna 0 RU&Index SU

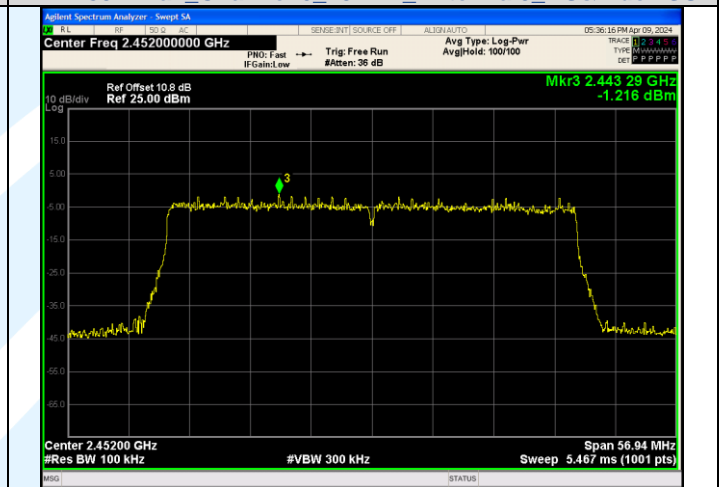
In-Band Reference Level
IEEE 802.11ax Channel 9 40MHz Antenna 0 RU&Index SU

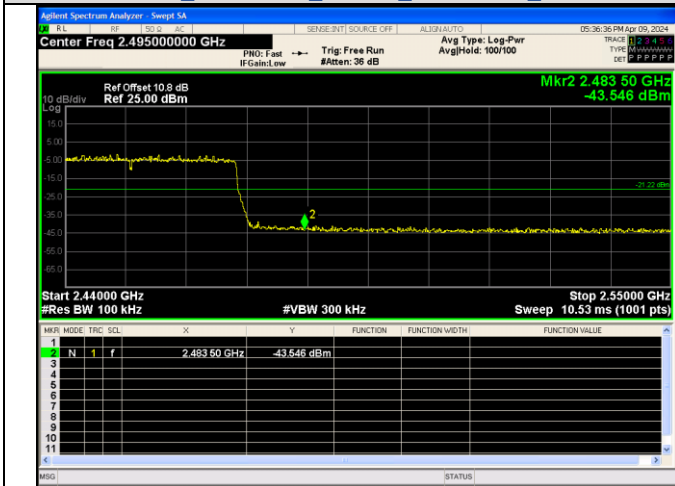
Out Of Band Emission
IEEE 802.11ax Channel 9 40MHz Antenna 0 RU&Index SU

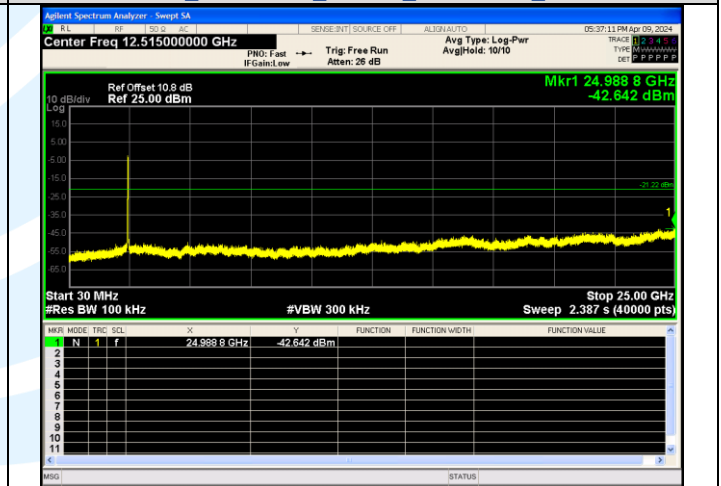
Spurious Emission
IEEE 802.11ax Channel 9 40MHz Antenna 0 RU&Index SU

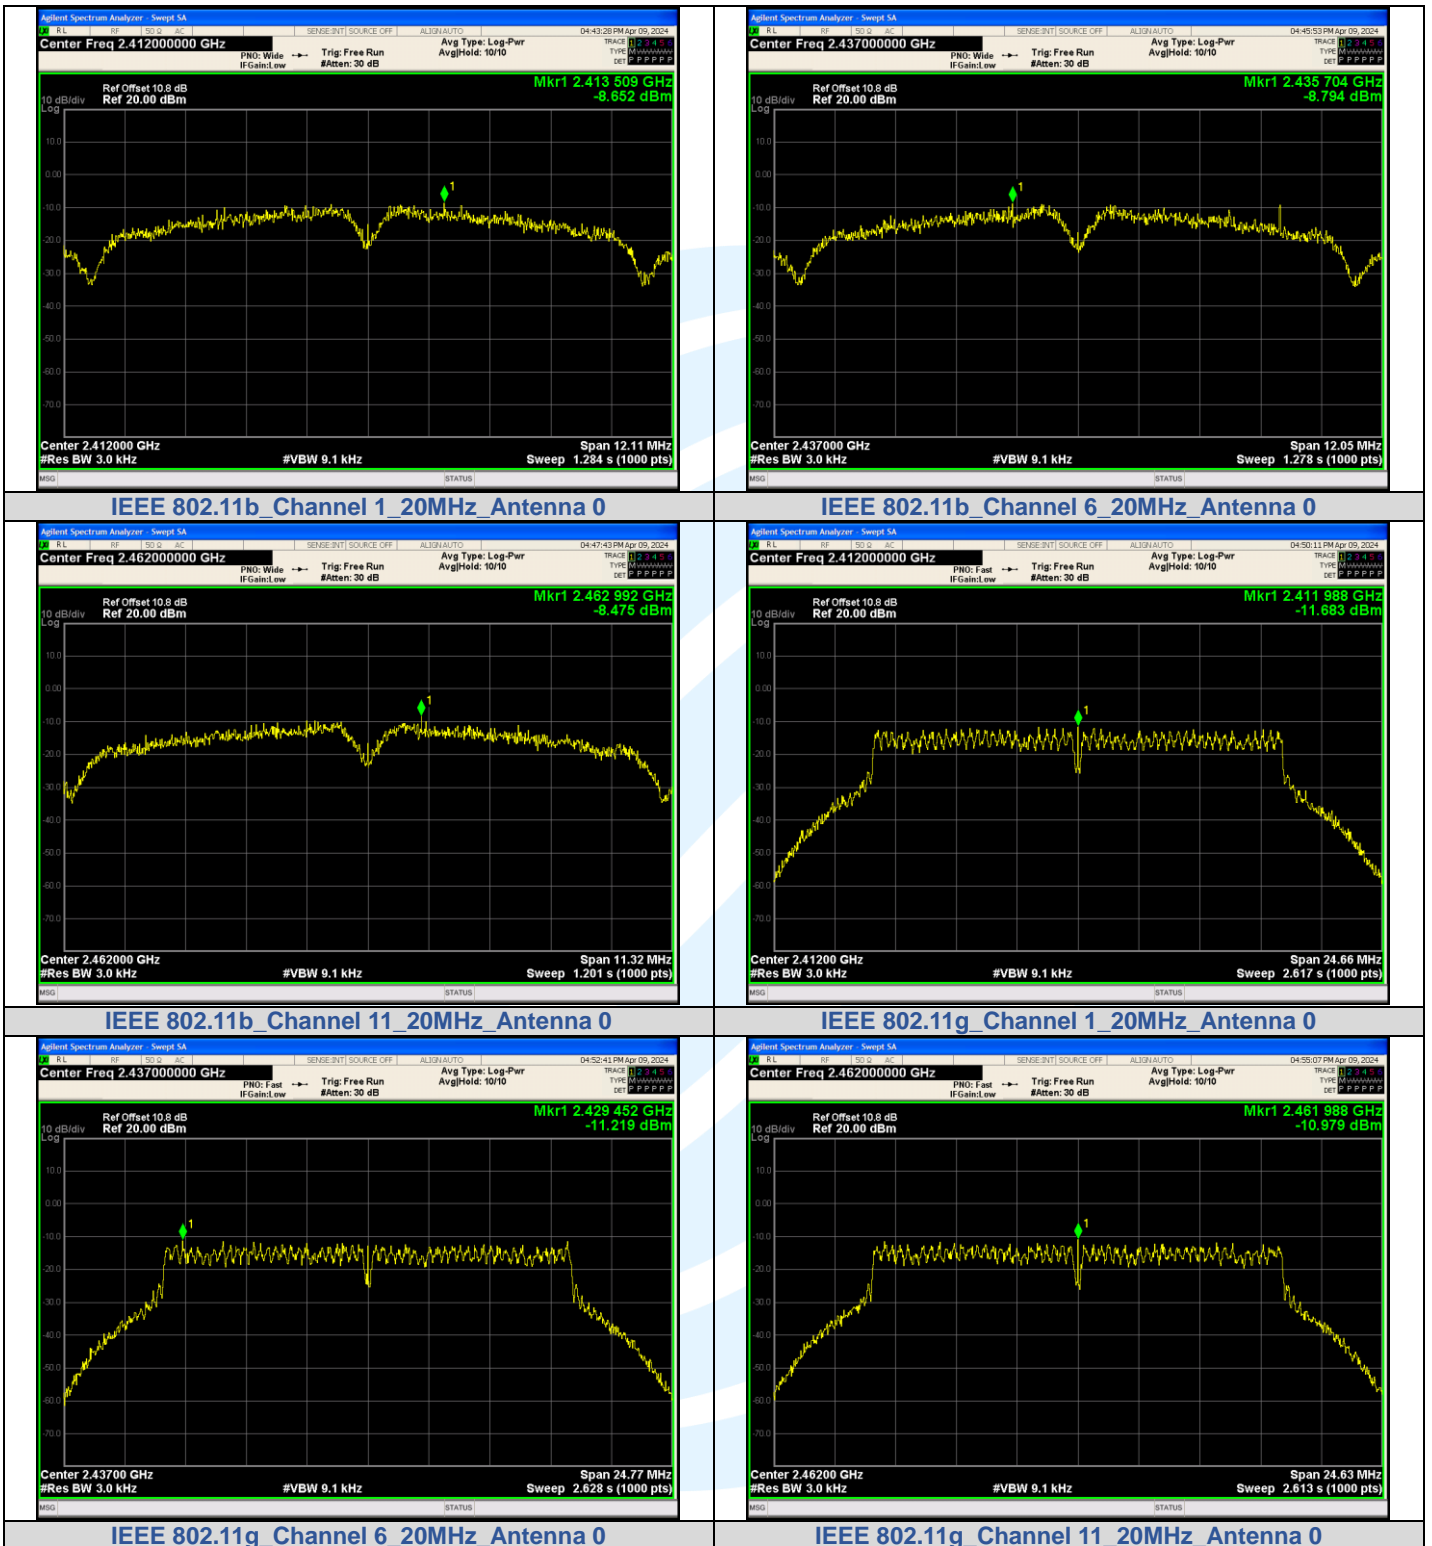
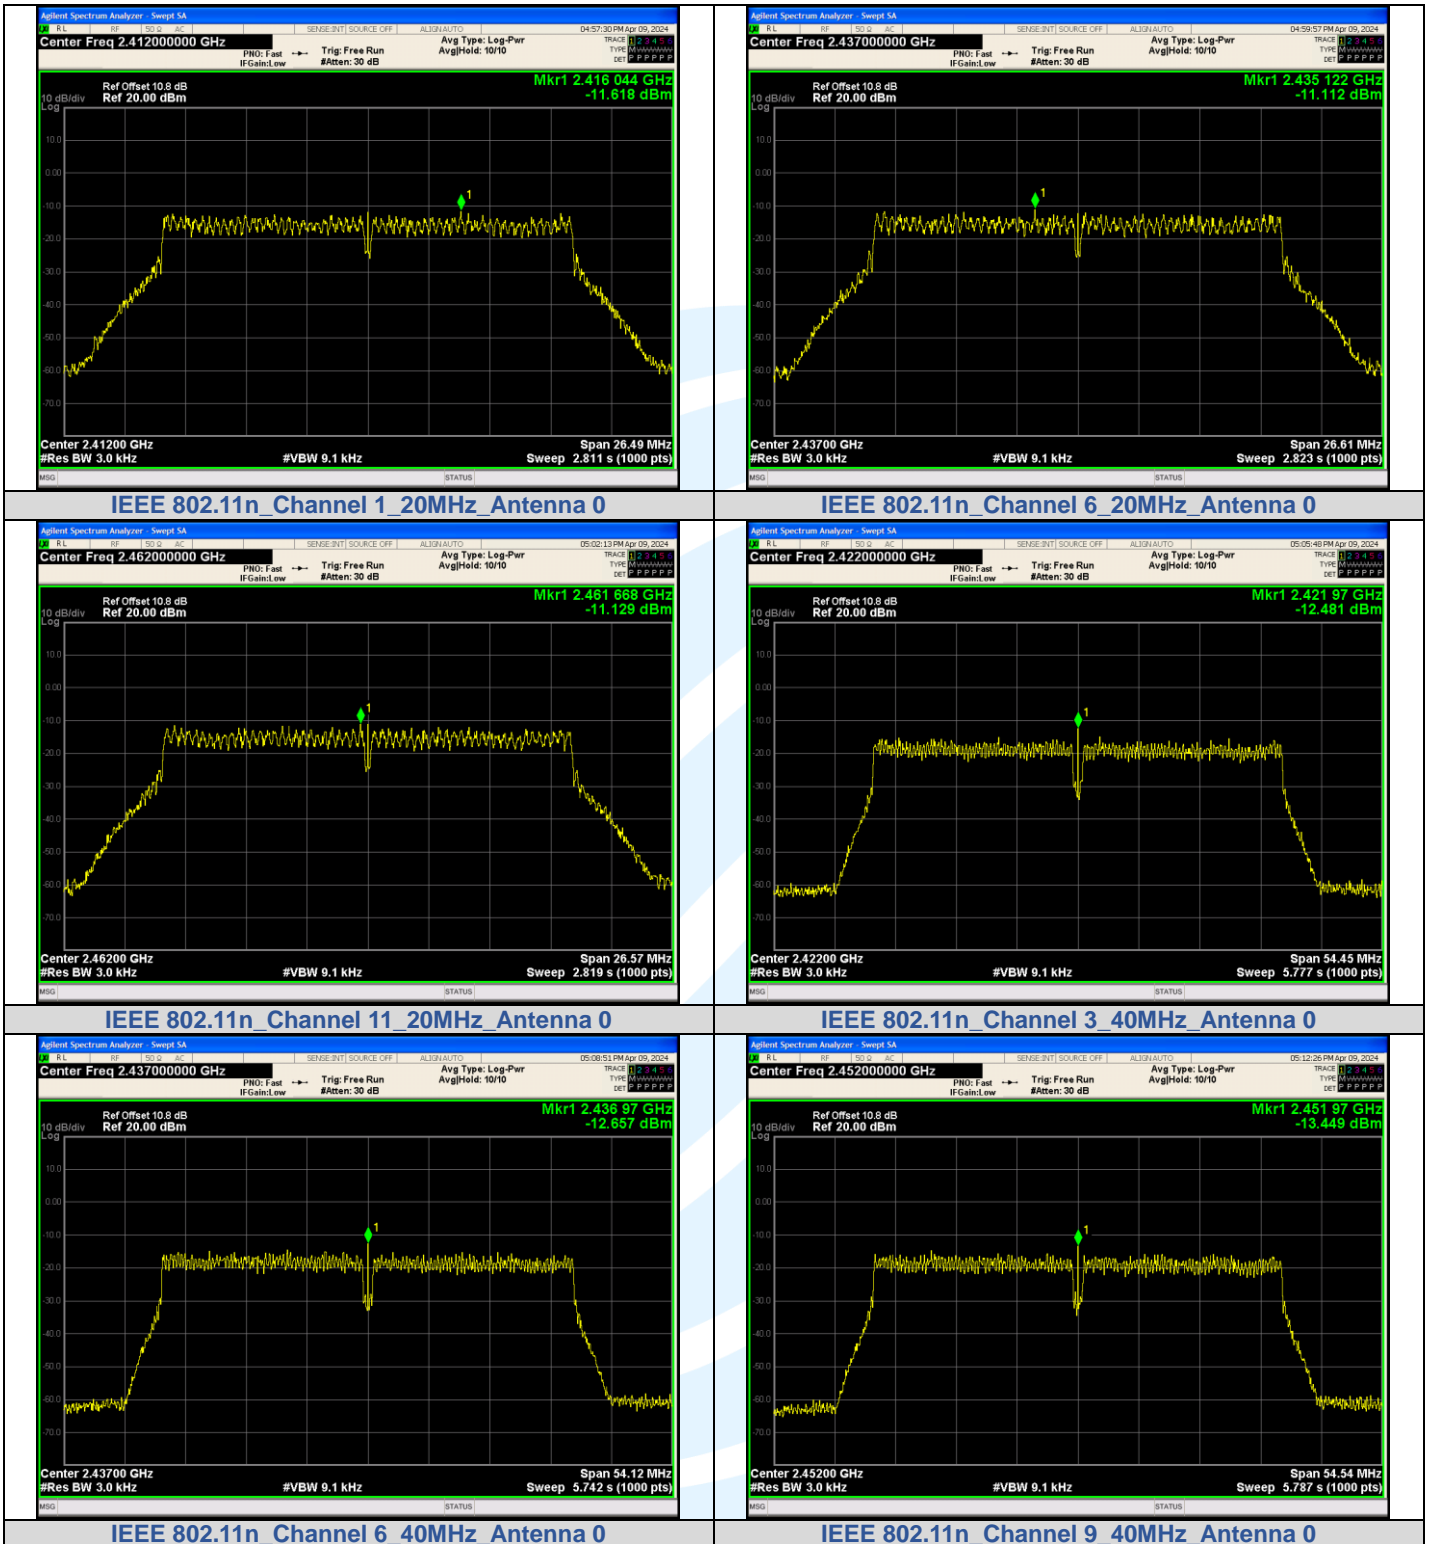
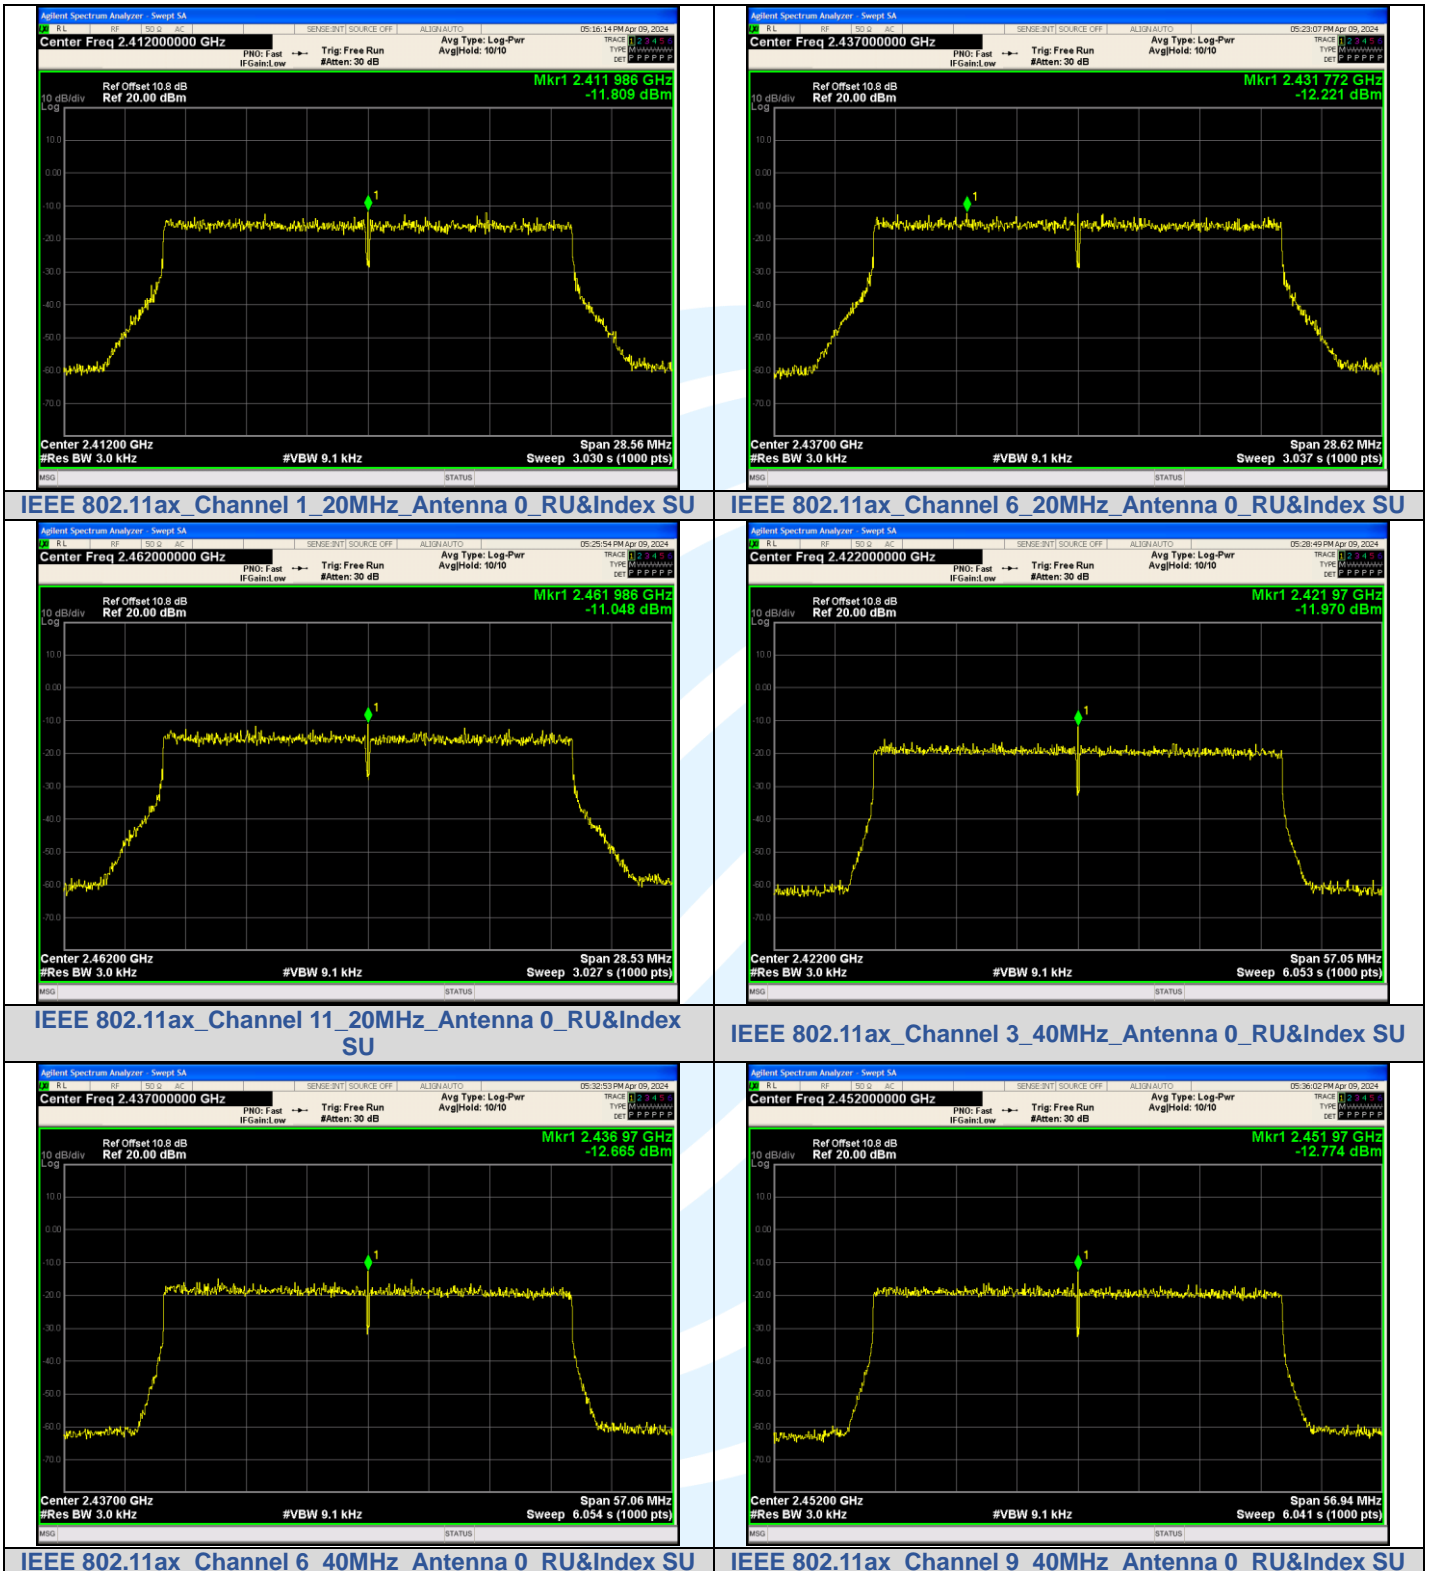
Test Graphs

Mode	Channel	RU & Index	PSD (dBm/3kHz) Ant. 0	Limit (dBm/3kHz)	Result
IEEE 802.11b	1	N/A	-8.652	8	PASS
	6		-8.794		PASS
	11		-8.475		PASS
IEEE 802.11g	1		-11.683		PASS
	6		-11.219		PASS
	11		-10.979		PASS
IEEE 802.11n_20	1		-11.618		PASS
	6		-11.112		PASS
	11		-11.129		PASS
IEEE 802.11n_40	3		-12.481		PASS
	6		-12.657		PASS
	9		-13.449		PASS
IEEE 802.11ax_20	1	SU	-11.809	8	PASS
	6		-12.221		PASS
	11		-11.048		PASS
IEEE 802.11ax_40	3		-11.970		PASS
	6		-12.665		PASS
	9		-12.774		PASS
