**PROGRESS REPORT
WA2XMY**

**Northpoint - DBS Compatibility Tests
Austin, TX
December 1998**

Diversified Communication Engineering, Inc.

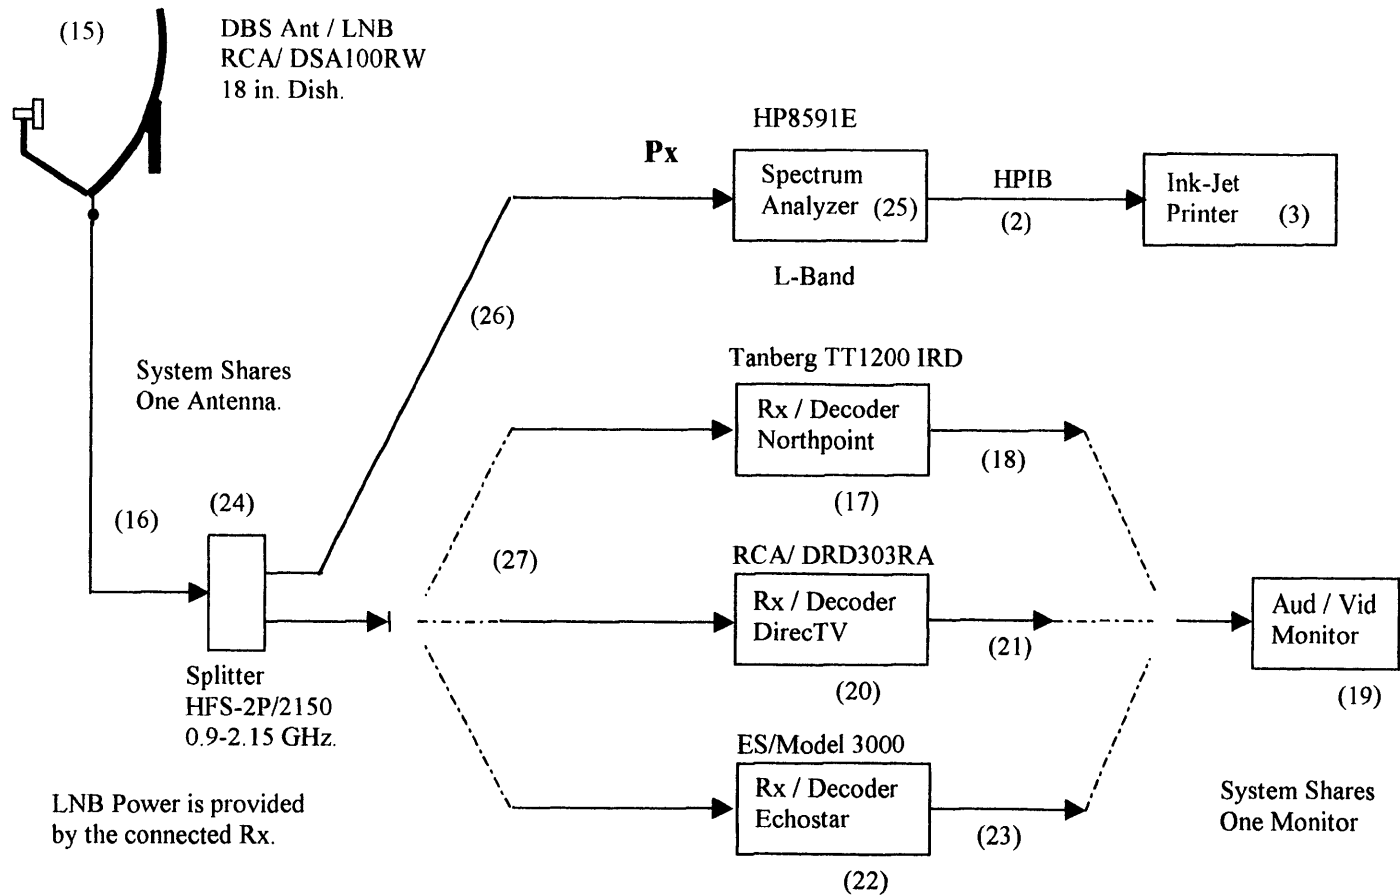
Fig. III-3: DBS Receiver System Block Diagram

Cables: (16), (26), (27) – RG-6/SAT/ Foam F(Male) (75 ohm) – L-Band

This receiver system was used to observe and measure the DBS satellite signals and the NP signal at each test site. The antenna is a standard RCA DBS antenna with an LNB down-block converter that outputs an L-band IF signal for use by the integrated Rx/Decoder (IRD) unit. The LNB output is passed through splitter (24), in order to provide signals to both the Spectrum Analyzer (25) and the IRD at the same time. The one antenna is shared with three separate IRDs, one for each of DirecTV, Echostar, and Northpoint, respectively. The TV monitor (19) is also shared among the three IRDs. The IRDs are interchanged by manually switching cables, while the signal path from the LNB to the spectrum analyzer remains fixed.

The HP8591E (25) is an L-band spectrum analyzer with a 75 ohm input impedance, to match the LNB IF output impedance and the related cables. The Printer (3) is provided to make screen copies.

This arrangement provides for the common use of precisely the same hardware system for all three DBS and NP signal measurements, so that the relative signal comparisons are valid.

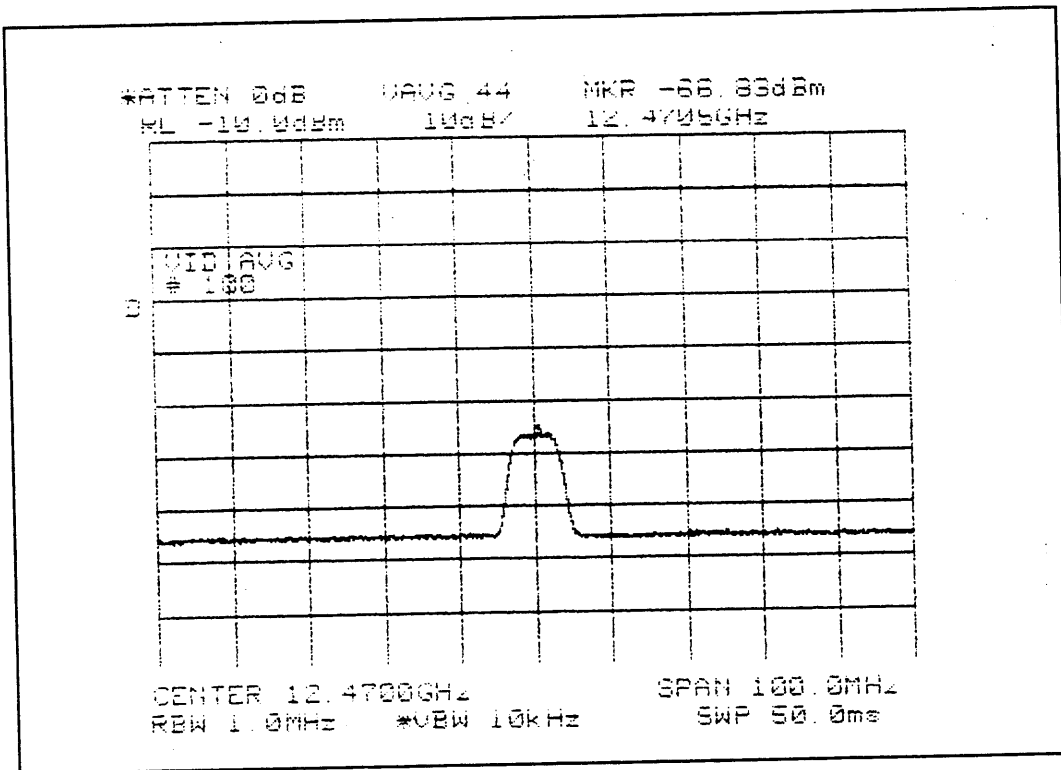
(a) NP Signal Power Spectrum – Po (Ku-Band)
 -Test Set and Precision Horn
 -HP8563E Spectrum Analyzer

Fig. IV-1: Sample Signal Power Spectrum -- Site 1

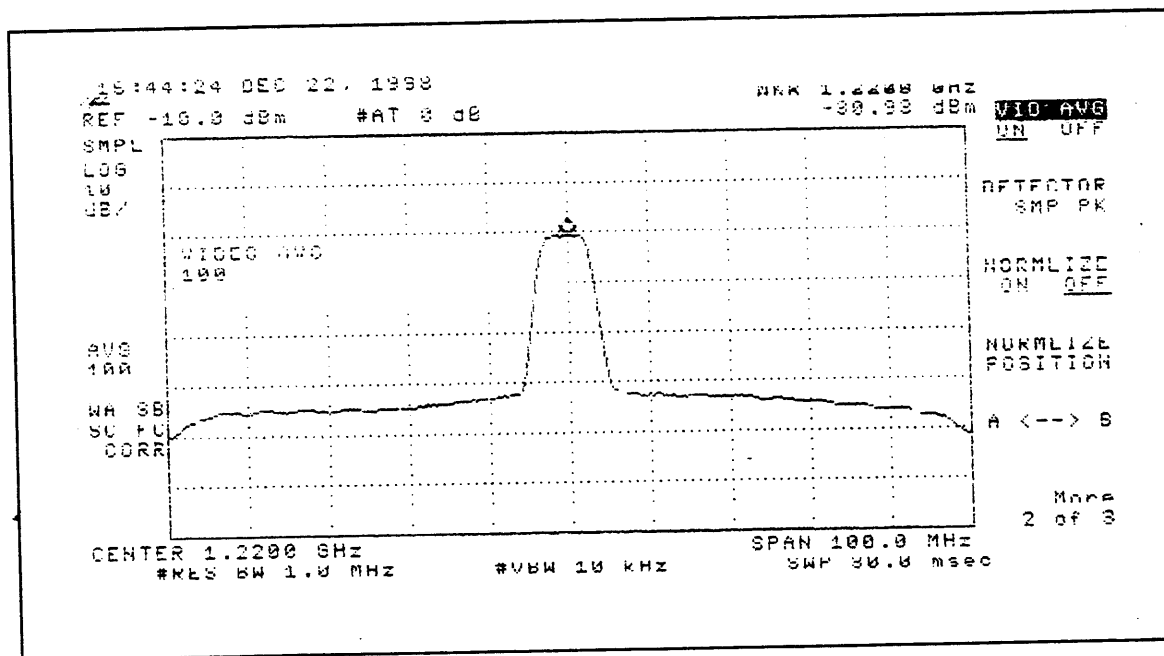
(b) NP Signal Power Spectrum – Px (L-Band)
 - DBS System and DBS Antenna
 - HP8591E Spectrum Analyzer

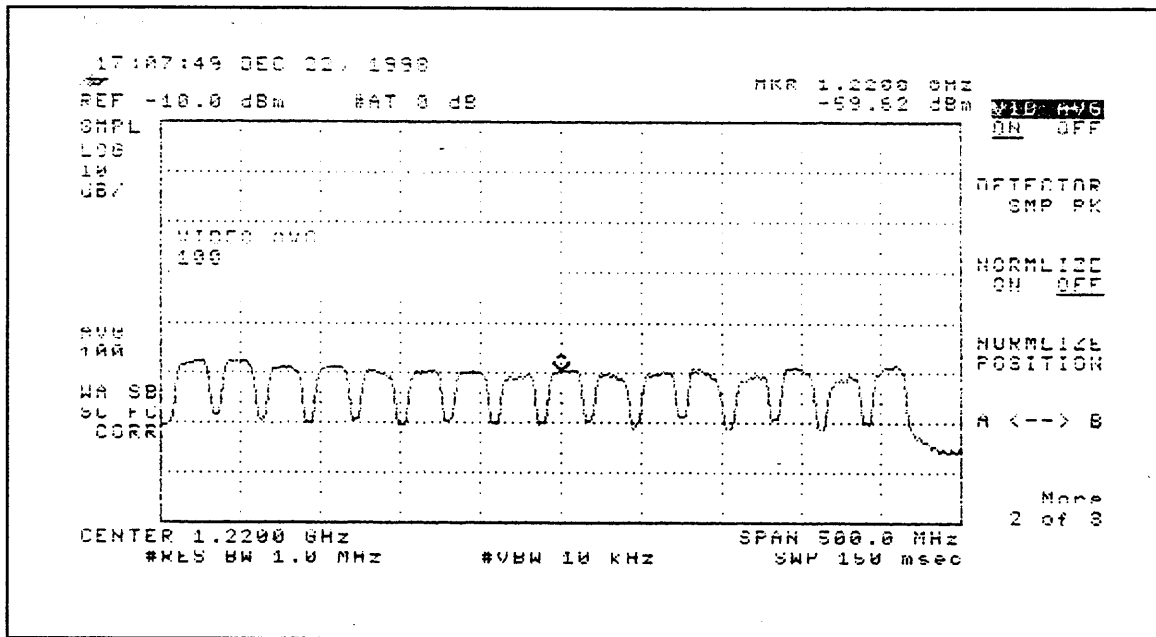
(a) Direct TV Signal - Px (L-Band)
 -HP8591E Spectrum Analyzer

Fig. IV-2: Sample Signal Power Spectrum -- Site 1

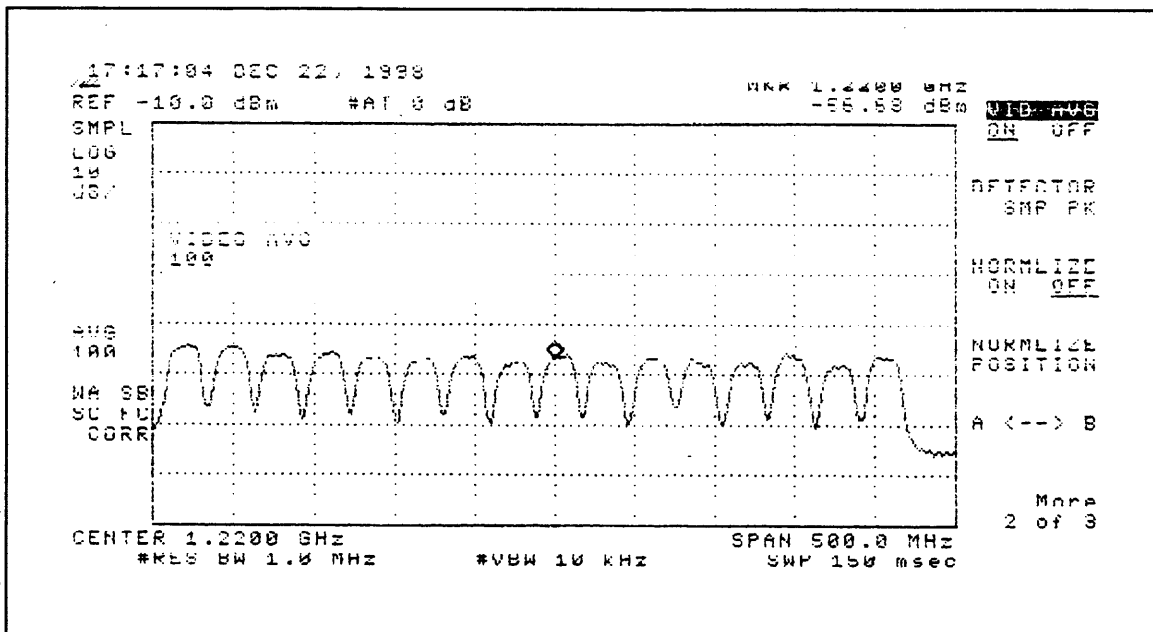
(b) EchoStar - Px (L-Band)
 -HP8591E Spectrum Analyzer
