Northpoint Technology – DBS Compatibility Test – Austin Test Area

Rx Site Data Log

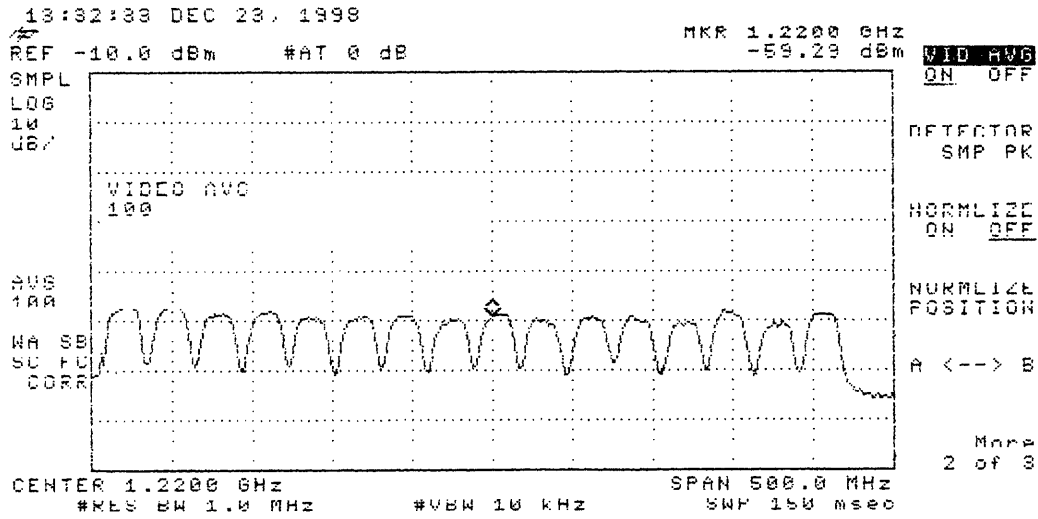
Plot 10-E

1. Estqr, Site-10, Set-1, 12/23/98
2. Beam Down
3. HP-8591E

Signal Power Spectrum – Tx ON: --Peak -- -59.29 dBm Plot ID Code 10-E
Tx OFF: – Peak -- _____ dBm Plot ID Code _____
