**The Boeing Company  
Thuraya Satellite Testing  
Building S-03A, Chamber A6  
El Segundo, CA**

**Submitted on**  
**12/20/06**

**Purpose:**

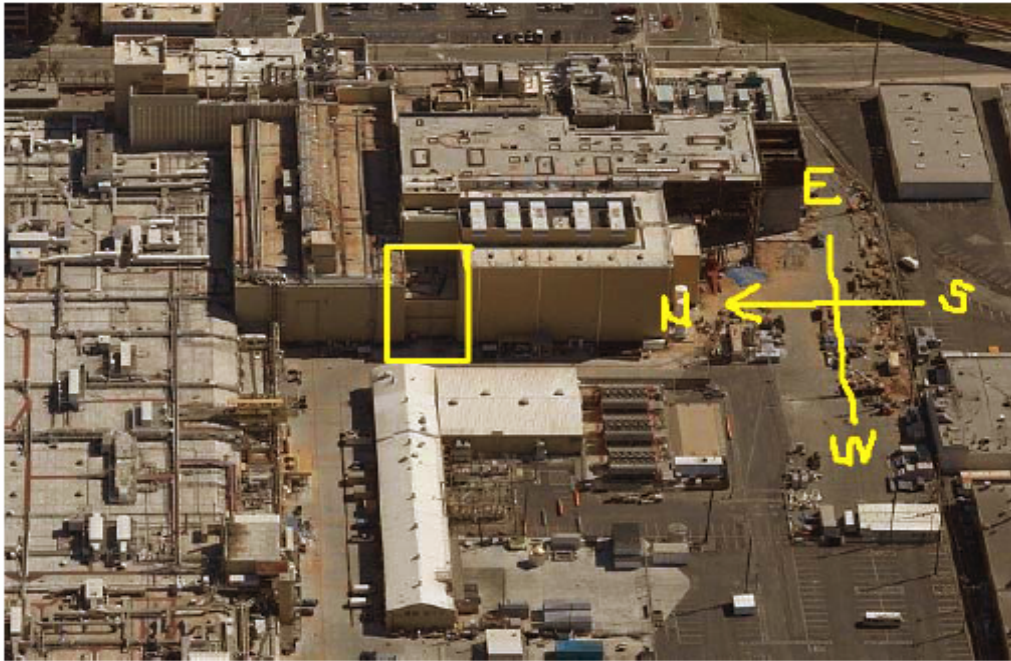
Figure 2 - Aerial Photo, west facing exterior wall and roof of the A6 Chamber

S-03A Exterior Building Wall Construction: All steel walls and doors, no windows.

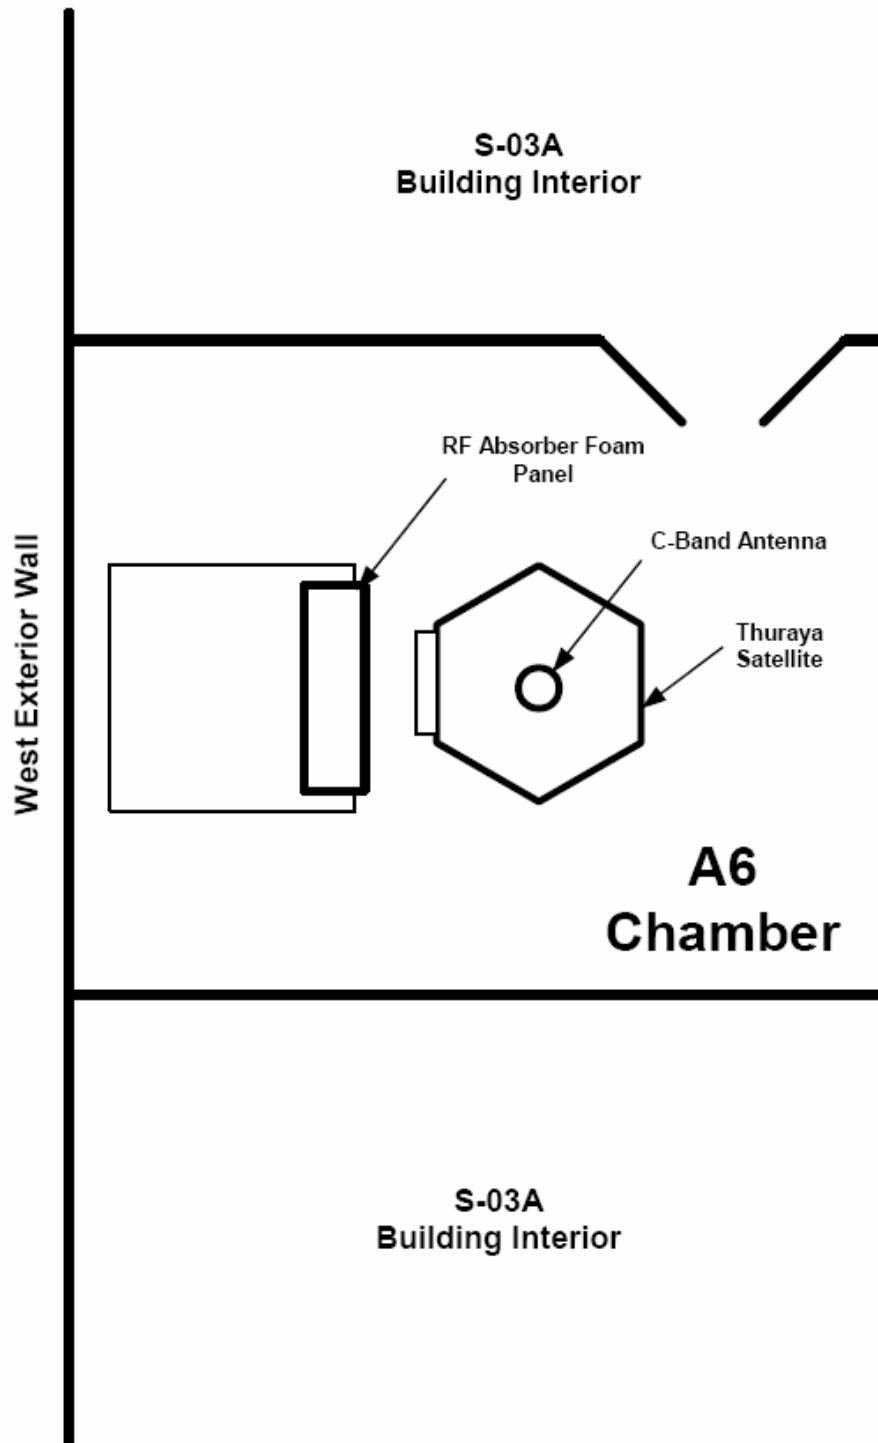
Figure 3- Thuraya Satellite Test Set Up in A6 Chamber

The article under test is the Thuraya Satellite. There are several test configurations that are required to be tested.

The Thuraya satellite internal transmitters will produce the RF signal. Boeing is the current owner and operator of the equipment.
