Conducted RF Spurious Emission

APPENDIX: PHOTOGRAPHS OF TEST CONFIGURATION

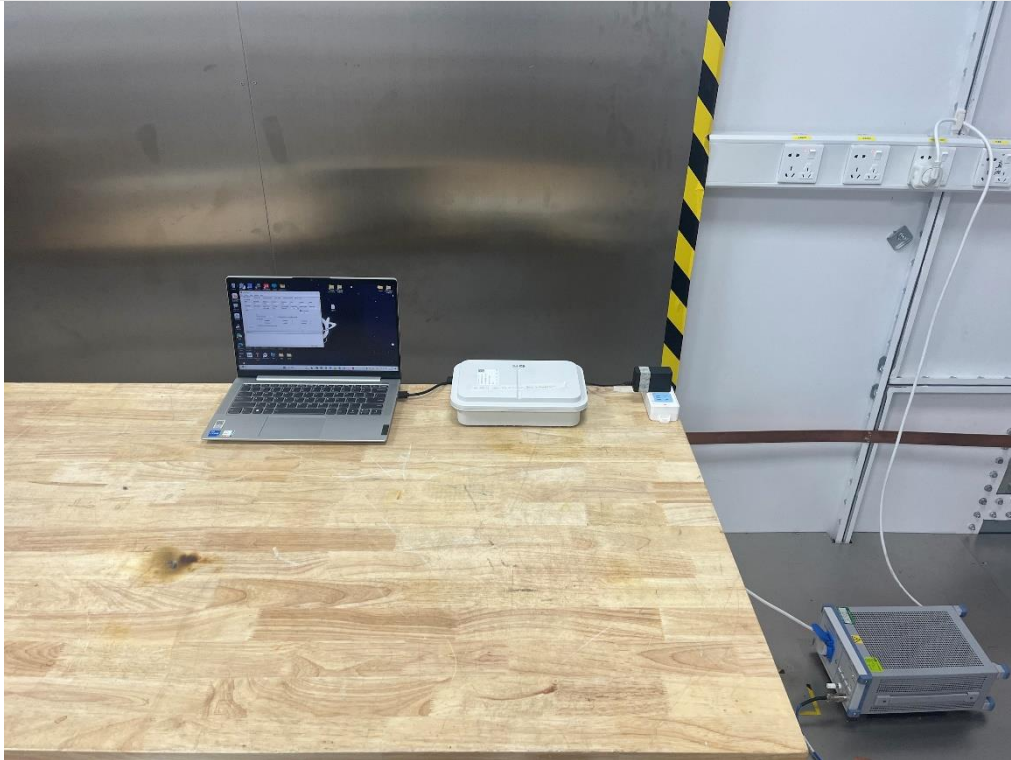
AC Power Line Conducted Emission
