## APPENDIX A: PHOTOGRAPHS OF TEST SETUP

Reference to the test report No. BLA-EMC-202302-A4101

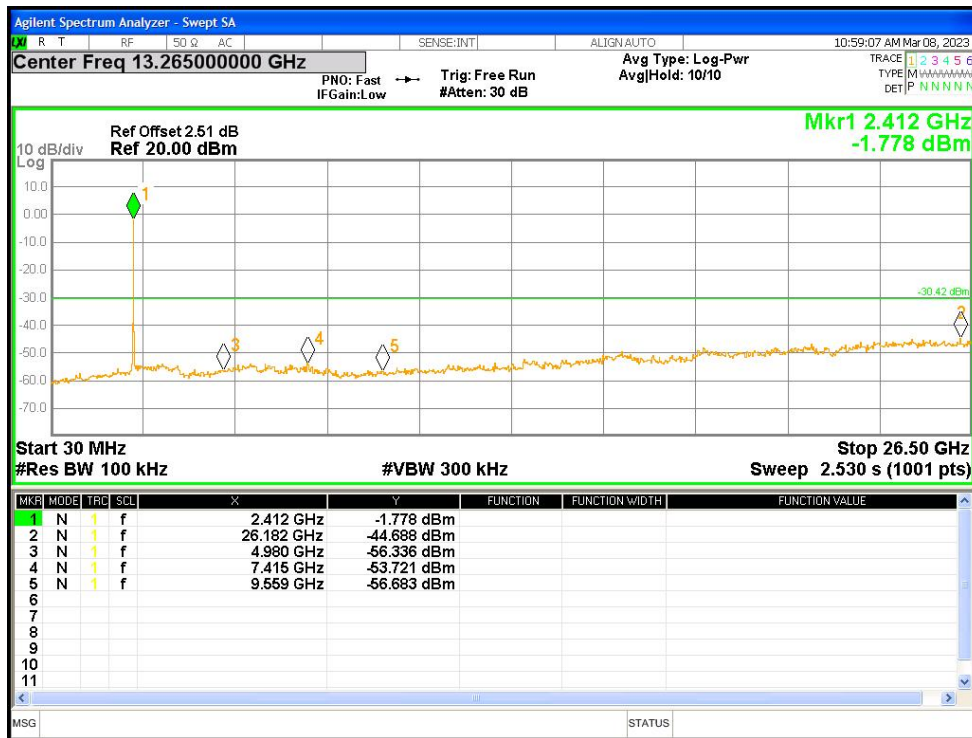
Tx. Spurious NVNT n20 2437MHz Ant1 Ref

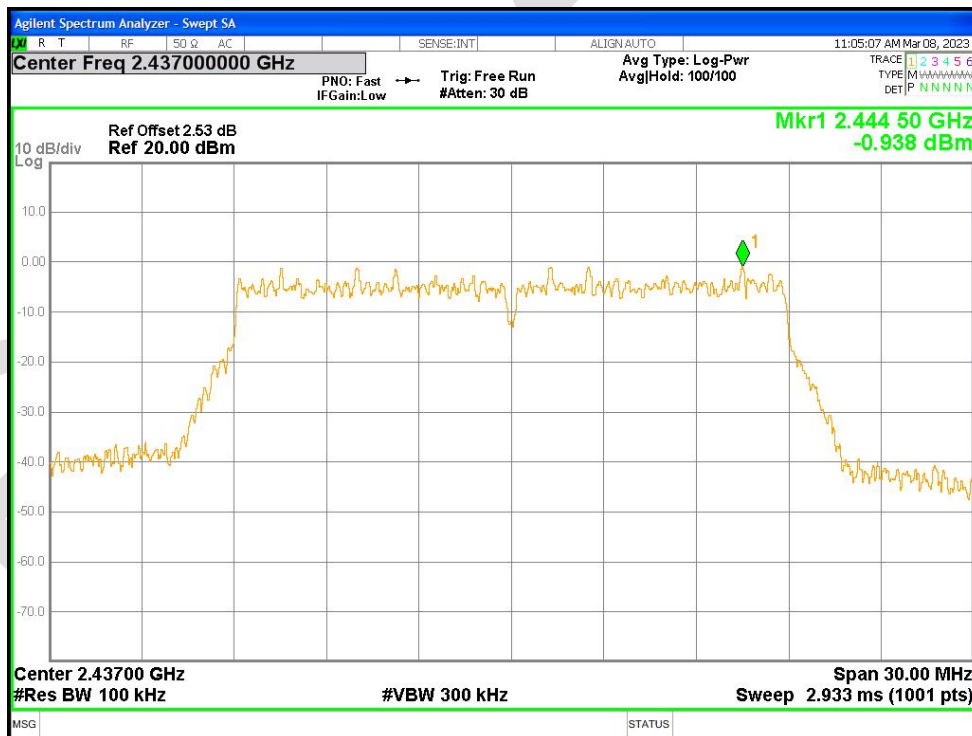
Tx. Spurious NVNT n20 2437MHz Ant1 Emission

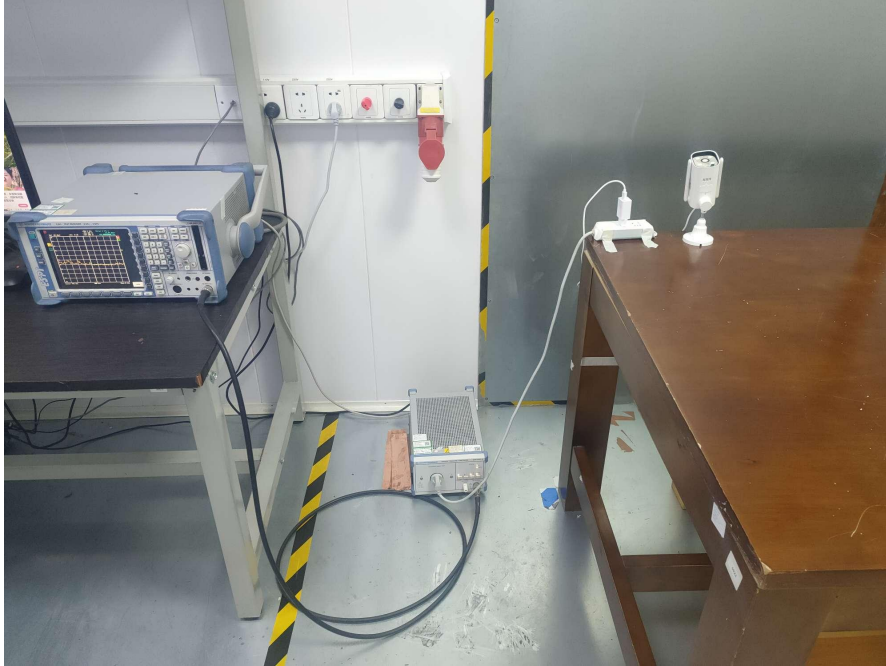
**Conducted Emissions at AC Power Line (150kHz-30MHz)**
