APPENDIX A: PHOTOGRAPHS OF TEST SETUP

APPENDIX B: PHOTOGRAPHS OF EUT

Reference to the test report No. BLA-EMC-202305-A0501

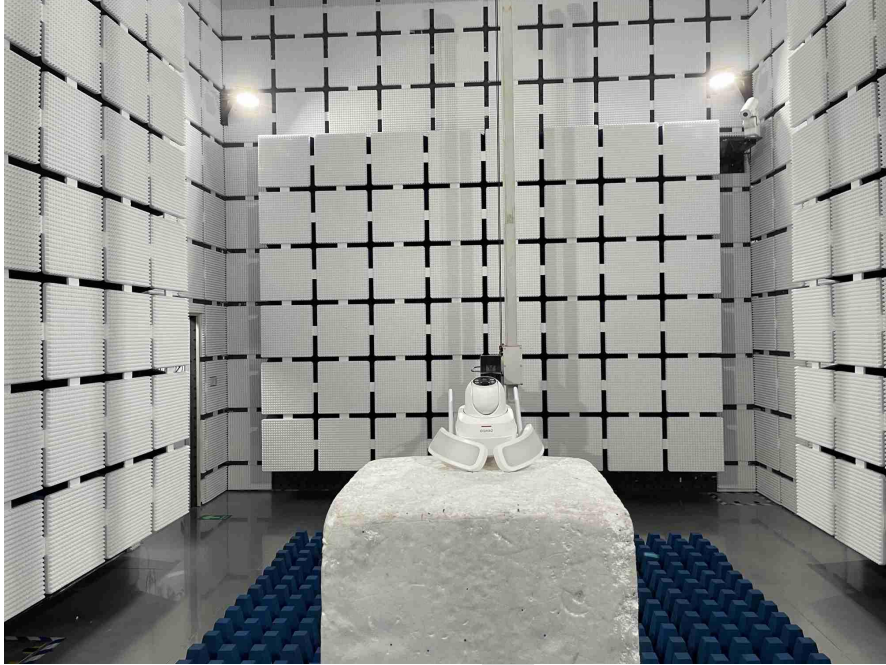
Radiated Spurious Emissions
