APPENDIX A: PHOTOGRAPHS OF TEST SETUP

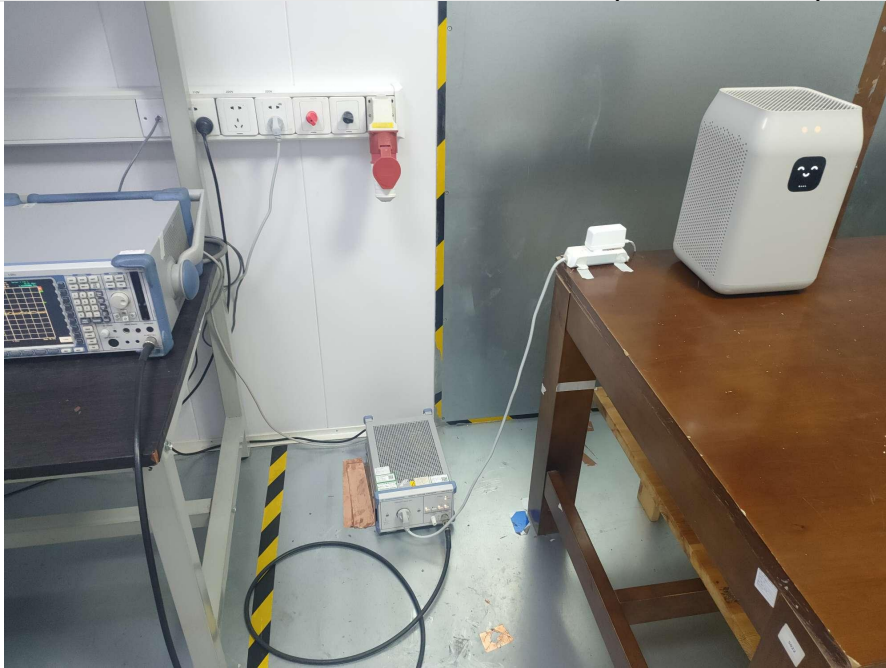
Conducted Emissions at AC Power Line (150kHz-30MHz)
