APPENDIX A: PHOTOGRAPHS OF TEST SETUP

APPENDIX B: PHOTOGRAPHS OF EUT

Reference to the test report No. BLA-EMC-202208-A2401

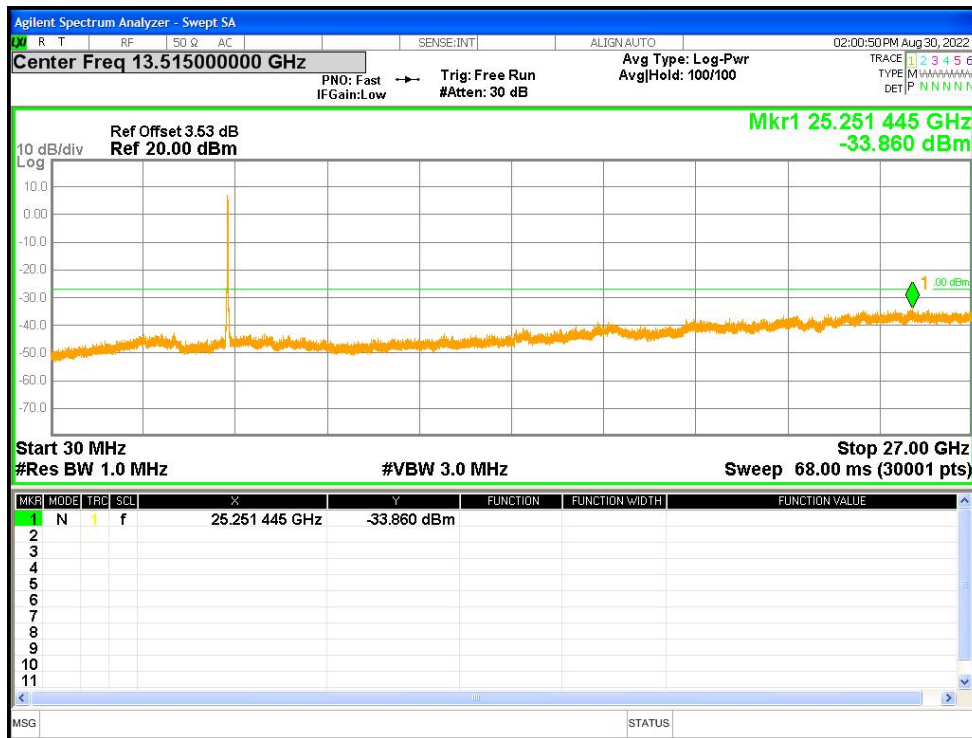
Tx. Spurious NVNT a 5240MHz Ant1 Emission

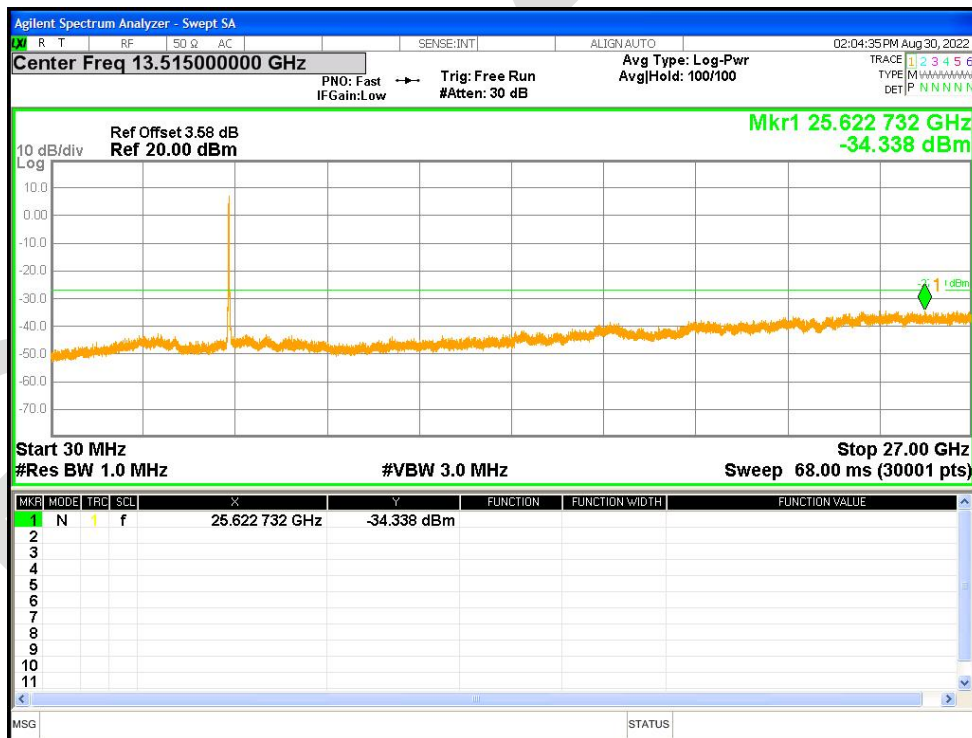
Tx. Spurious NVNT ac20 5180MHz Ant1 Emission

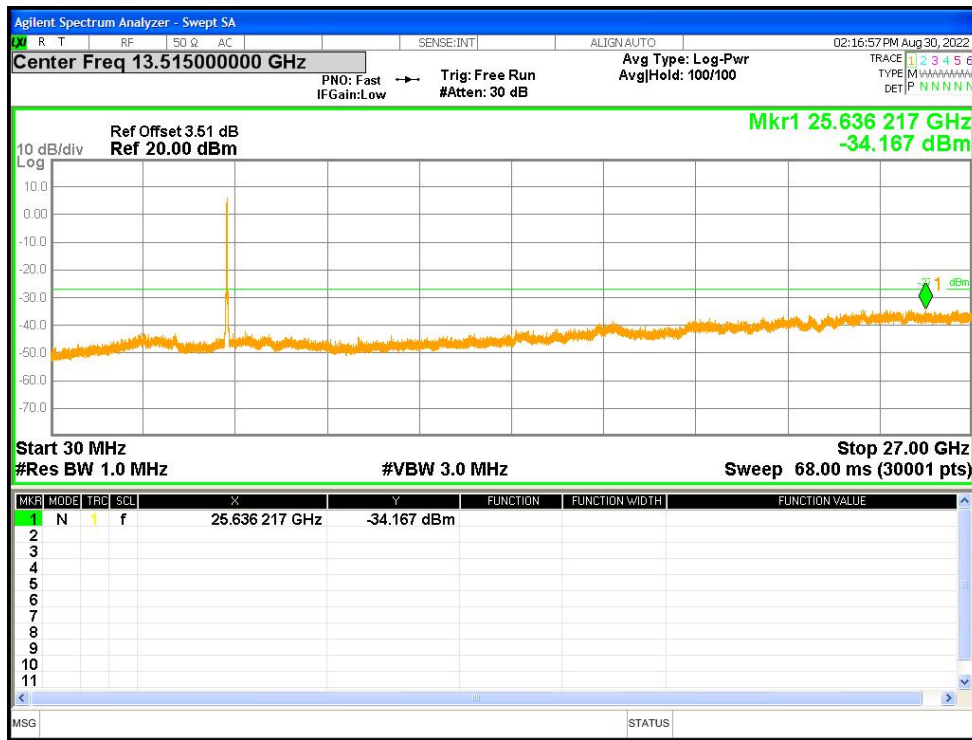
Tx. Spurious NVNT ac20 5200MHz Ant1 Emission

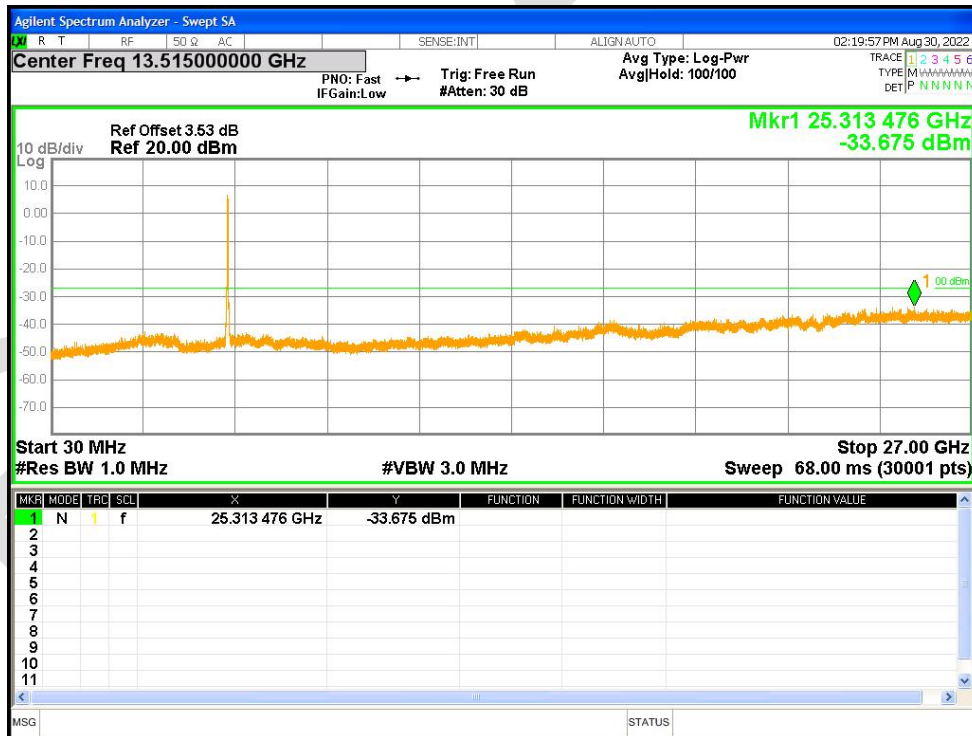
Tx. Spurious NVNT ac20 5240MHz Ant1 Emission

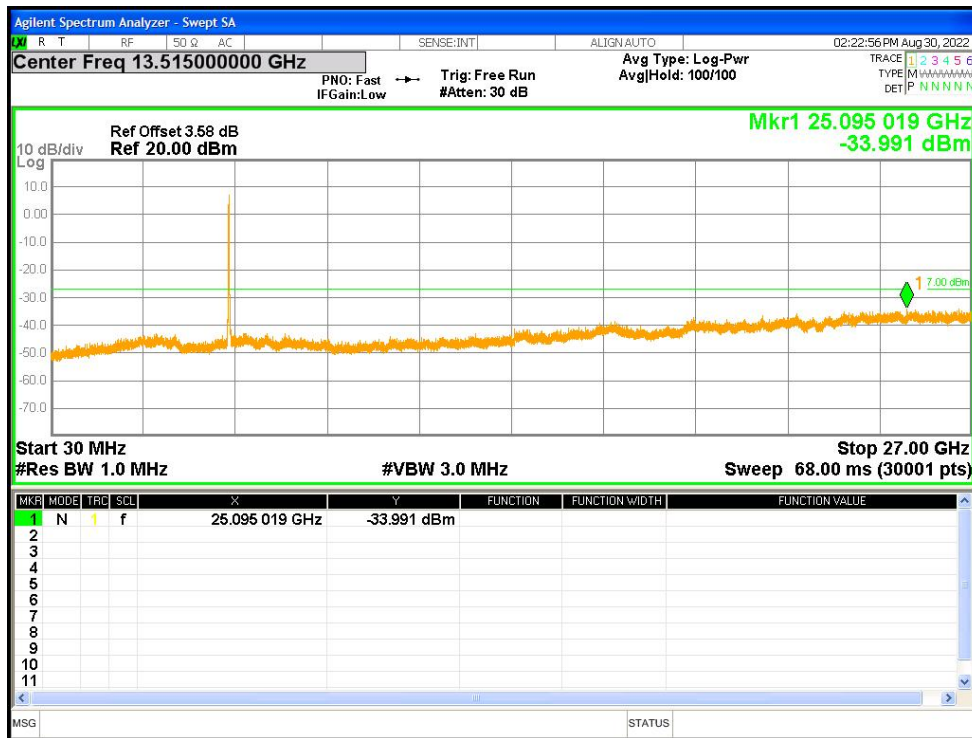
Tx. Spurious NVNT ac40 5190MHz Ant1 Emission

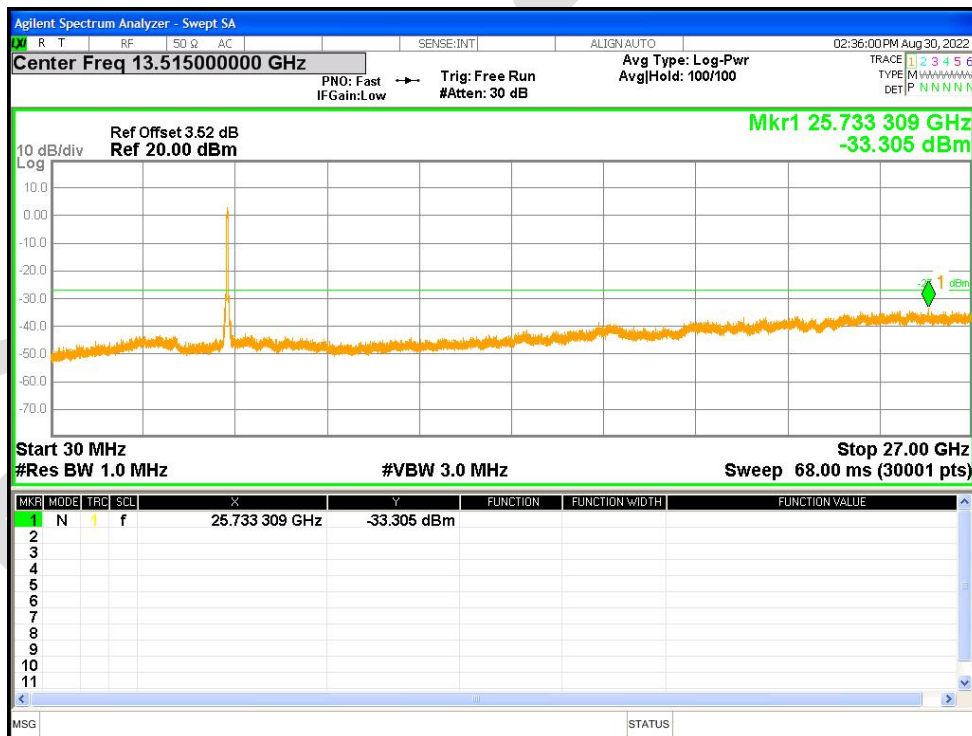
Tx. Spurious NVNT ac40 5230MHz Ant1 Emission

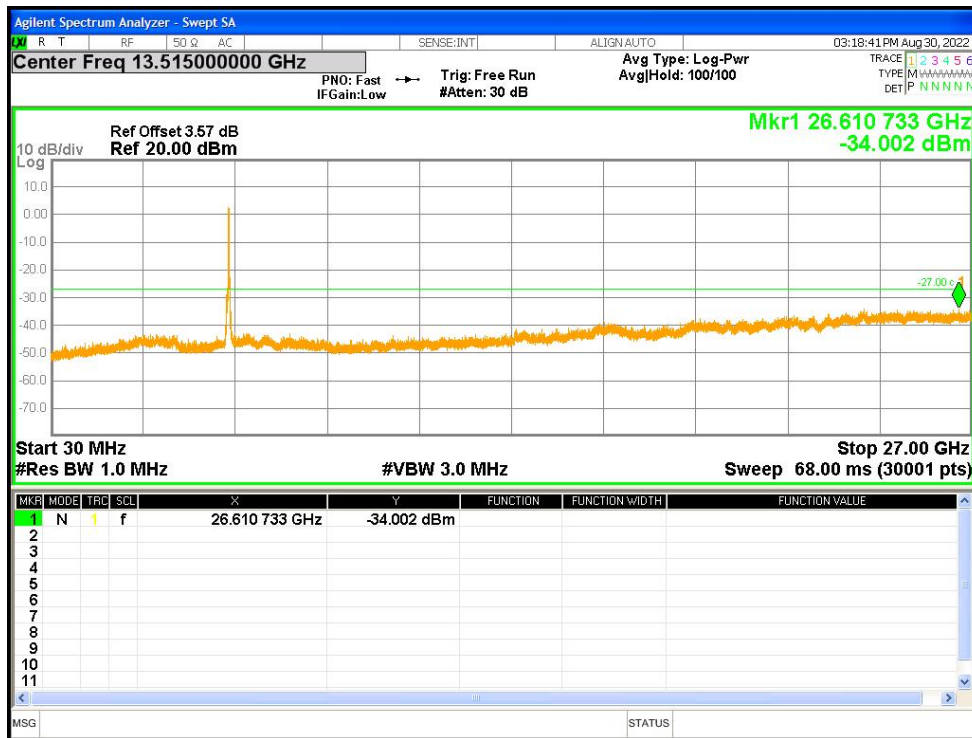
Tx. Spurious NVNT ac80 5210MHz Ant1 Emission

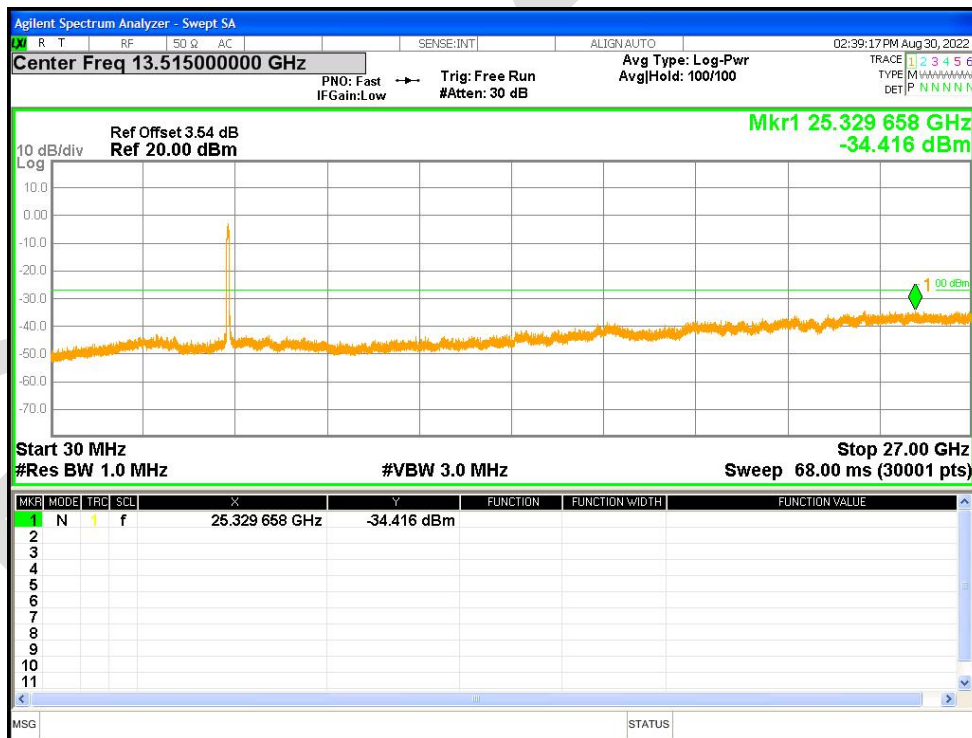
Tx. Spurious NVNT n20 5180MHz Ant1 Emission

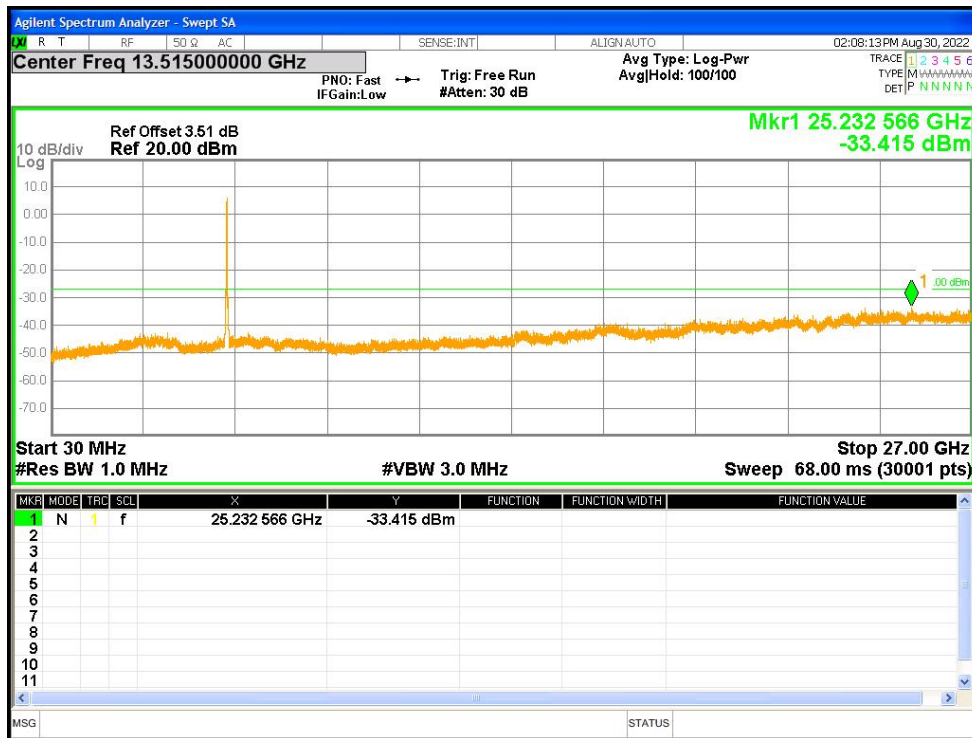
Tx. Spurious NVNT n20 5200MHz Ant1 Emission

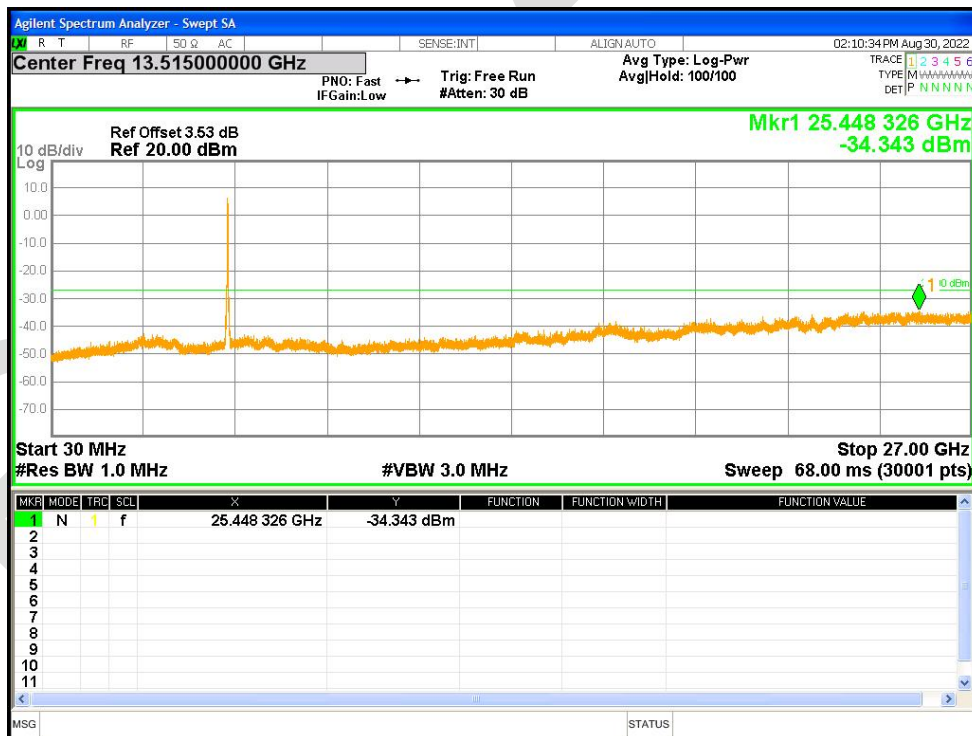
Tx. Spurious NVNT n20 5240MHz Ant1 Emission

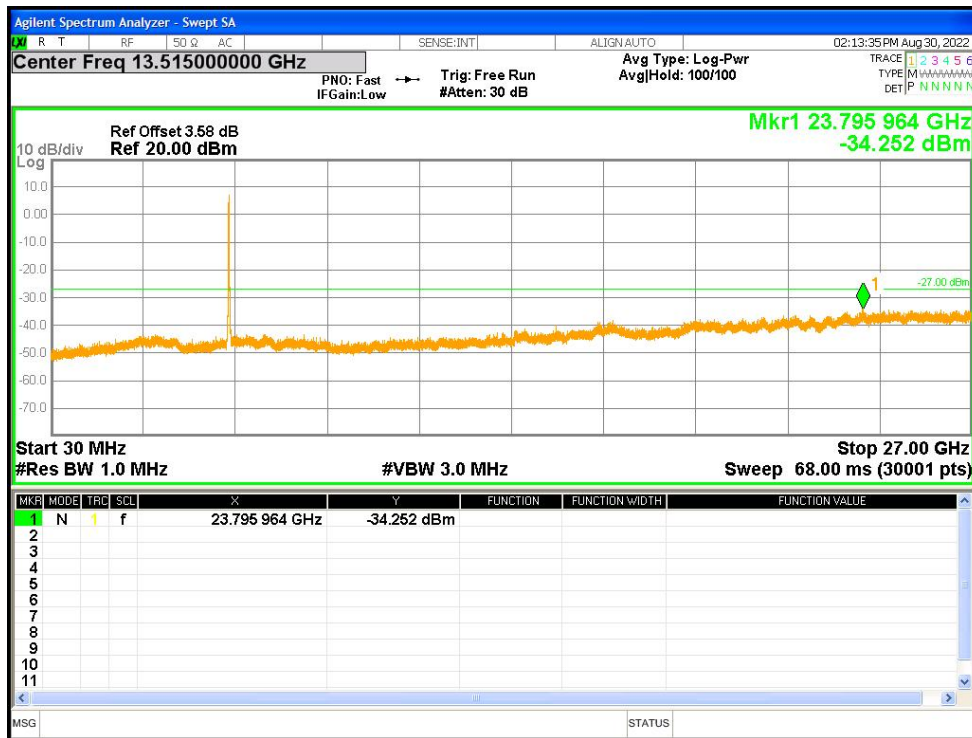
Tx. Spurious NVNT n40 5190MHz Ant1 Emission

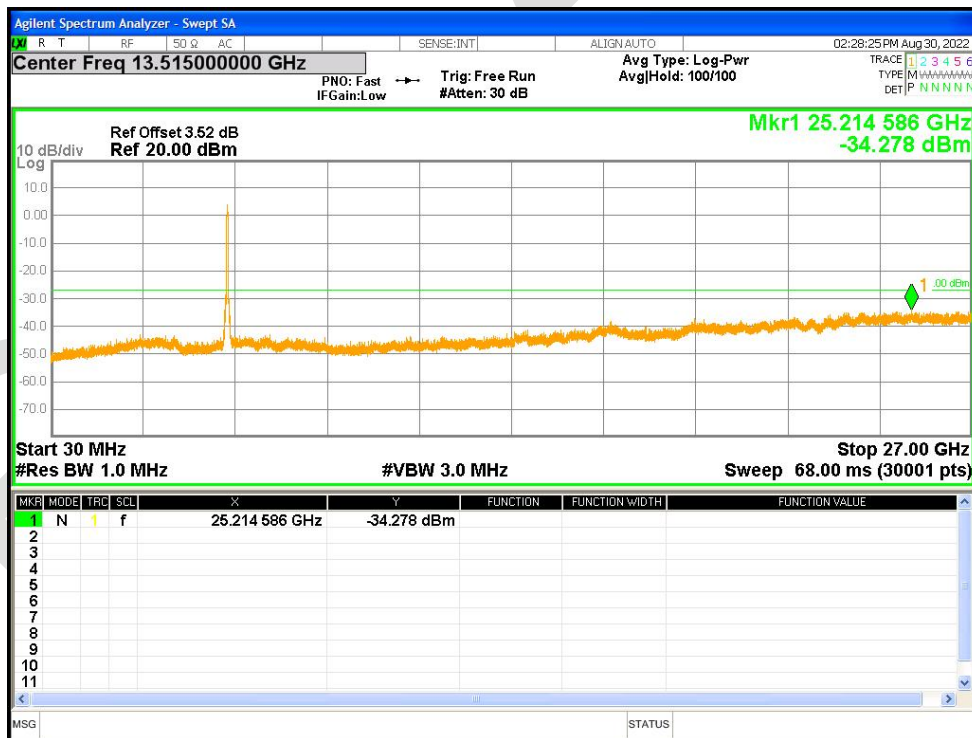
Tx. Spurious NVNT n40 5230MHz Ant1 Emission

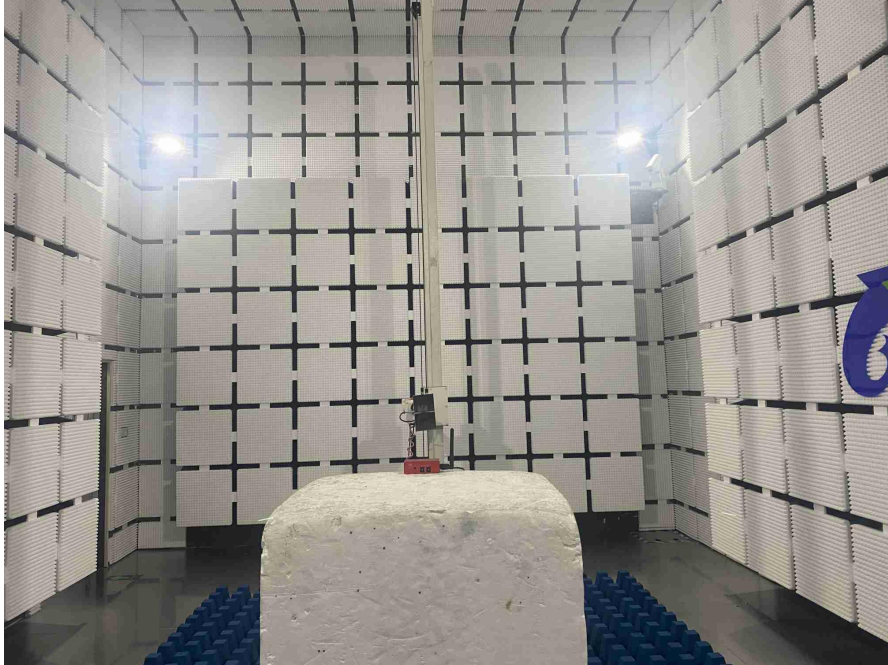
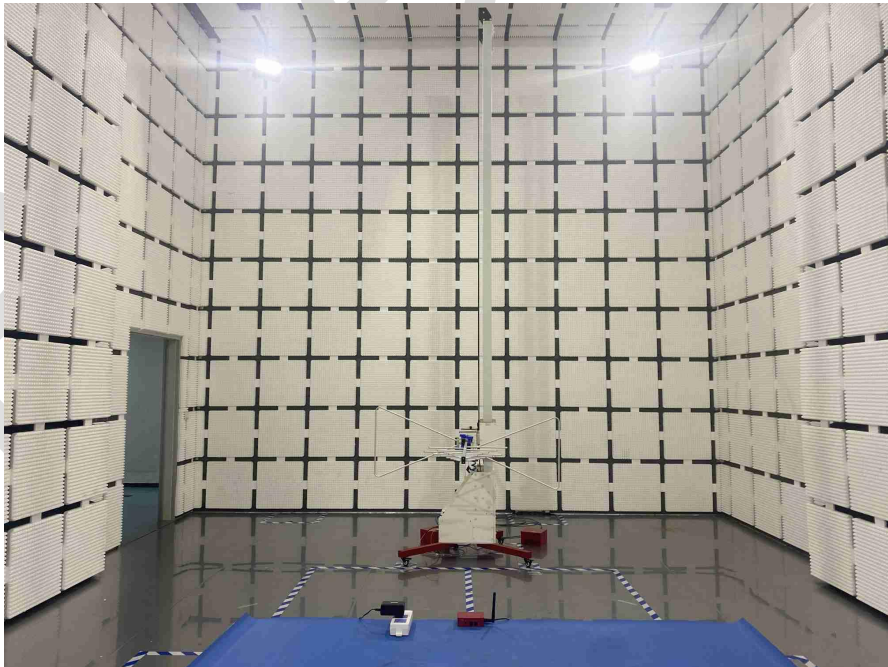
Radiated Emissions

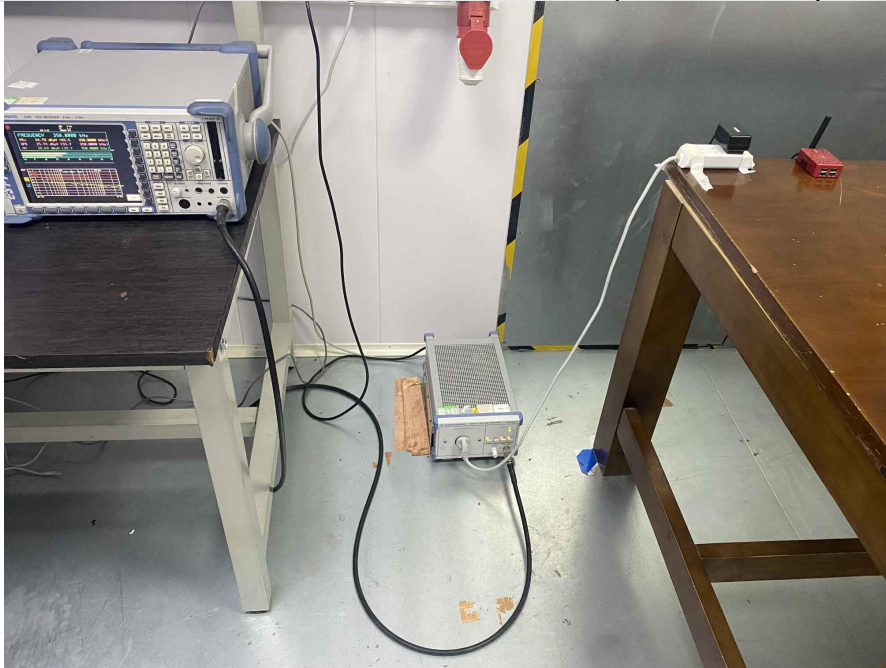
Conducted Emissions at AC Power Line (150kHz-30MHz)
