APPENDIX A: PHOTOGRAPHS OF TEST SETUP

Reference to the test report No. BLA-EMC-202207-A3401

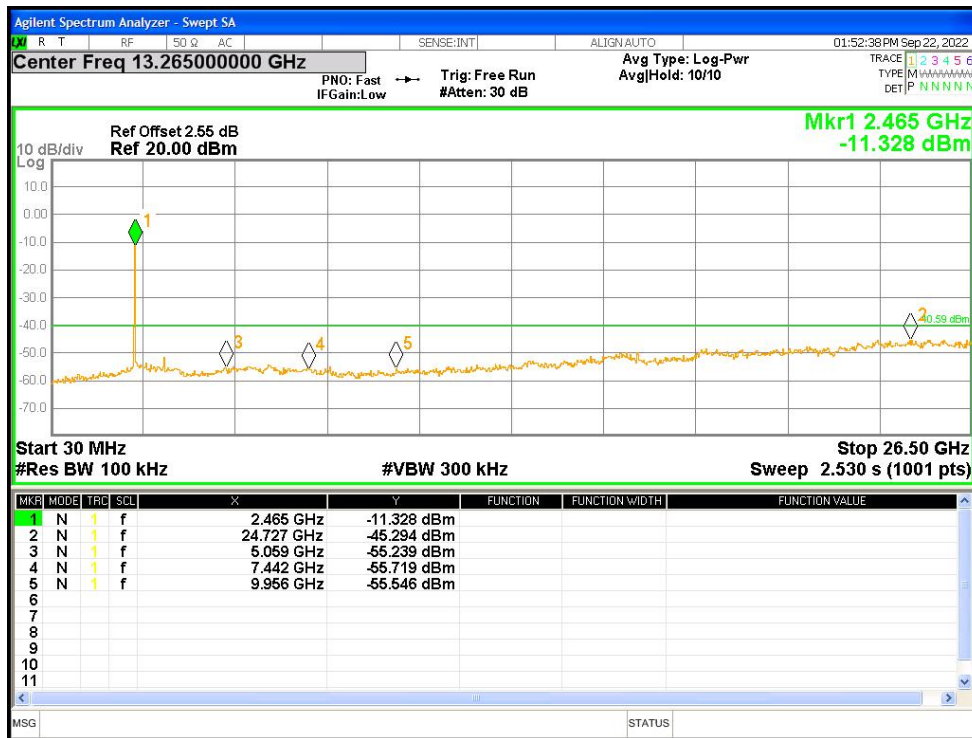
Tx. Spurious NVNT n40 2422MHz Ant1 Ref

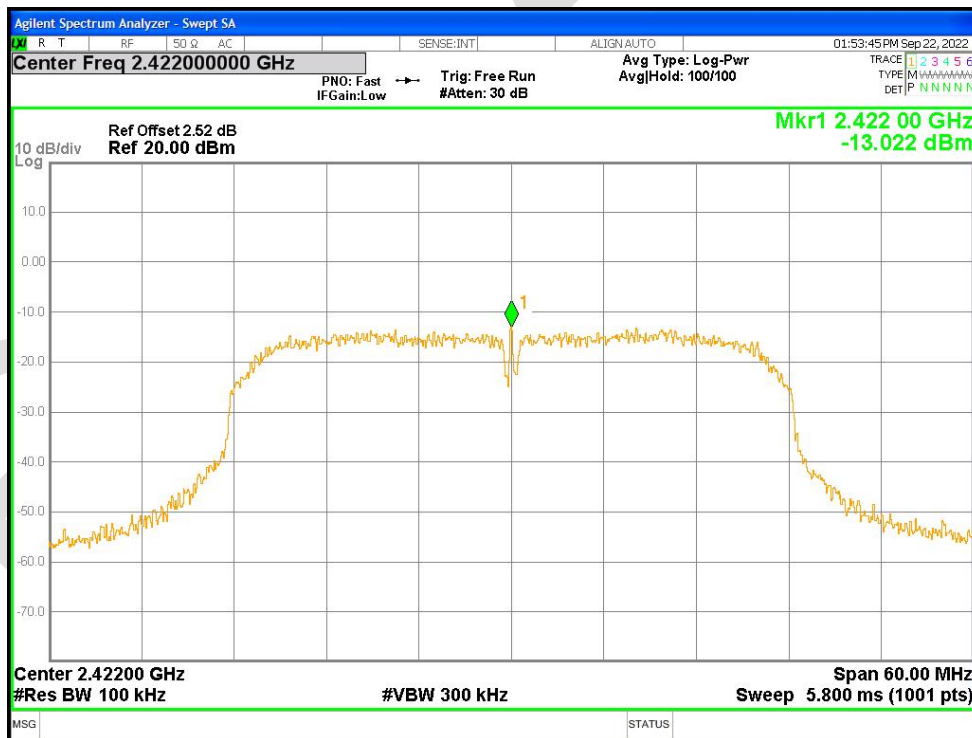
Tx. Spurious NVNT n40 2422MHz Ant1 Emission

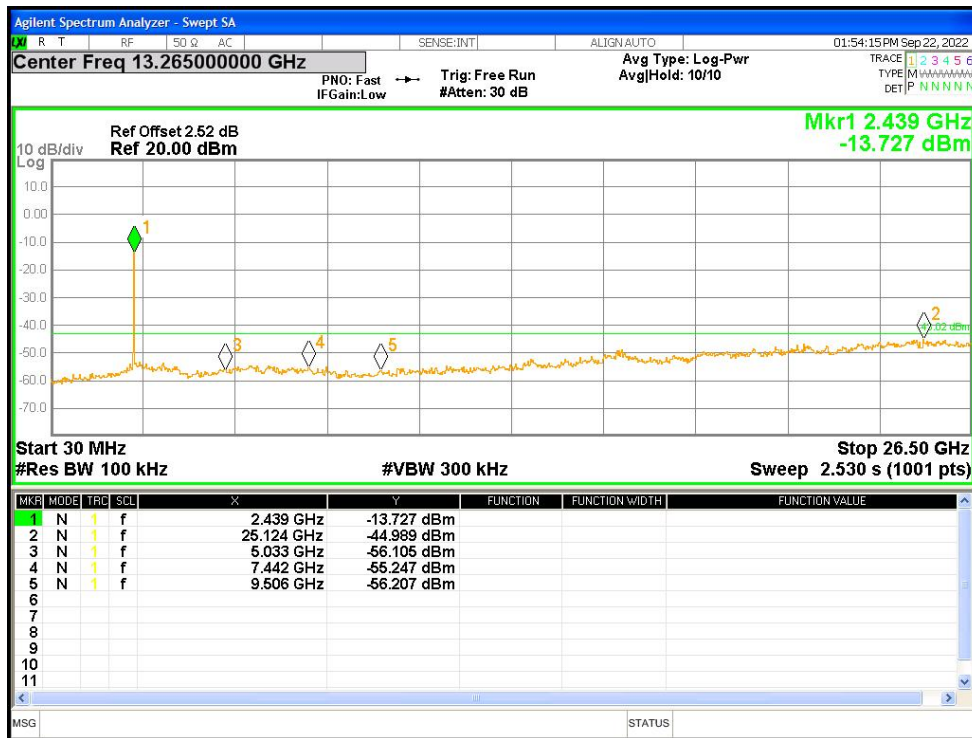
Tx. Spurious NVNT n40 2437MHz Ant1 Ref

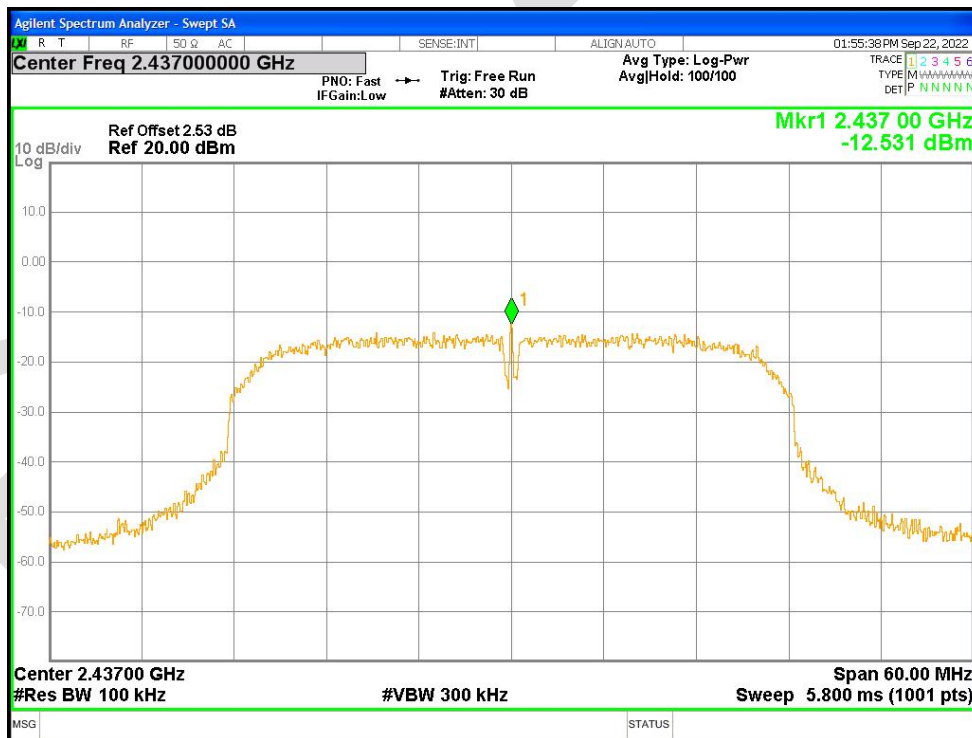
Tx. Spurious NVNT n40 2437MHz Ant1 Emission

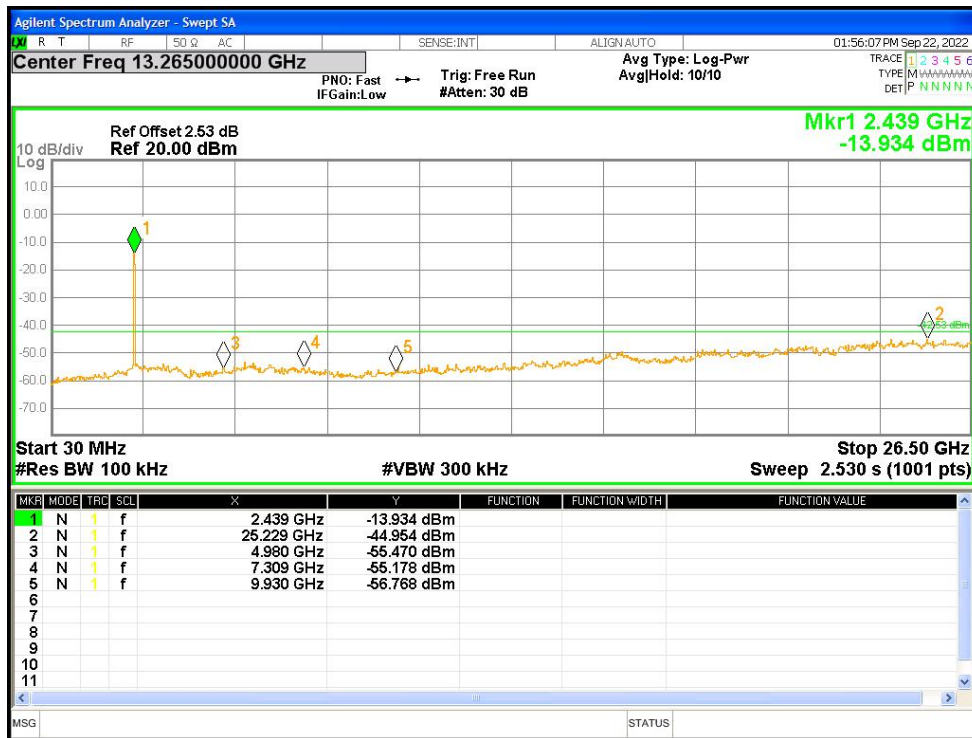
Tx. Spurious NVNT n40 2452MHz Ant1 Ref

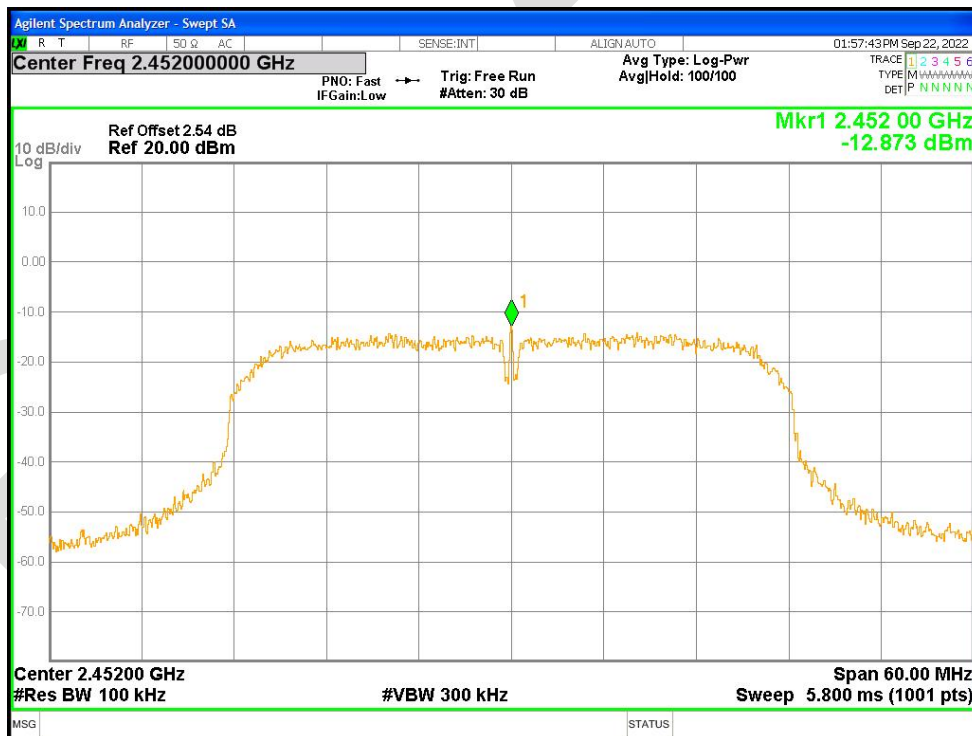
Tx. Spurious NVNT n40 2452MHz Ant1 Emission

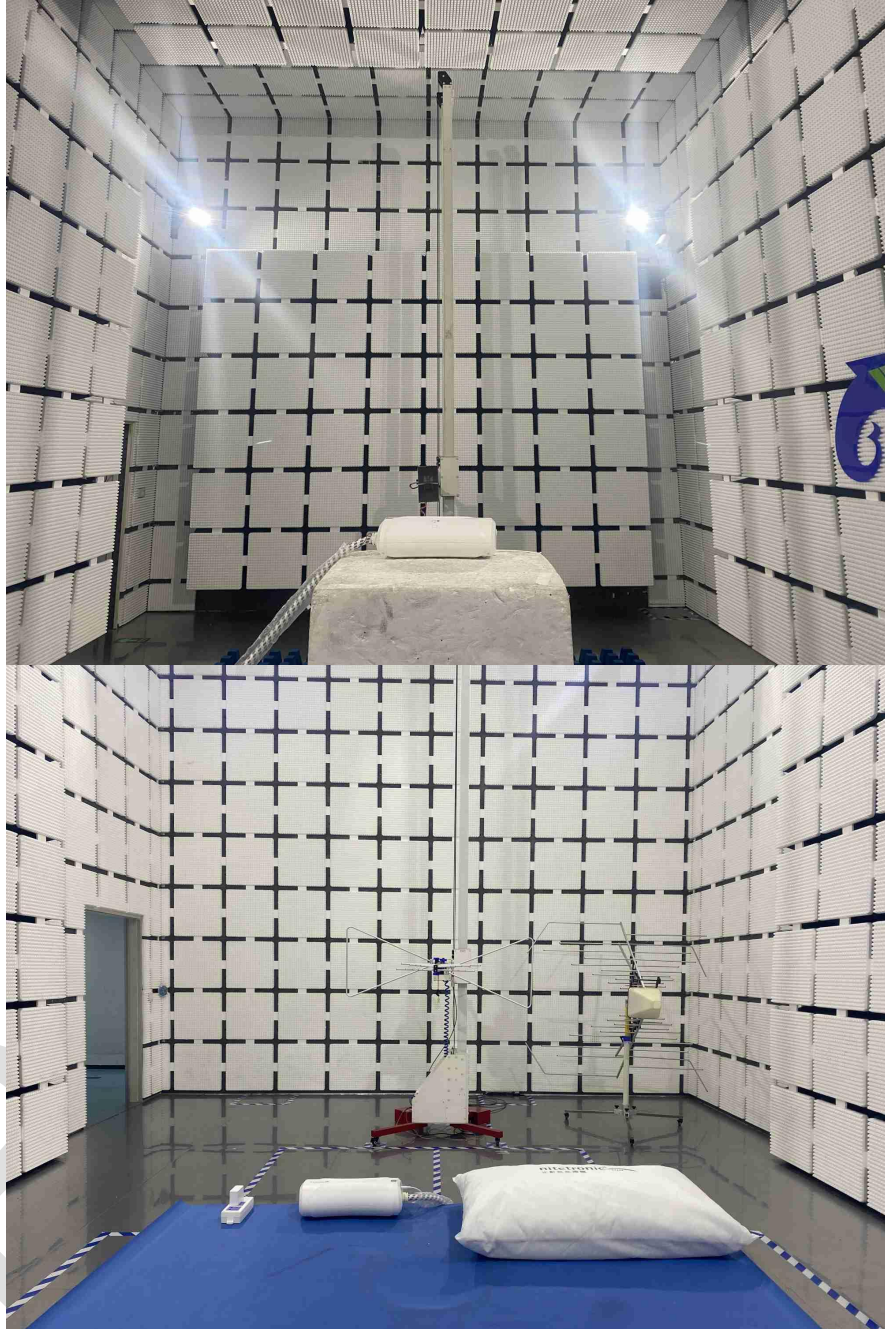
Radiated Spurious Emissions

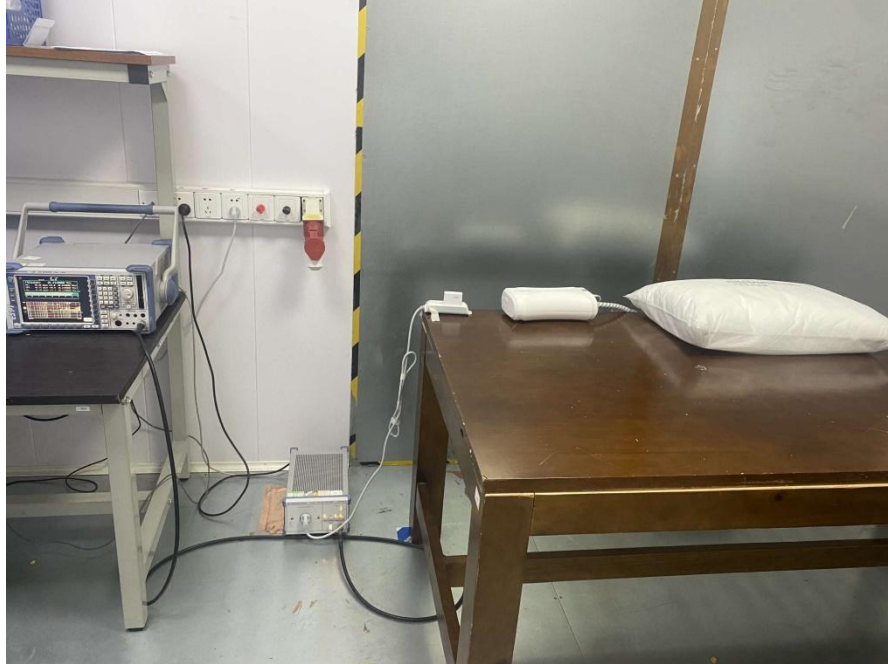
Conducted Emissions at AC Power Line (150kHz-30MHz)
