## APPENDIX A: PHOTOGRAPHS OF TEST SETUP

Reference to the test report No. BLA-EMC-202303-A2201

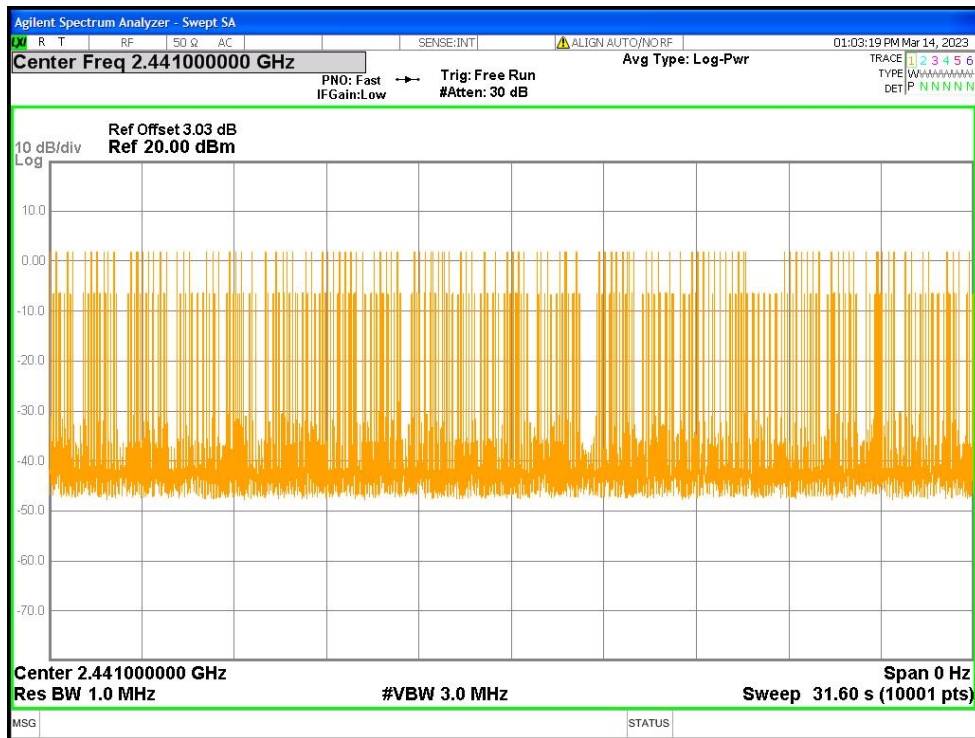
Dwell NVNT 1-DH5 2441MHz Ant1 One Burst

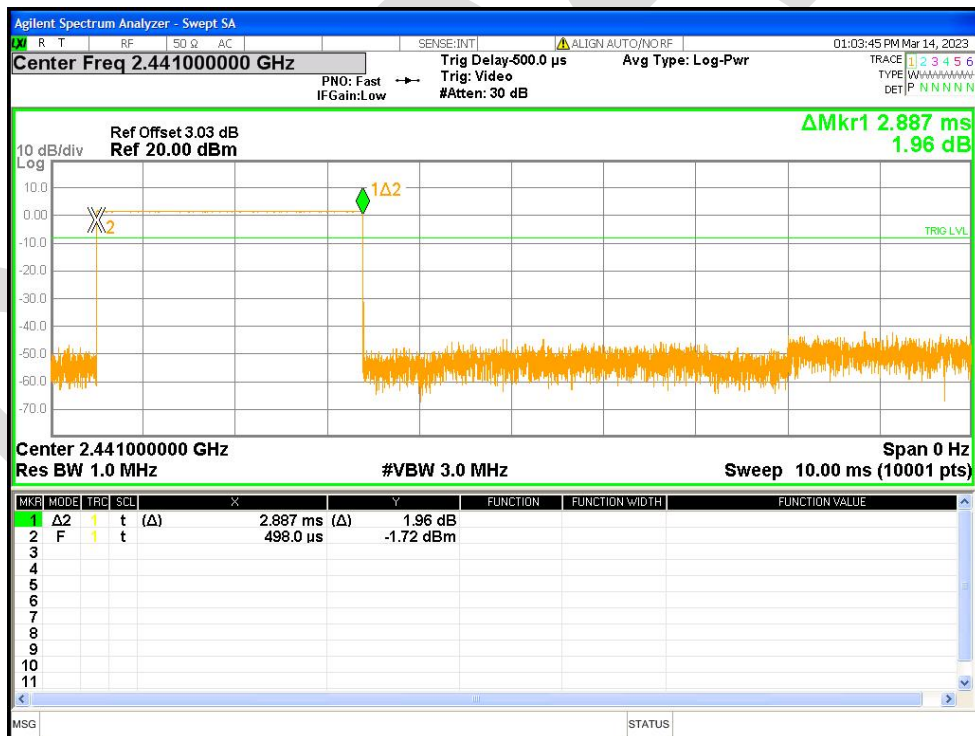
Dwell NVNT 1-DH5 2441MHz Ant1 Accumulated

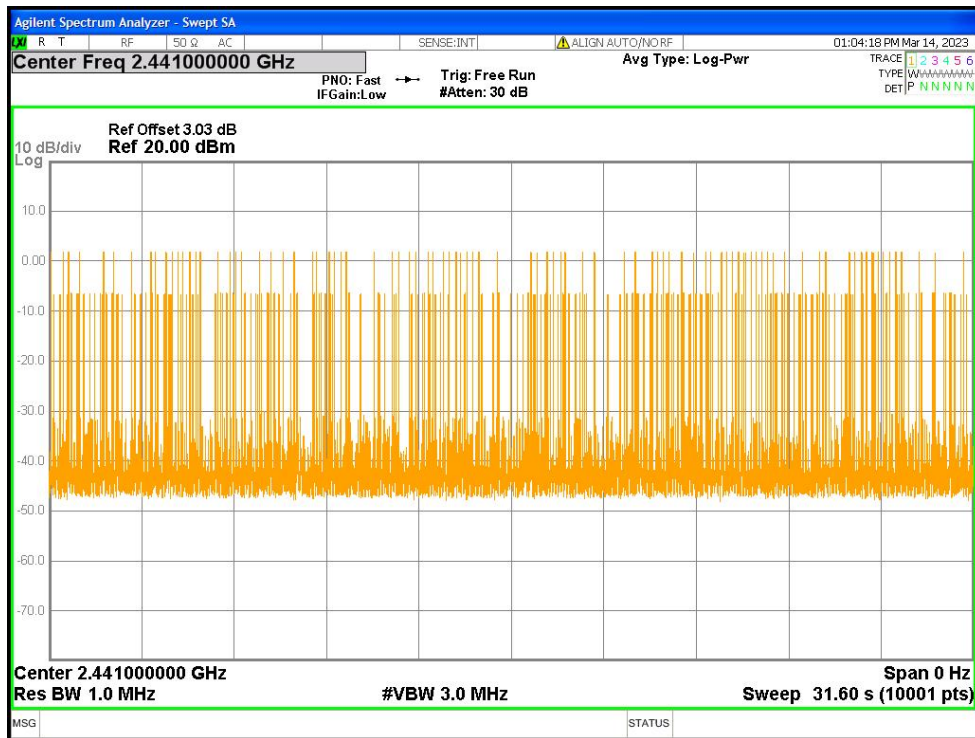
Dwell NVNT 2-DH1 2441MHz Ant1 One Burst

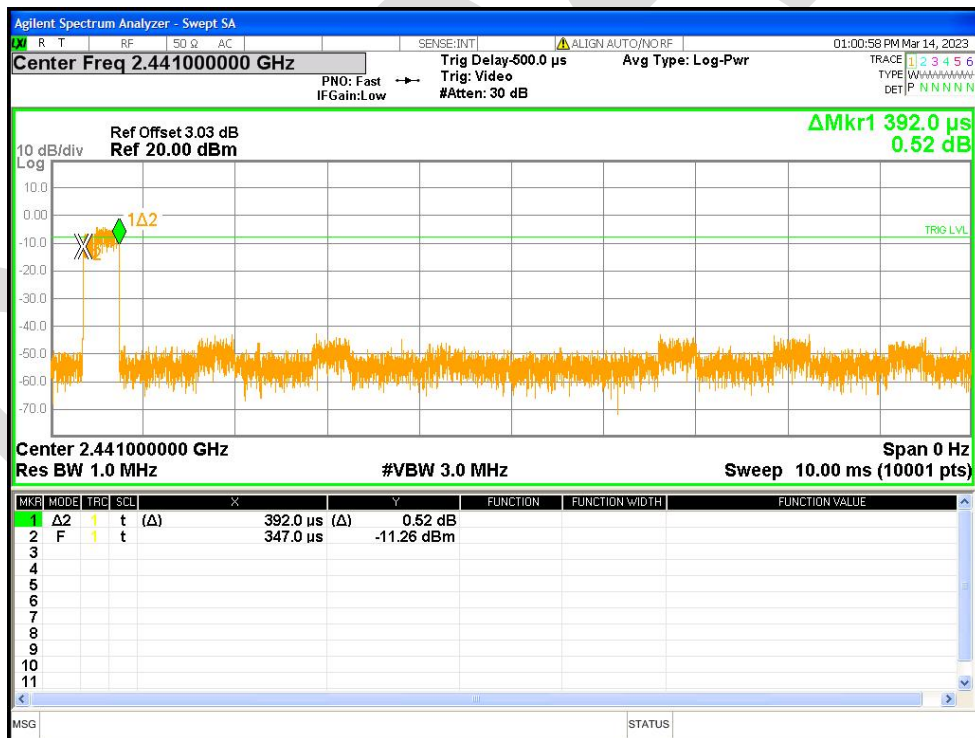
Dwell NVNT 2-DH1 2441MHz Ant1 Accumulated

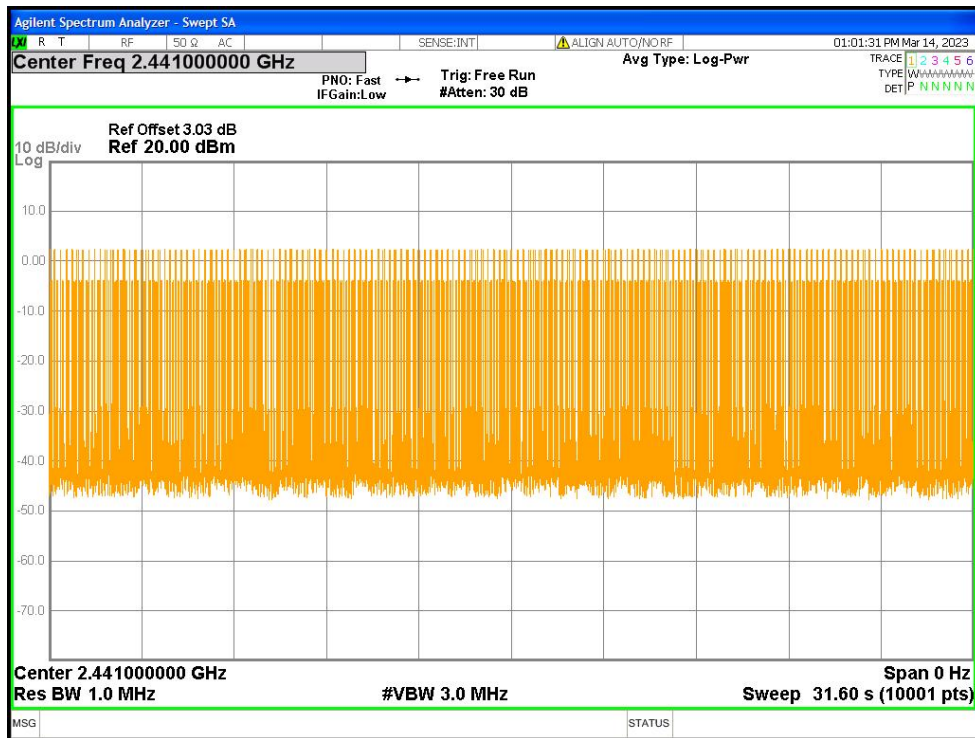
Dwell NVNT 2-DH3 2441MHz Ant1 One Burst

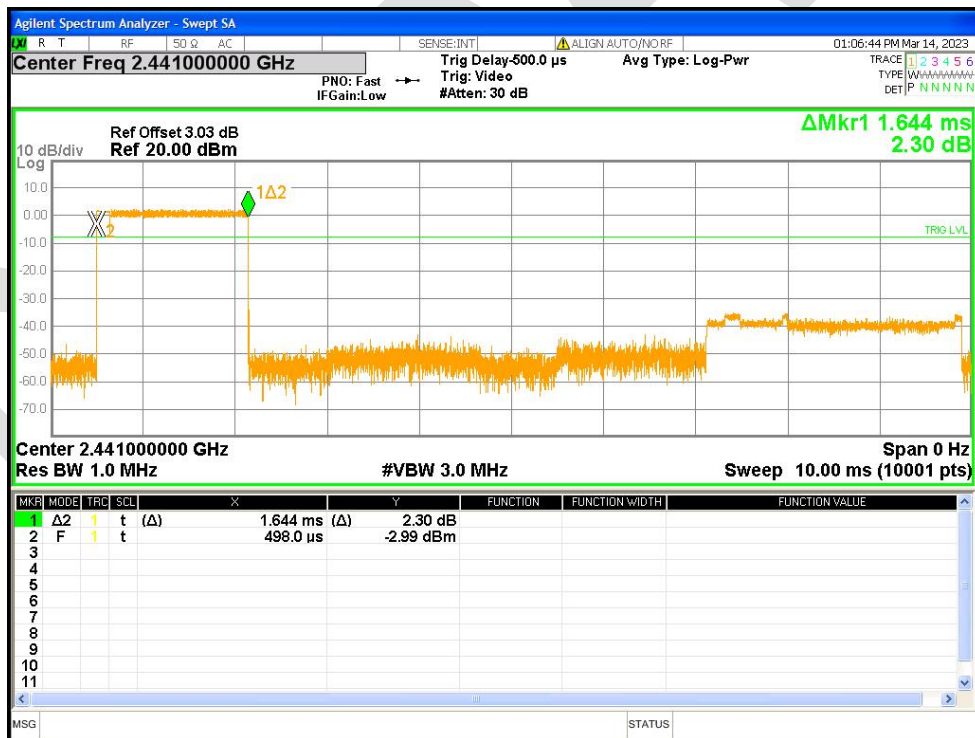
Dwell NVNT 2-DH3 2441MHz Ant1 Accumulated

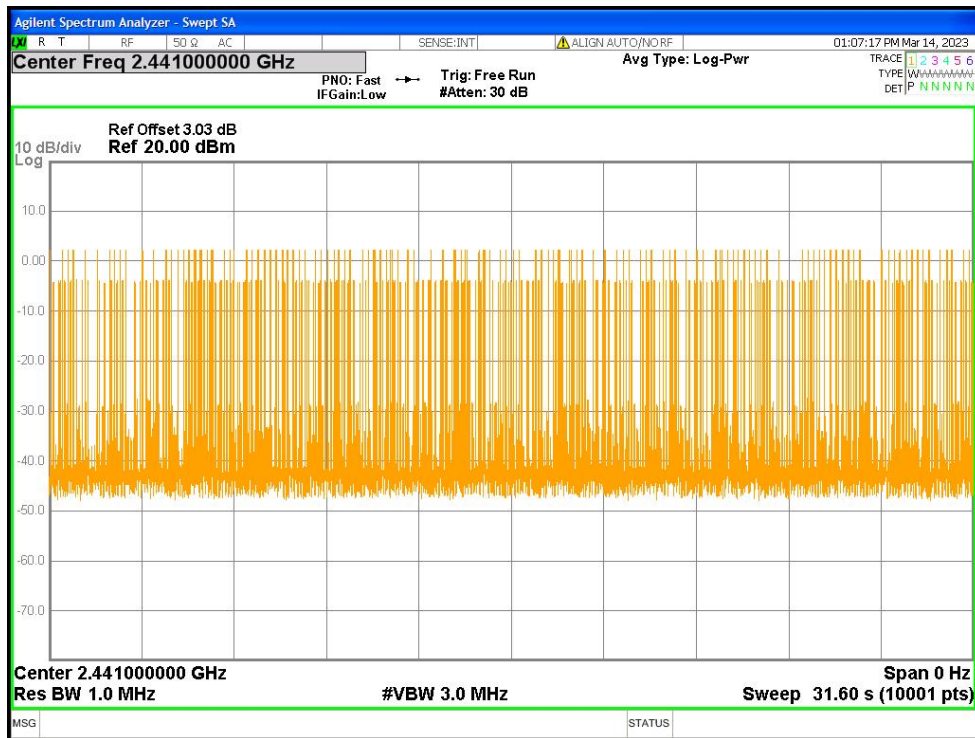
Dwell NVNT 2-DH5 2441MHz Ant1 One Burst

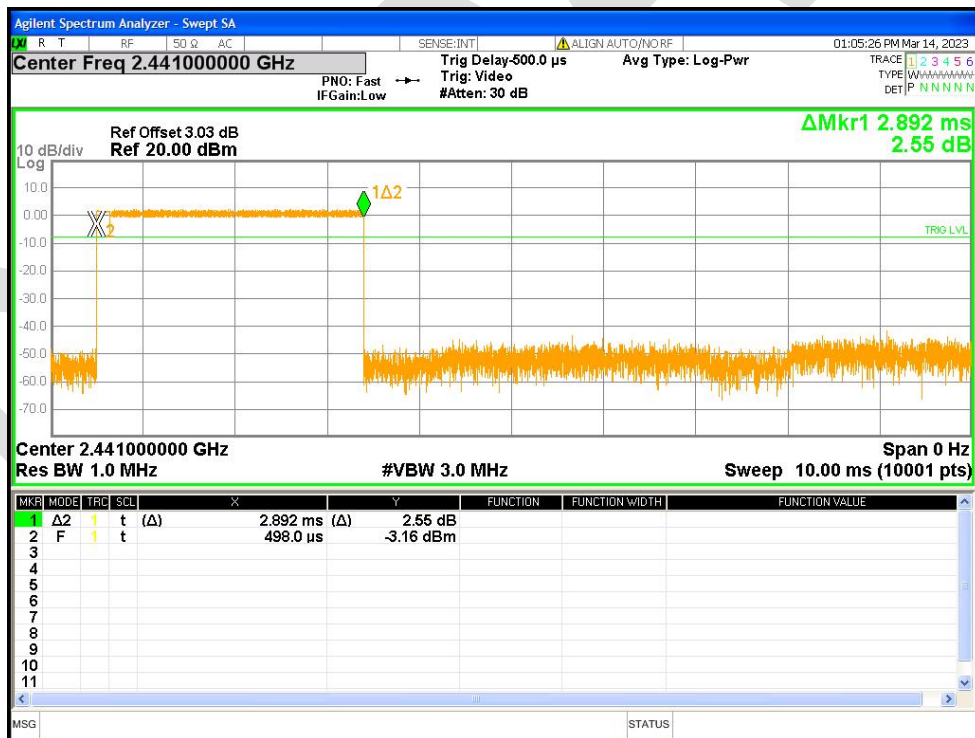
Dwell NVNT 2-DH5 2441MHz Ant1 Accumulated

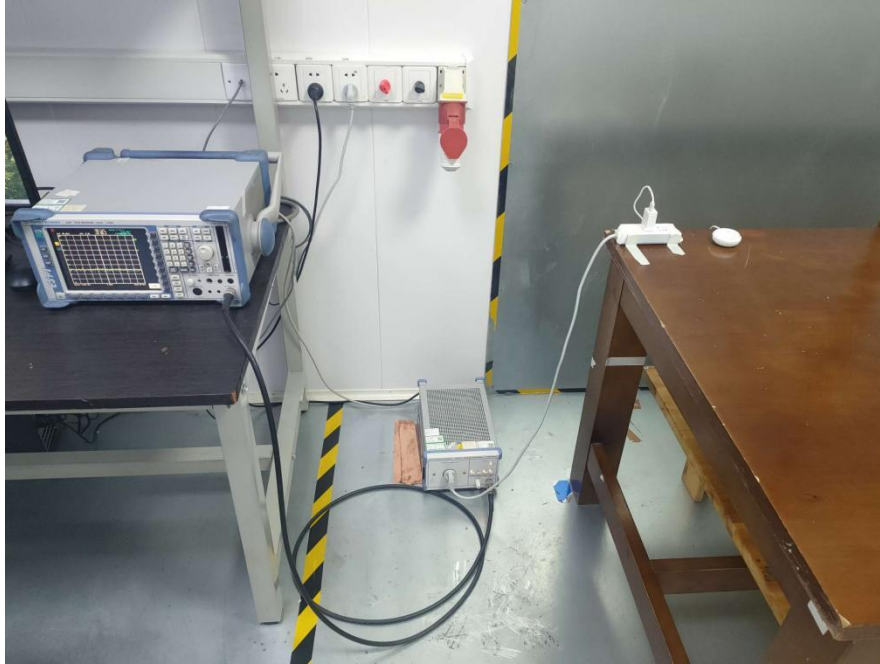
### Conducted Emissions at AC Power Line (150kHz-30MHz)

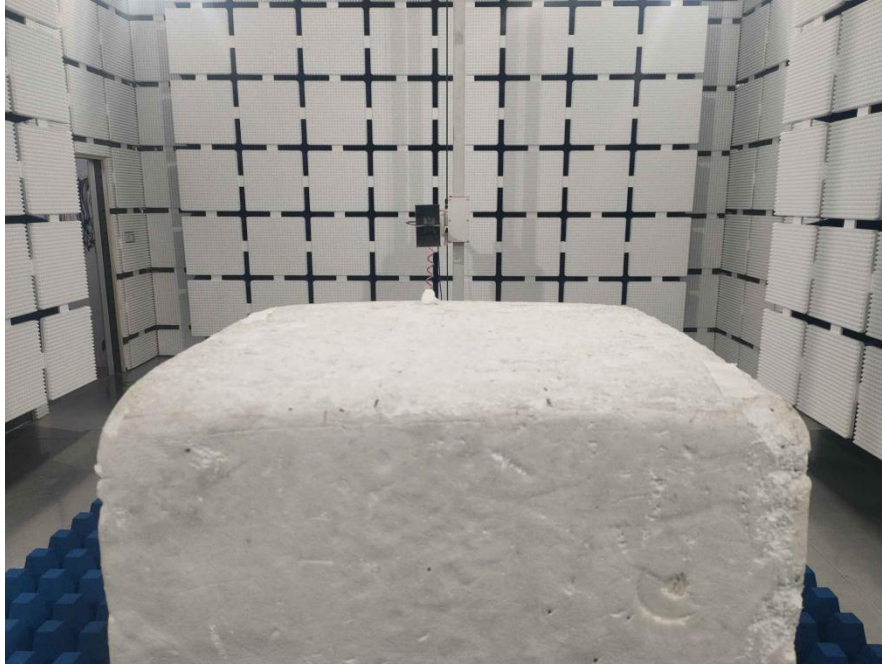
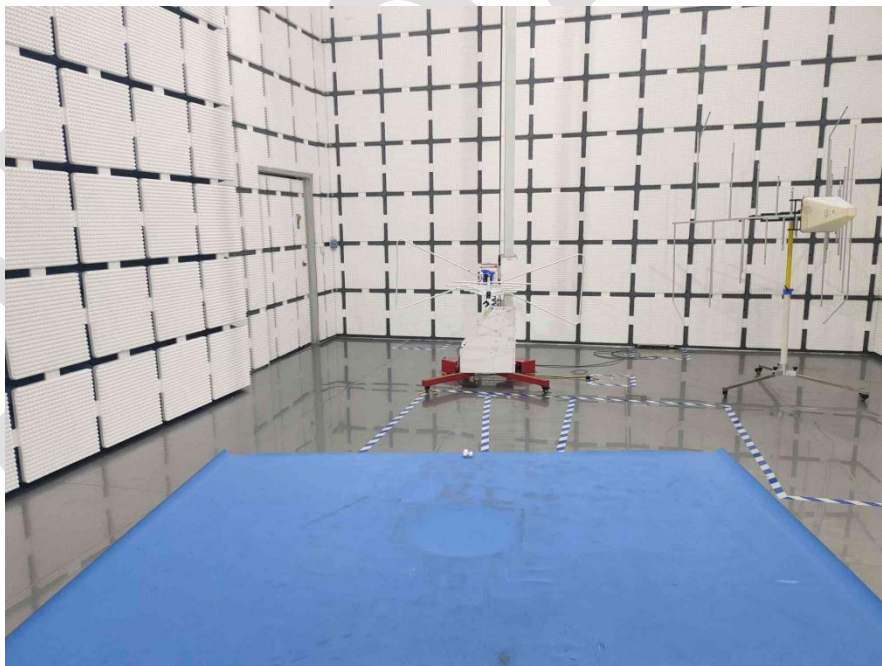
### Radiated Spurious Emissions
