9 PHOTOGRAPHS OF TEST SETUP

Report No.: EED32P81829401 Page 34 of 43

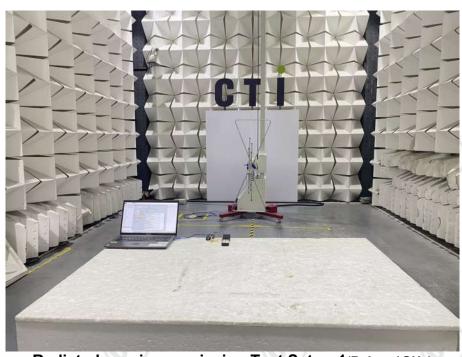
Radiated spurious emission Test Setup-1(Below 1GHz)

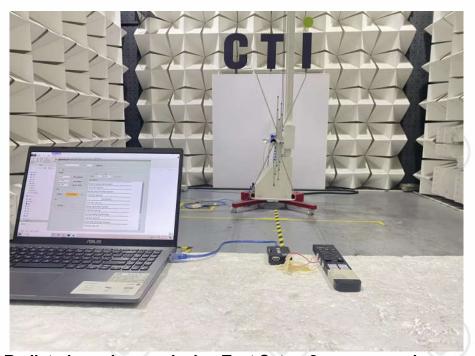
Radiated spurious emission Test Setup-2(Below 1GHz)close up

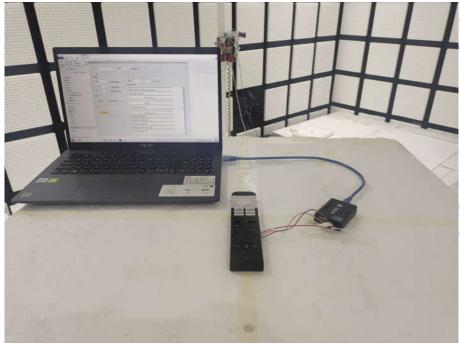
Radiated spurious emission Test Setup-3(Above 1GHz)

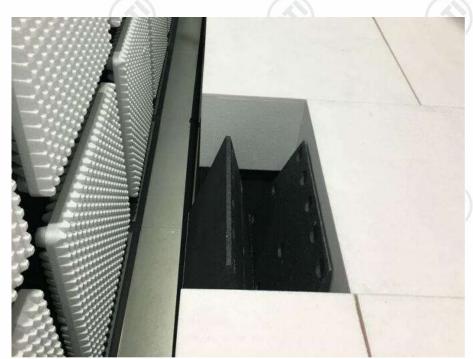
Radiated spurious emission Test Setup-4(Above 1GHz) There are absorbing materials under the ground.
