Reference to the test report No. BLA-EMC-202203-A4001

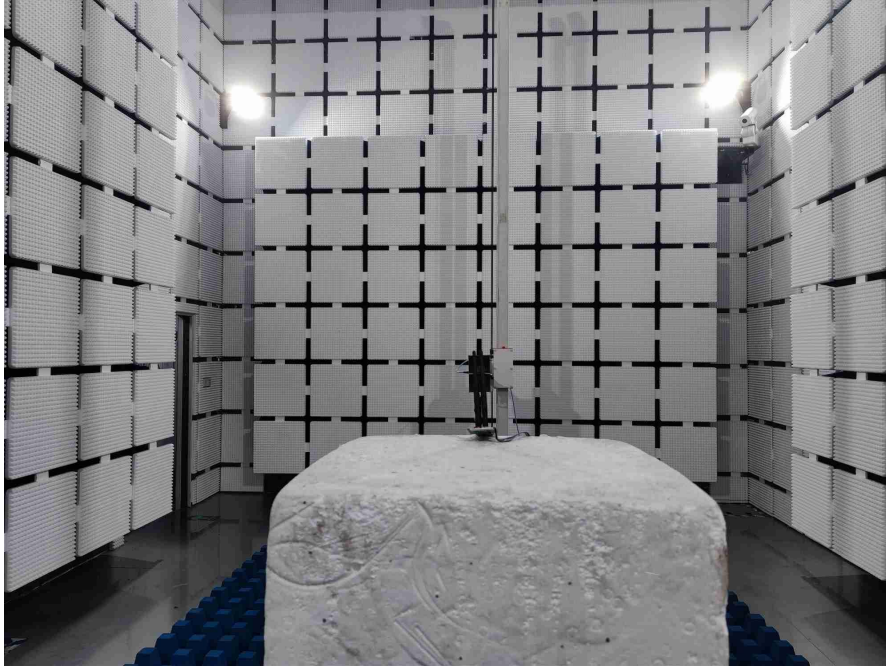
APPENDIX A: PHOTOGRAPHS OF TEST SETUP

Radiated Spurious Emissions
