## APPENDIX A: PHOTOGRAPHS OF TEST SETUP

## APPENDIX B: PHOTOGRAPHS OF EUT

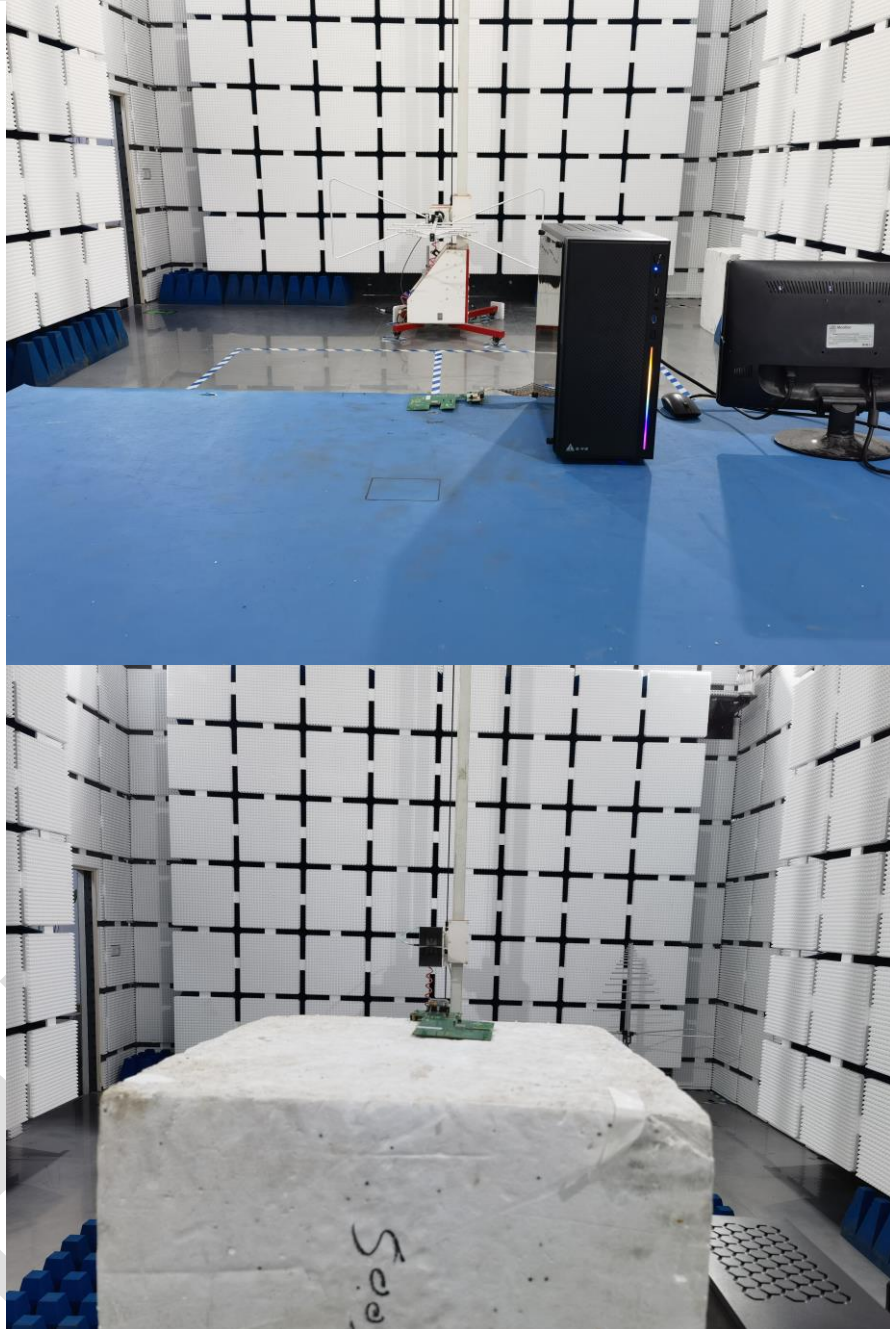
Radiated Spurious Emissions

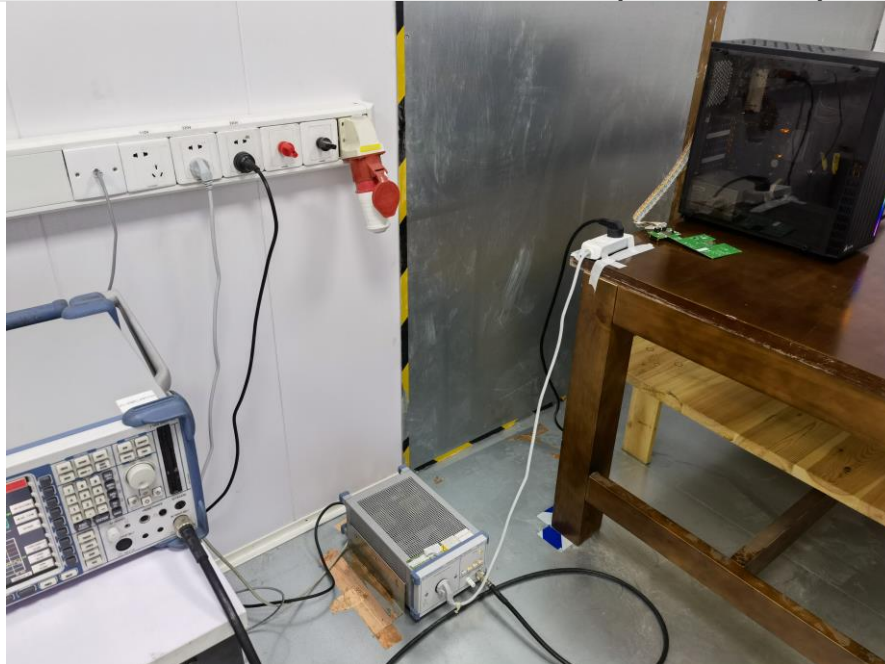
**Conducted Emissions at AC Power Line (150kHz-30MHz)**
