## The Photos of SAR test

No. I18Z60711-SEM01

**TCL Communication Ltd.**

Model Name: 50330

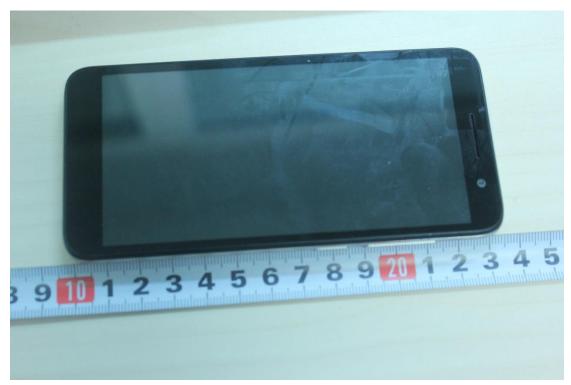
Picture - 1 Constituents of the sample

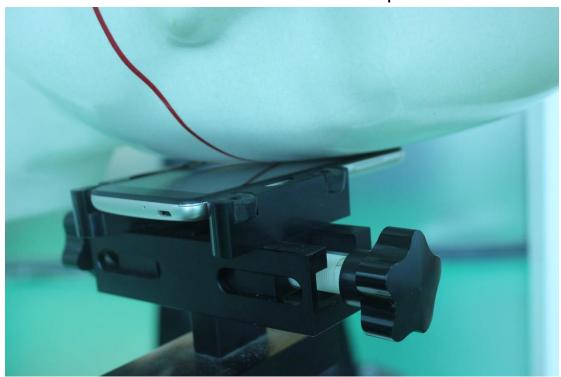
Picture - 2 Left Hand Touch Cheek Position

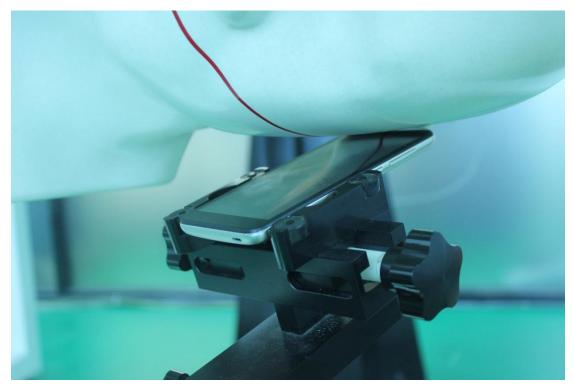
Picture - 3 Left Hand Tilt 15° Position

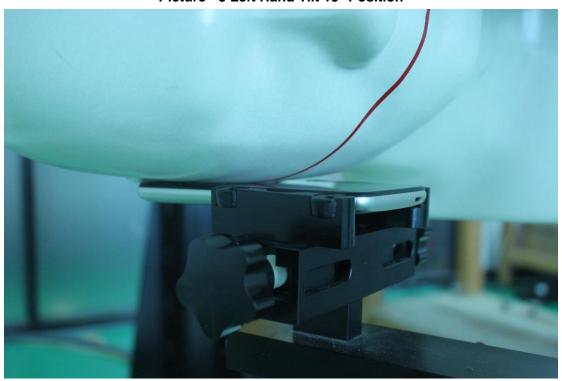
Picture - 4 Right Hand Touch Cheek Position

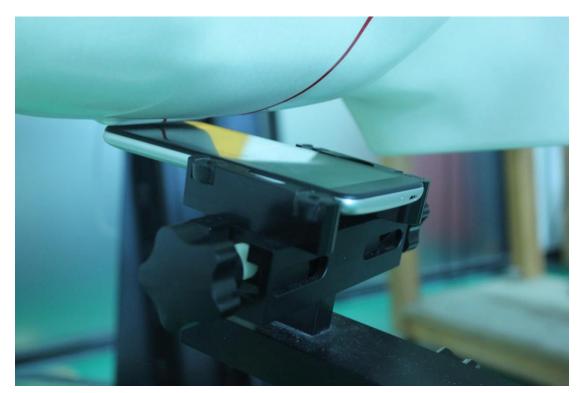
Picture - 5 Right Hand Tilt 15° Position

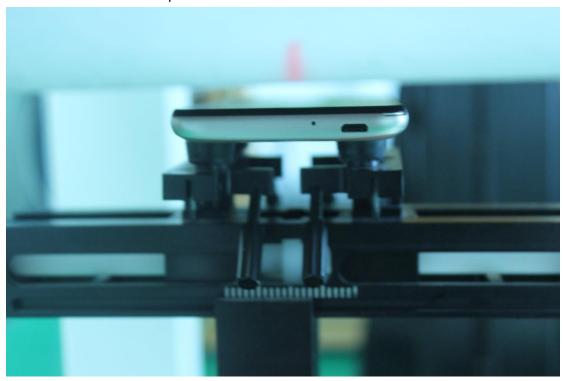
The Body SAR is tested at the following 6 test positions all with the distance =10mm between the EUT and the phantom bottom:

**Picture - 6 Front**

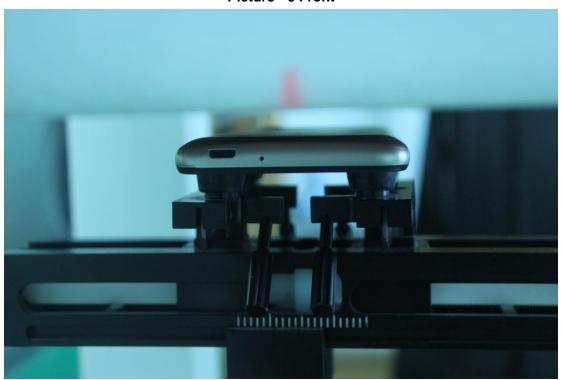
Picture - 7 Rear

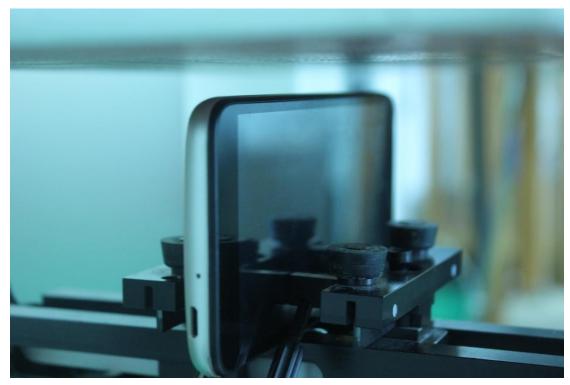
Picture - 8 Left edge

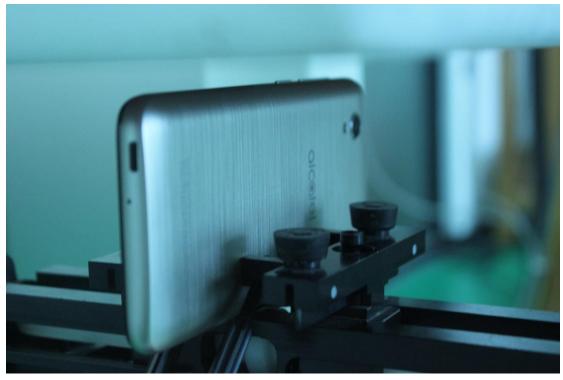
Picture - 9 Right edge

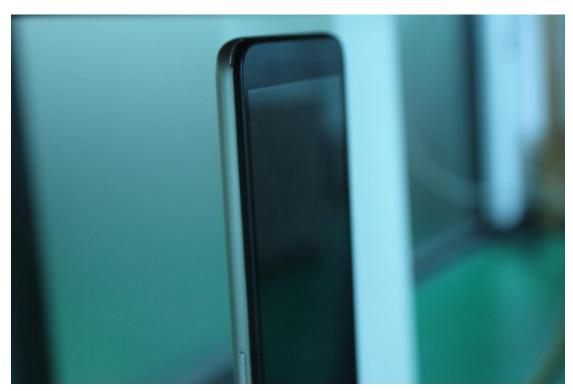
Picture - 10 Bottom edge

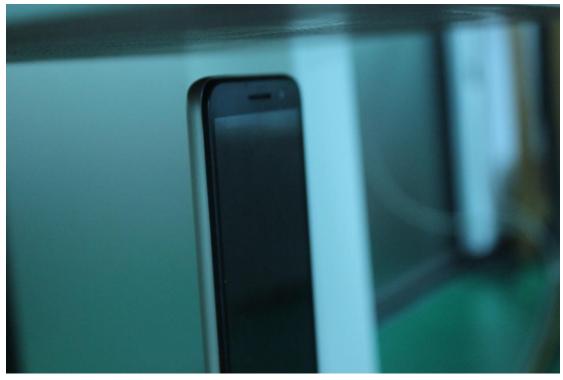
Picture - 11 Top edge
