6. Photographs of the Test Setup

Prüfbericht - Nr.: 50006140 001
Test Report No.:Seite 23 von 26
Page 23 of 26**Photograph 2: Set-up for AC Power Line Conducted Emission of Transmitter, Rear View**

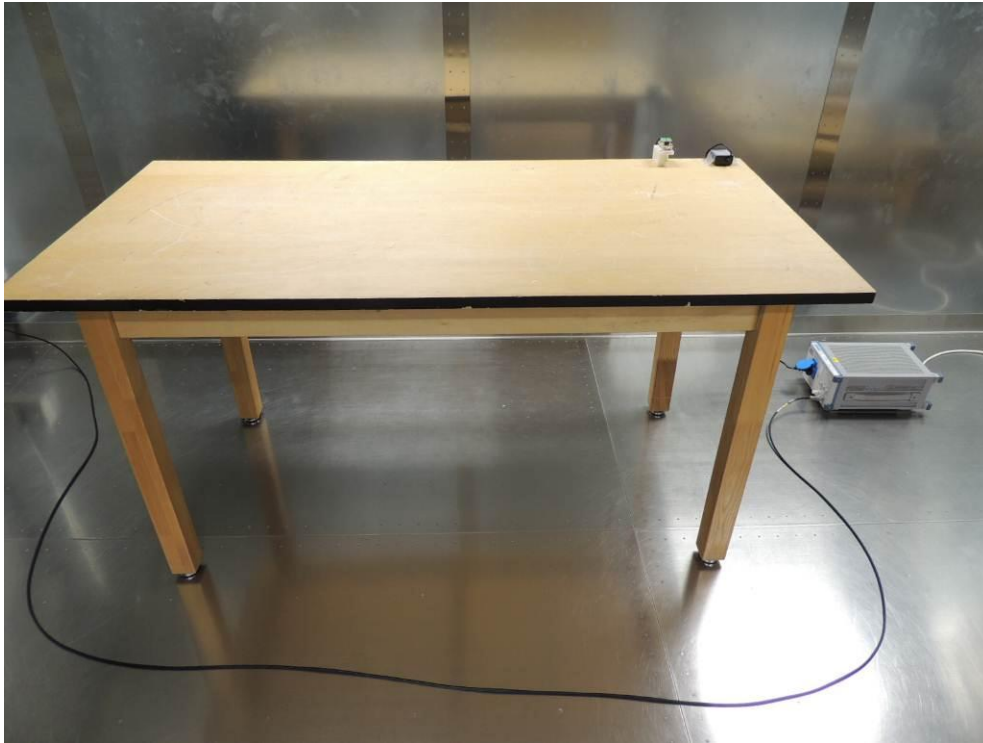
Photograph 1: Set-up for AC Power Line Conducted Emission of Transmitter, Front View

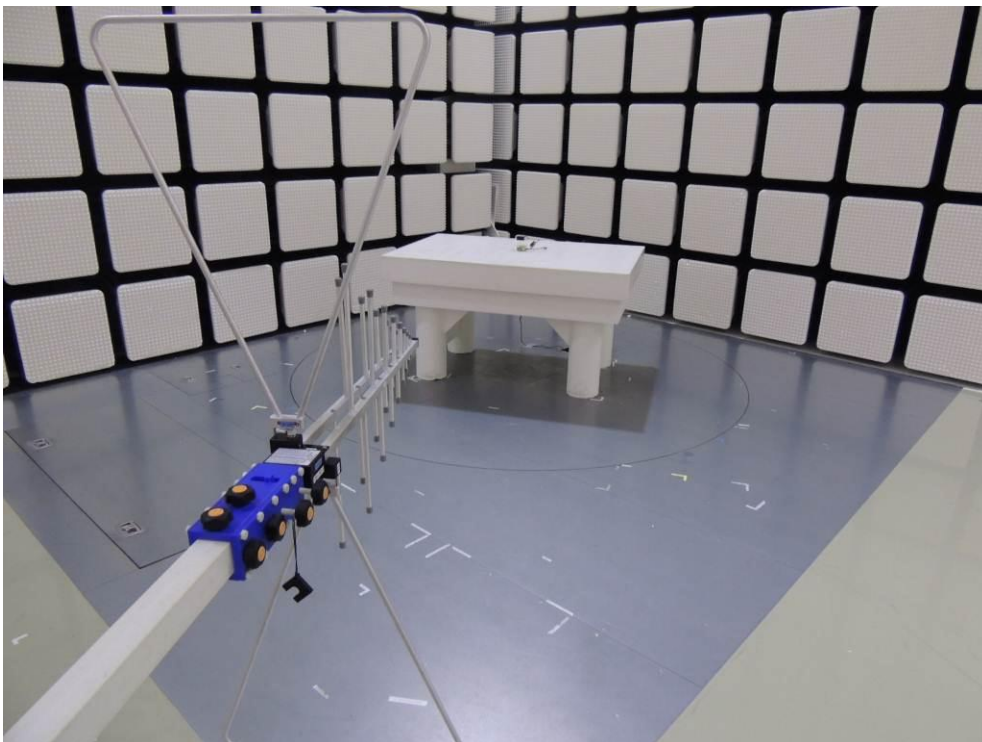
**Photograph 3: Set-up for Radiated Emission of Transmitter, Front View**

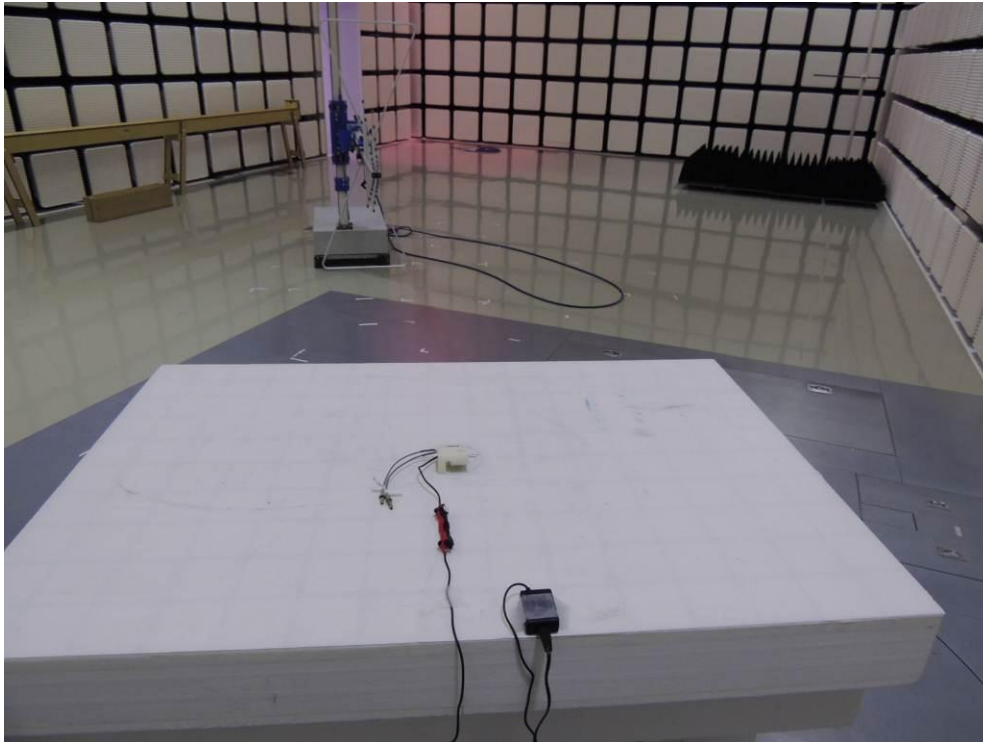
Photograph 4: Set-up for Radiated Emission of Transmitter, Rear View

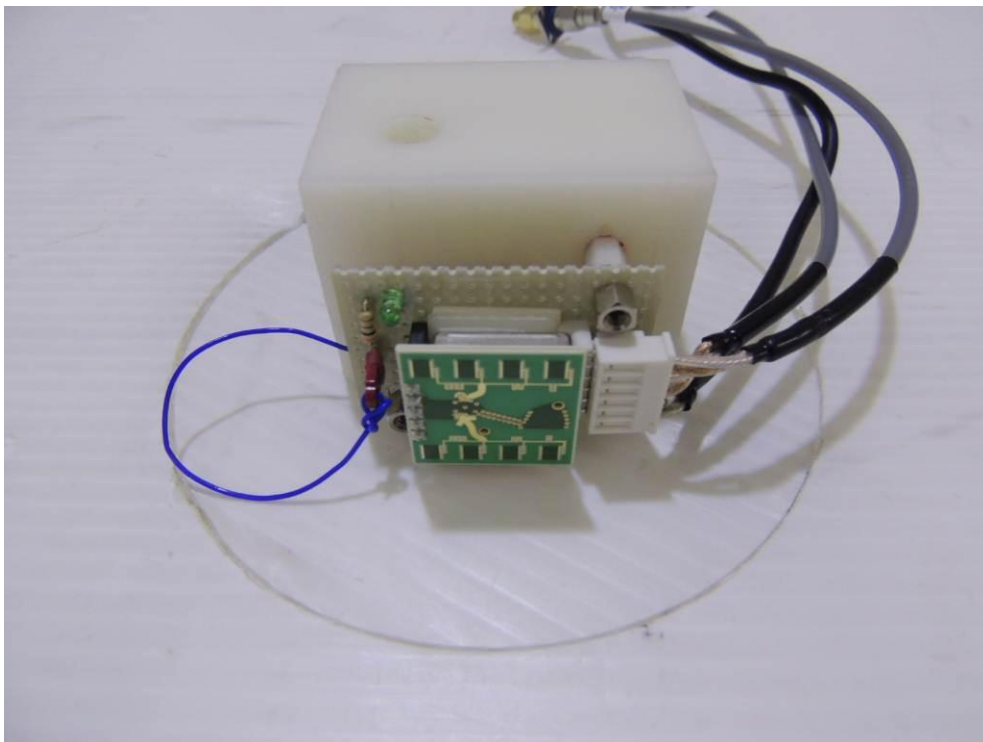
**Photograph 5: Set-up for Radiated Emission, EUT Configuration X-Axis**

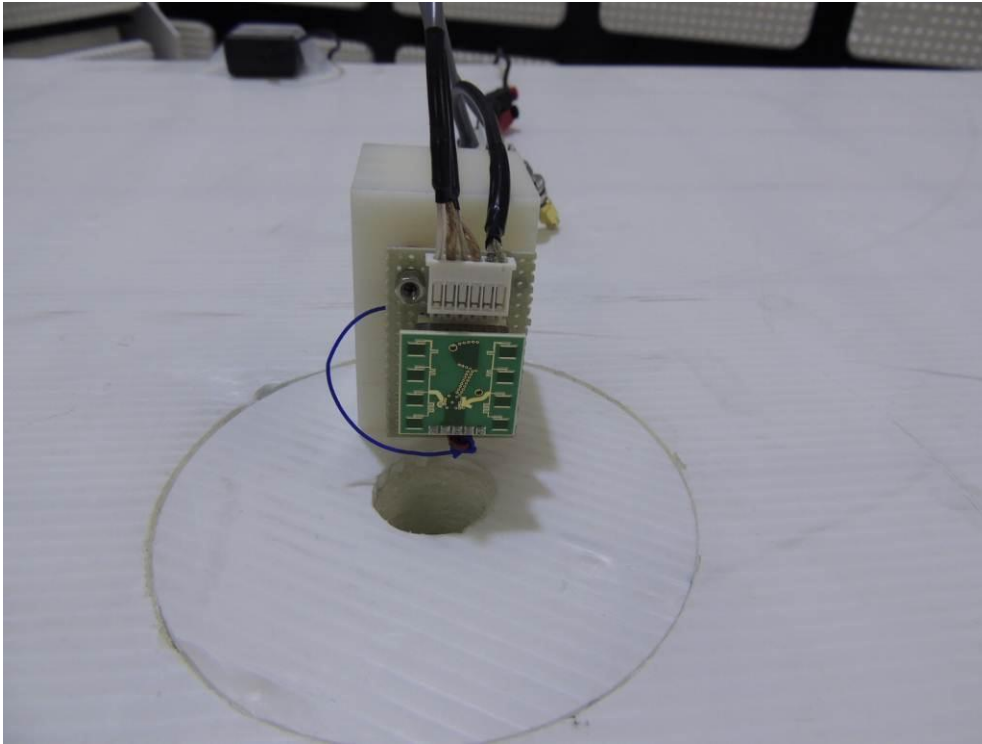
Photograph 6: Set-up for Radiated Emission, EUT Configuration Y-Axis

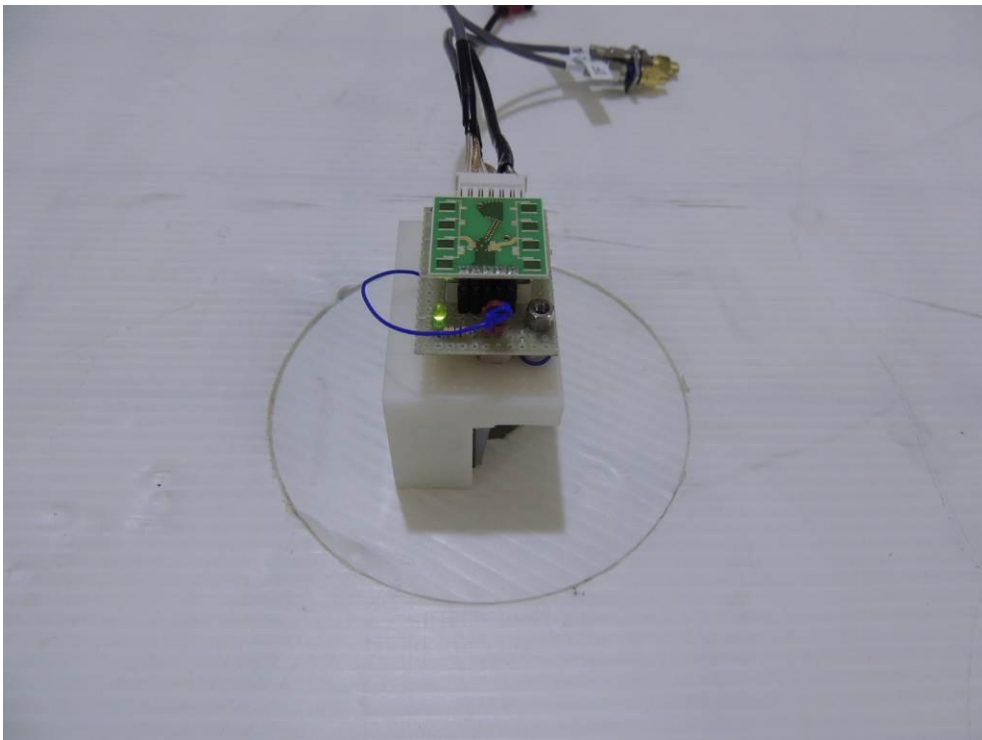
**Photograph 7: Set-up for Radiated Emission, EUT Configuration Z-Axis**
