10.5. TEST RESULT OF LINE CONDUCTED EMISSION TEST

Report No.: AGC00210190532FE03 Page 33 of 46

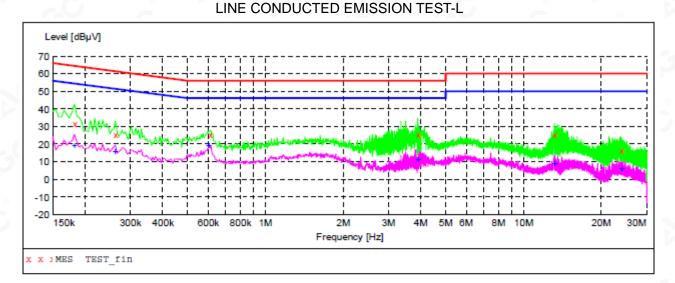
MEASUREMENT RESULT: "TEST fin"

6/12/2019 Frequency MH:	•	Transd dB	Limit dBµV	Margin dB	Detector	Line	PE
0.182000 0.262000 0.610000 3.898000 13.198000 23.938000	0 25.60 0 25.40 0 25.70 0 25.40	10.9 10.9 10.7 11.6 12.1 12.6	64 61 56 60 60	32.9 35.8 30.6 30.3 34.6 43.8	QP QP QP QP QP	L1 L1 L1 L1 L1 L1	FLO FLO FLO FLO FLO FLO

MEASUREMENT RESULT: "TEST fin2"

6,	/12/2019 10:2	22AM							
	Frequency	Level	Transd	Limit		Detector	Line	PE	
	MHz	dBµV	dB	dBµV	dB				
	0 100000	10 50	10.0		24.0			TT O	
	0.182000	19.50	10.9	54	34.9	AV	L1	FLO	
	0.262000	15.90	10.9	51	35.5	AV	L1	FLO	
	0.602000	19.40	10.7	46	26.6	AV	L1	FLO	
	3.898000	11.40	11.6	46	34.6	AV	L1	FLO	
	13.198000	8.90	12.1	50	41.1	AV	L1	FLO	
	23.942000	6.10	12.6	50	43.9	AV	L1	FLO

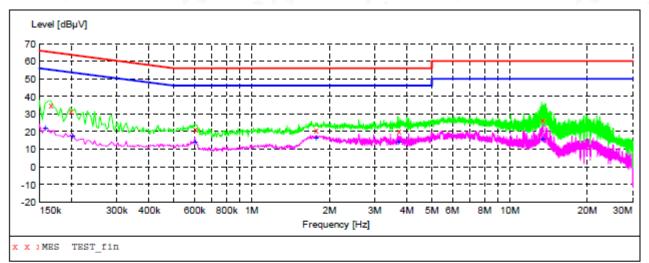
LINE CONDUCTED EMISSION TEST-N

MEASUREMENT RESULT: "TEST fin"

6/12/2019 11:10AM									
Frequency	Level	Transd	Limit	Margin	Detector	Line	PE		
MHz	dBµV	dB	dBµV	dB					
0.166000	35.30	10.8	65	29.9	QP	N	FLO		
0.198000	31.90	10.9	64	31.8	QP	N	FLO		
0.602000	21.60	10.7	56	34.4	OP	N	FLO		
1.774000	21.30	11.5	56	34.7	Q̃₽	N	FLO		
3.698000	20.60	11.6	56	35.4	QP	N	FLO		
13.398000	26.70	12.1	60	33.3	QP	N	FLO

MEASUREMENT RESULT: "TEST fin2"

6/12/2019 11:1	10AM						
Frequency	Level	Transd	Limit	Margin	Detector	Line	PE
MHz	dBµV	dB	dBµV	dB			
0.158000	22.00	10.8	56	33.6	AV	N	FLO
0.202000	17.40	10.9	54	36.1	AV	N	FLO
0.602000	14.00	10.7	46	32.0	AV	N	FLO
1.774000	16.40	11.5	46	29.6	AV	N	FLO
3,698000	14.40	11.6	46	31.6	AV	N	FLO
13.398000	16.10	12.1	50	33.9	AV	N	FLO
10.000000	10.10		20				110

RESULT: PASS
