EUT	4K UST Laser Projector	Model Name	VA-LT002
Temperature	25° C	Relative Humidity	55.4%
Pressure	960hPa	Test Voltage	Normal Voltage
Test Mode	Mode 3	Antenna	Horizontal

8. LINE CONDUCTED EMISSION TEST

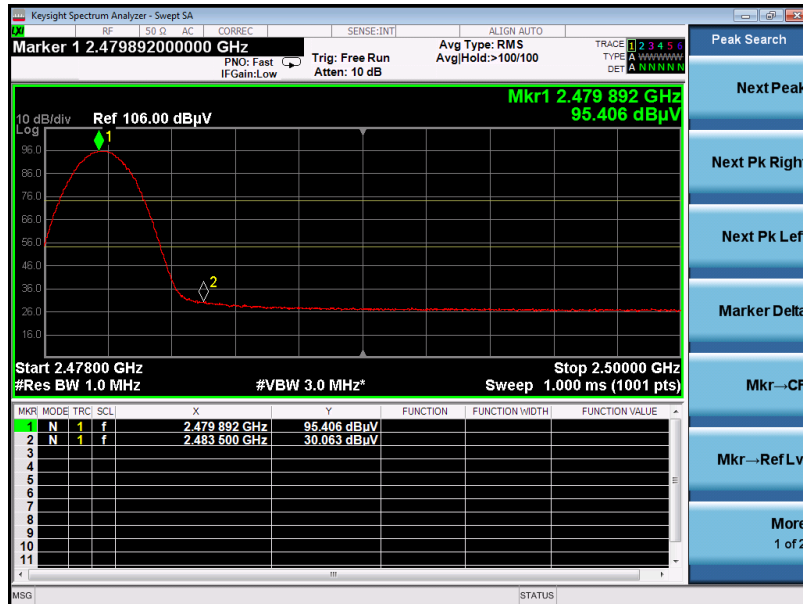
AV

EUT	4K UST Laser Projector	Model Name	VA-LT002
Temperature	25° C	Relative Humidity	55.4%
Pressure	960hPa	Test Voltage	Normal Voltage
Test Mode	Mode 3	Antenna	Vertical

RESULT: PASS

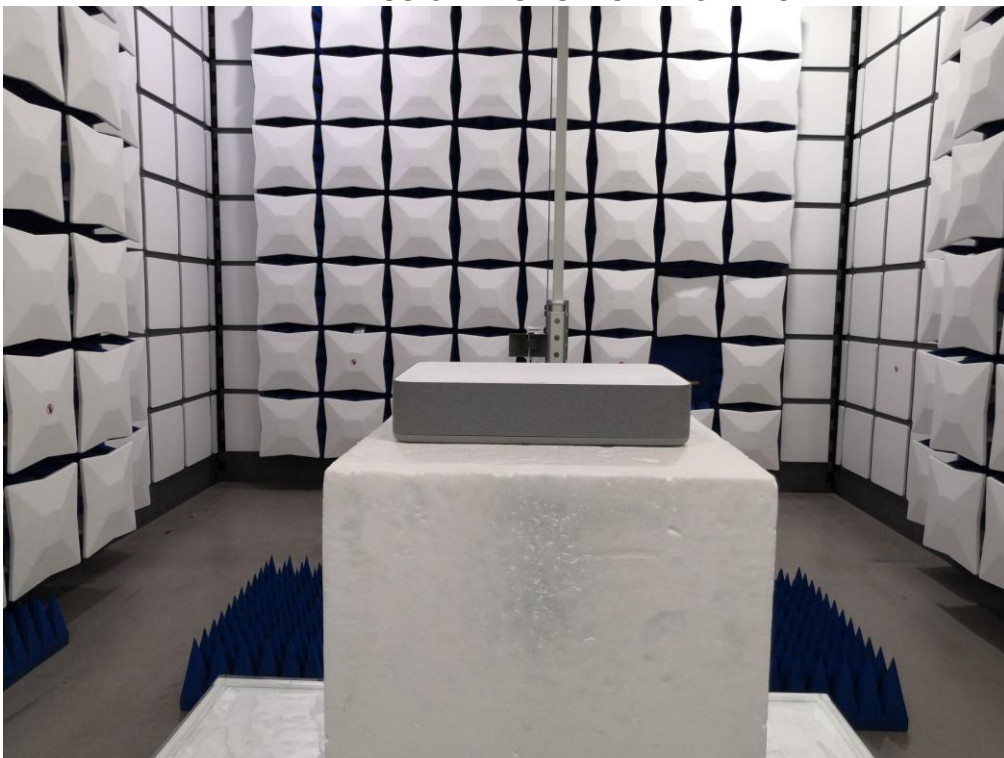
RADIATED EMISSION TEST SETUP ABOVE 1GHZ

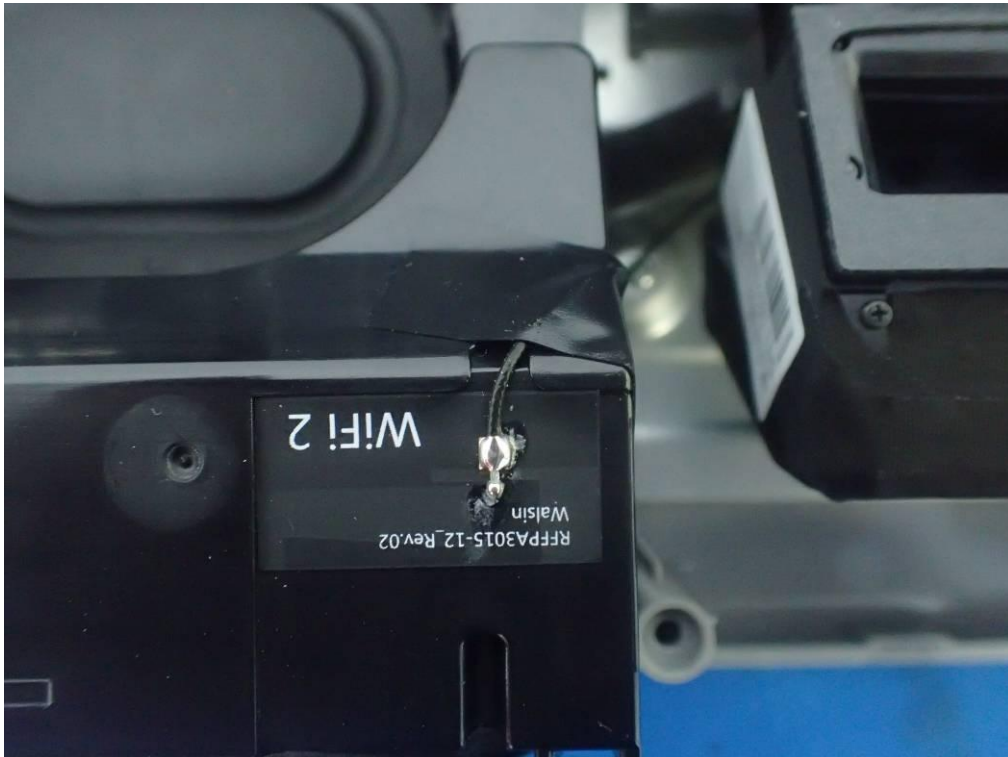
OPEN VIEW OF EUT-5(WIFI Antenna 2)

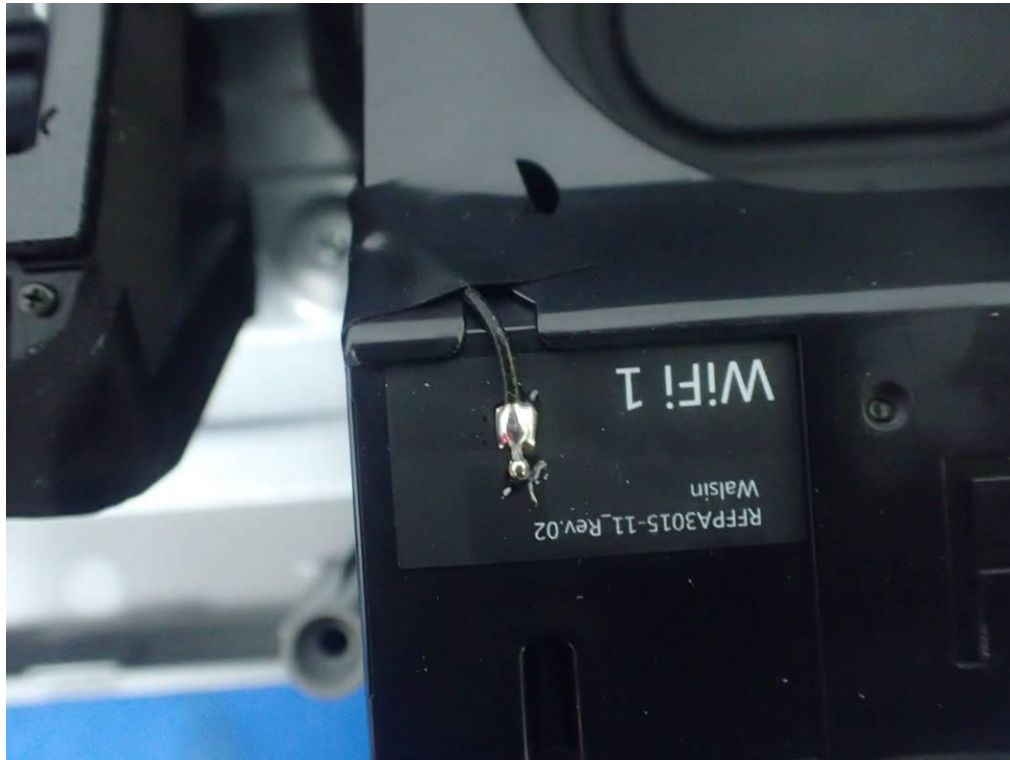
OPEN VIEW OF EUT-6(WIFI Antenna 1)
