## APPENDIX A: PHOTOGRAPHS OF TEST SETUP

### APPENDIX B: PHOTOGRAPHS OF EUT

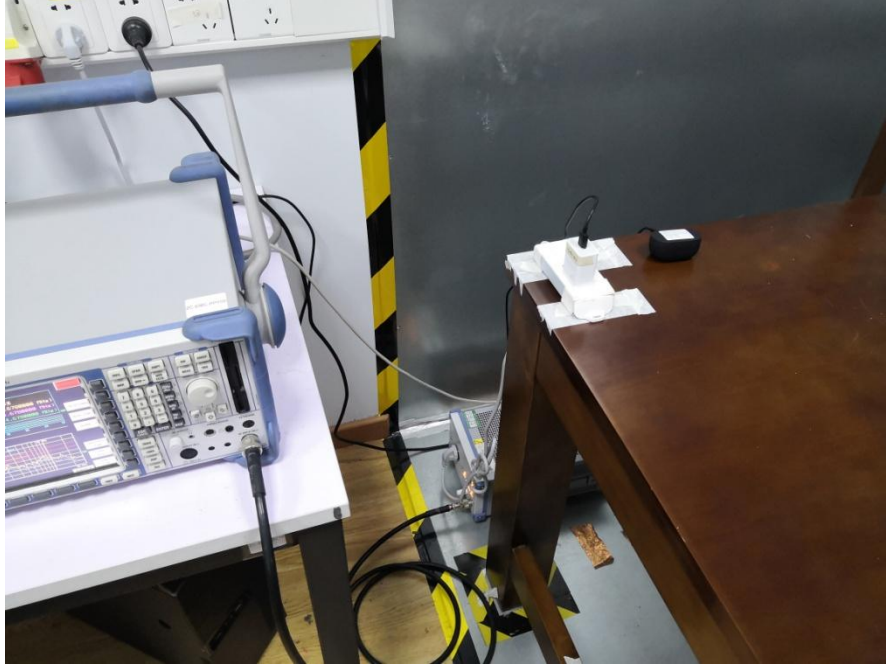
**Conducted Emissions at AC Power Line (150kHz-30MHz)**

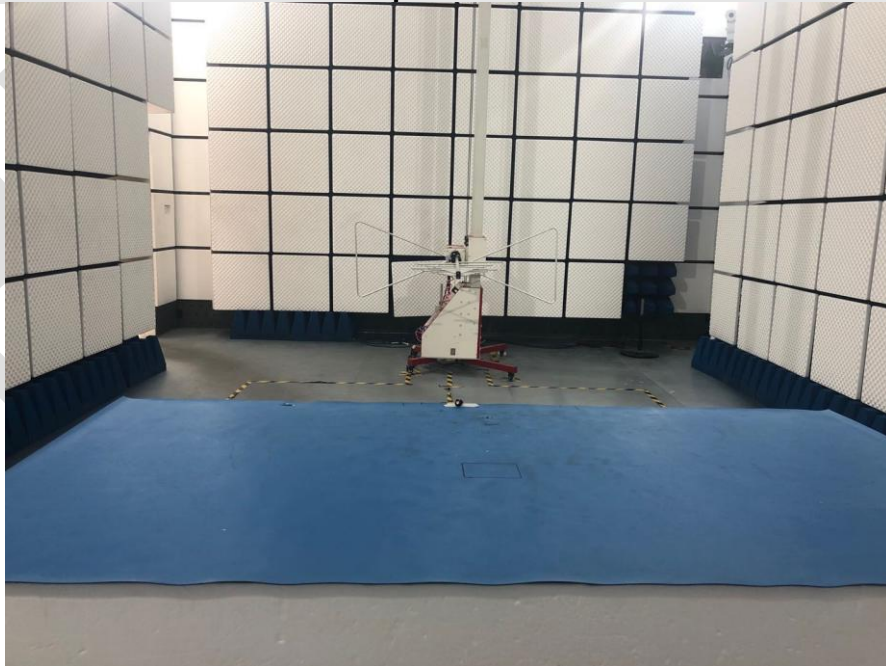
**Radiated Spurious Emissions**
