10.7 APPENDIX: CONDUCTED SPURIOUS EMISSION
Test Result

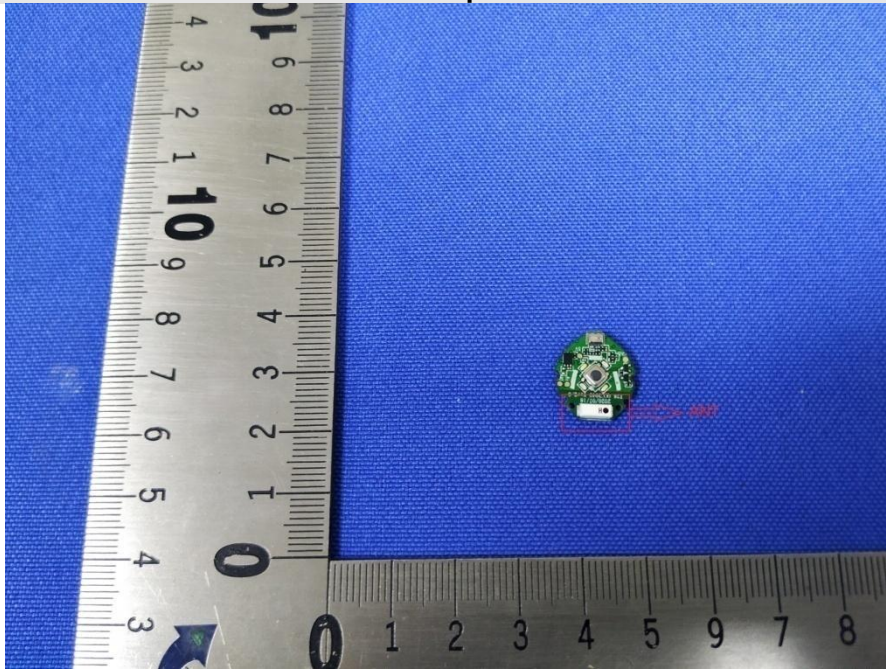
Antenna Requirement

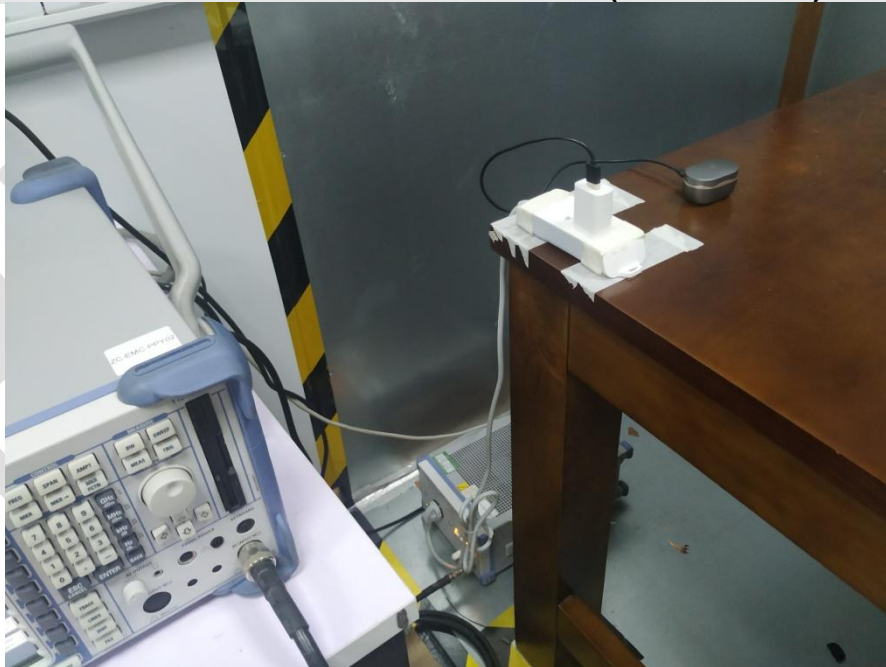
Conducted Emissions at AC Power Line (150kHz-30MHz)

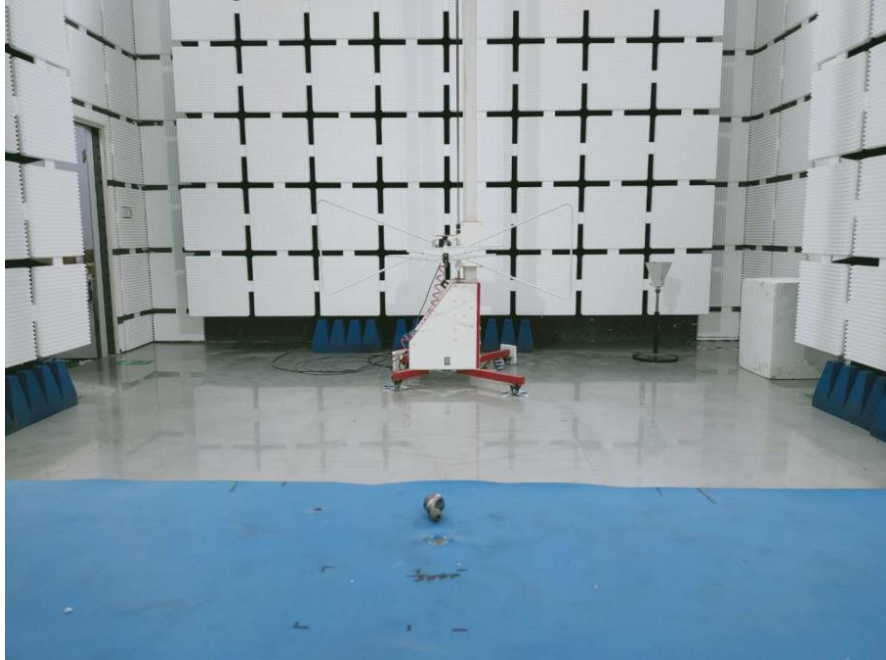
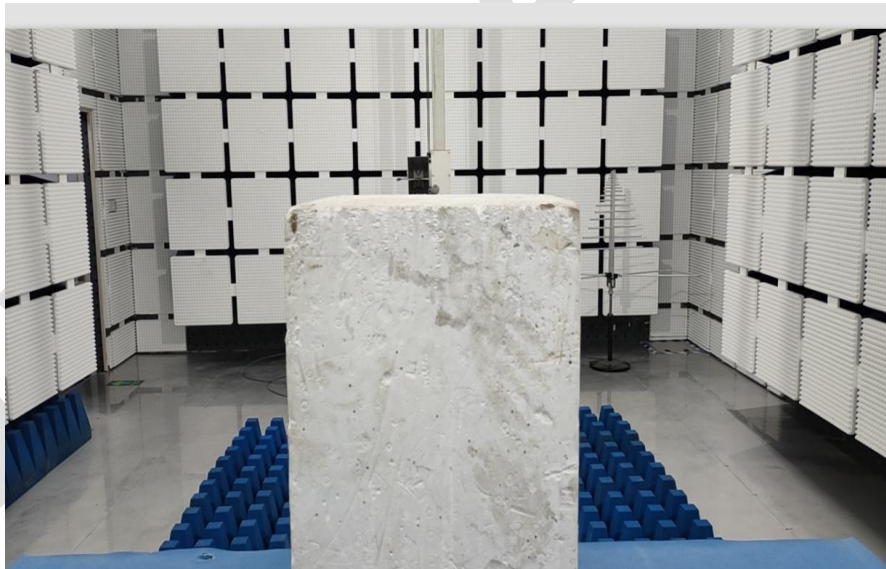
Radiated Spurious Emissions
