Appendix F: Band edge measurements

Appendix G: Conducted Spurious Emission Test Result

12. TEST SETUP PHOTO

13. EUT PHOTO

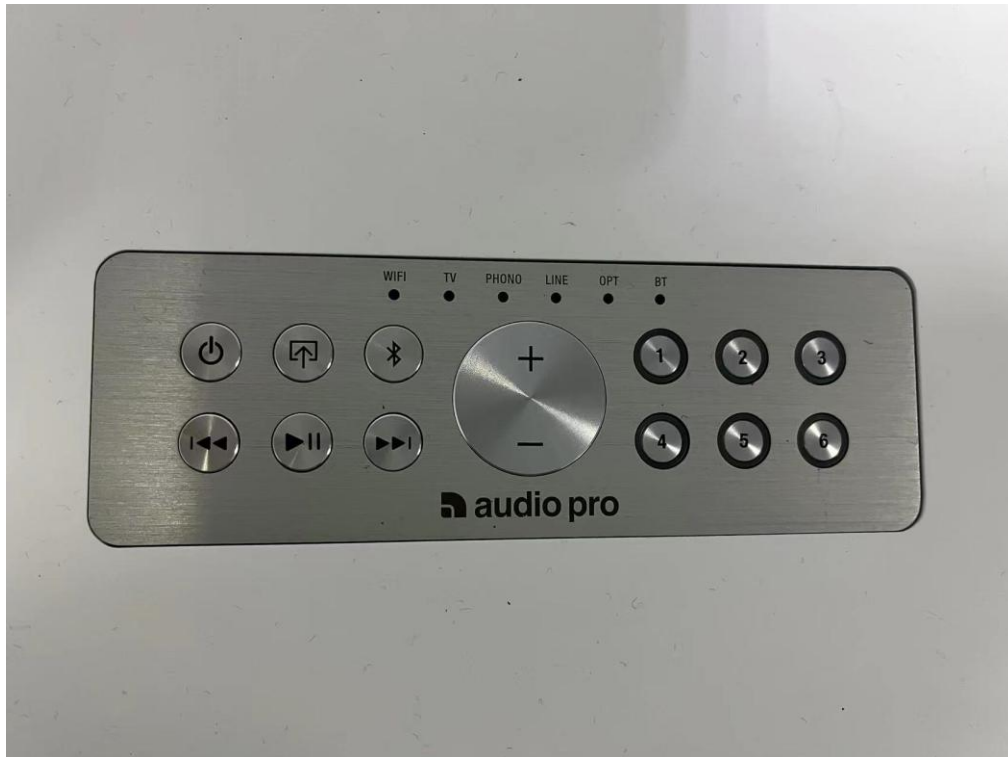
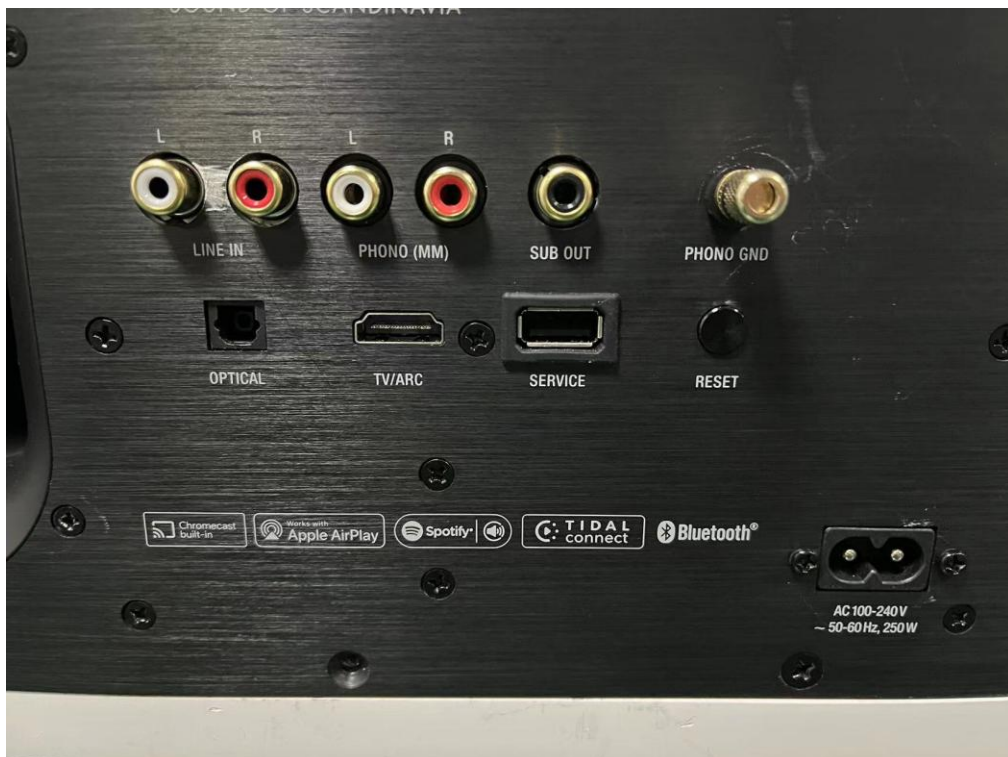
Internal Photos
M/N: C20

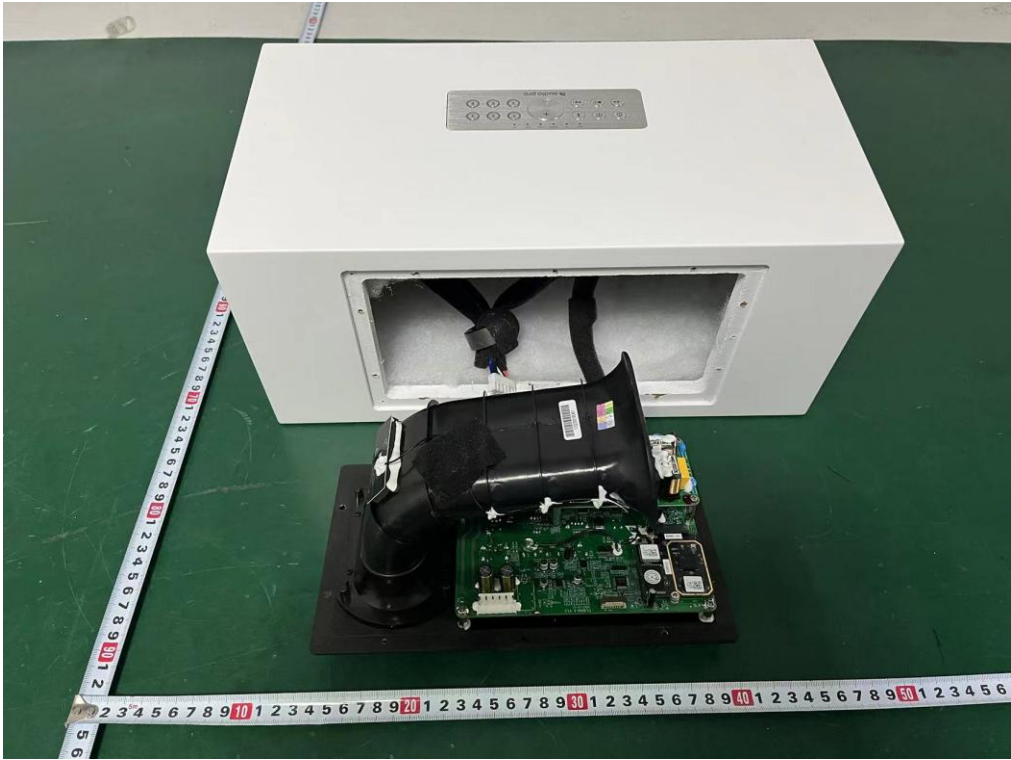
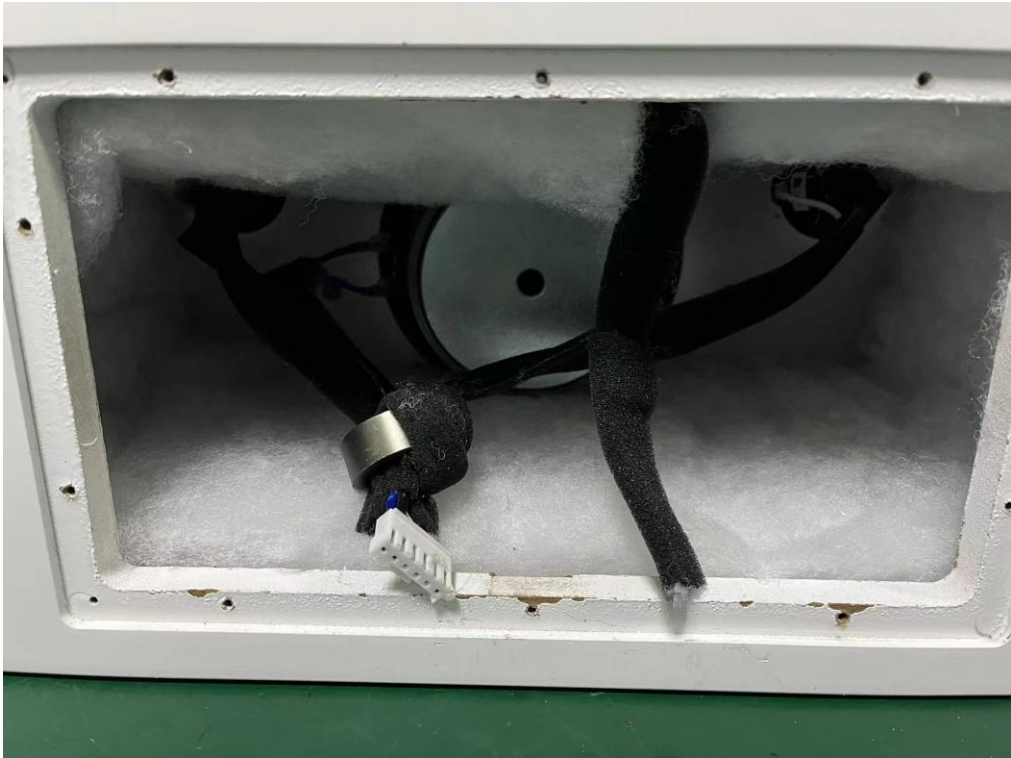
Internal Photos
M/N: C20
