## Appendix G: Conducted Spurious Emission Test Result

# 12. TEST SETUP PHOTO

### 13. EUT PHOTO

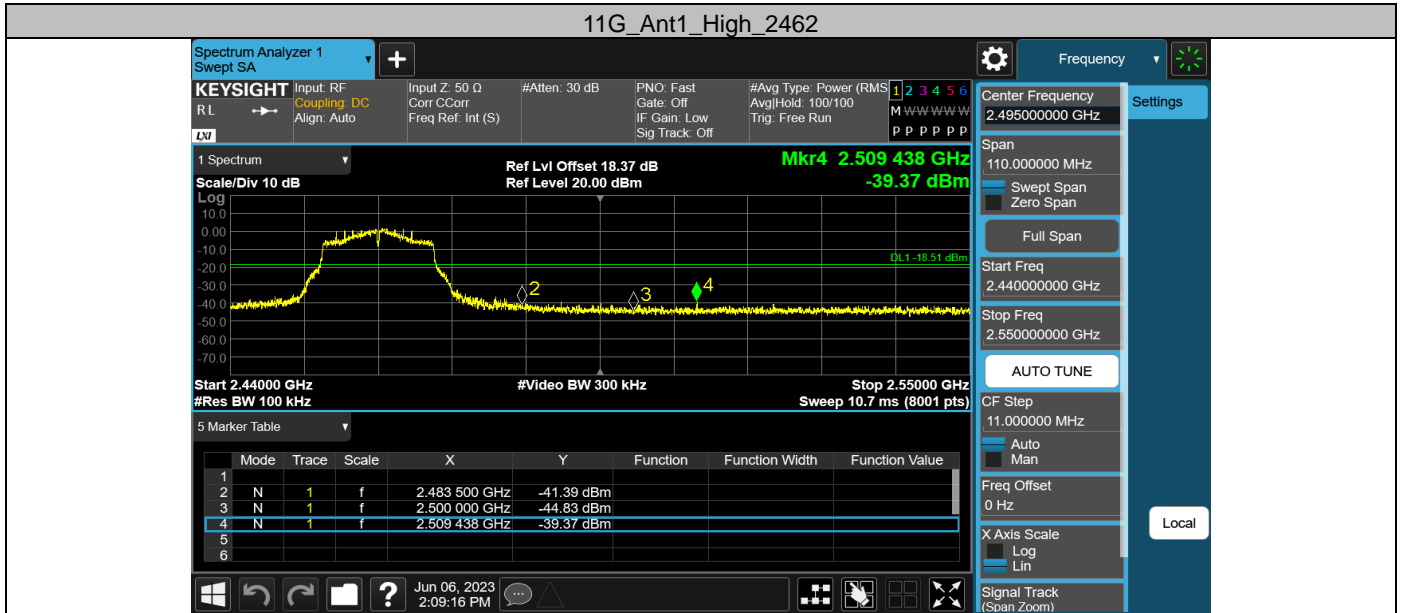
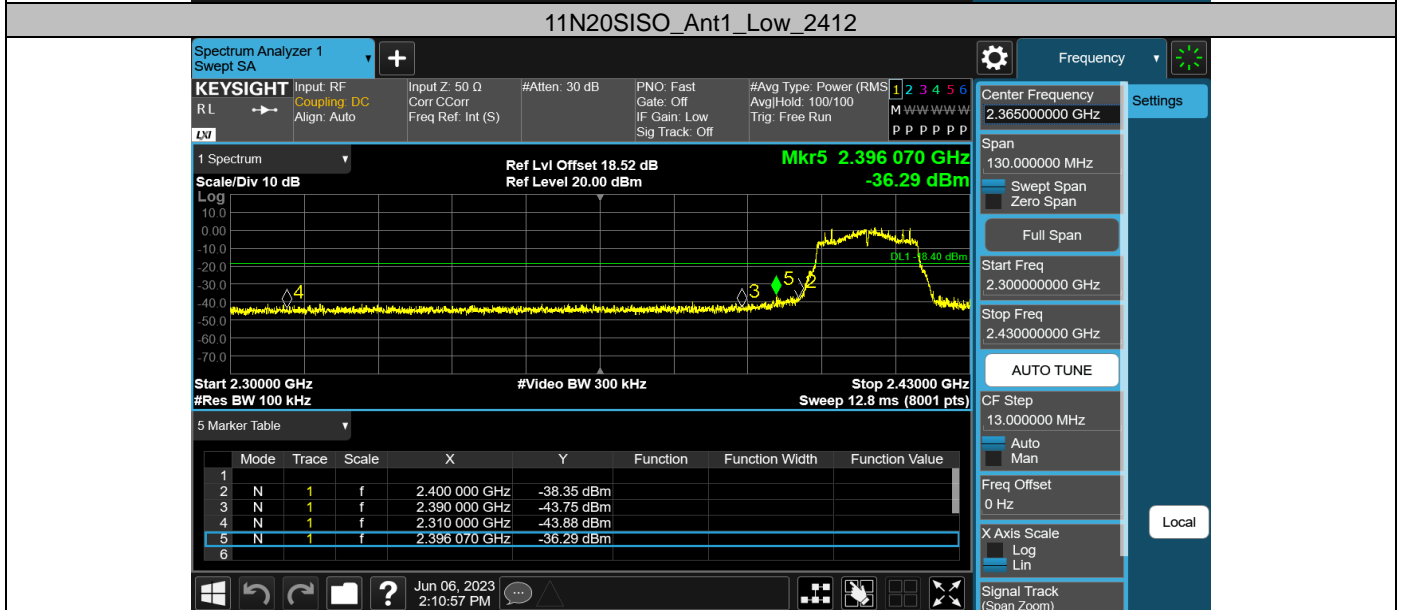
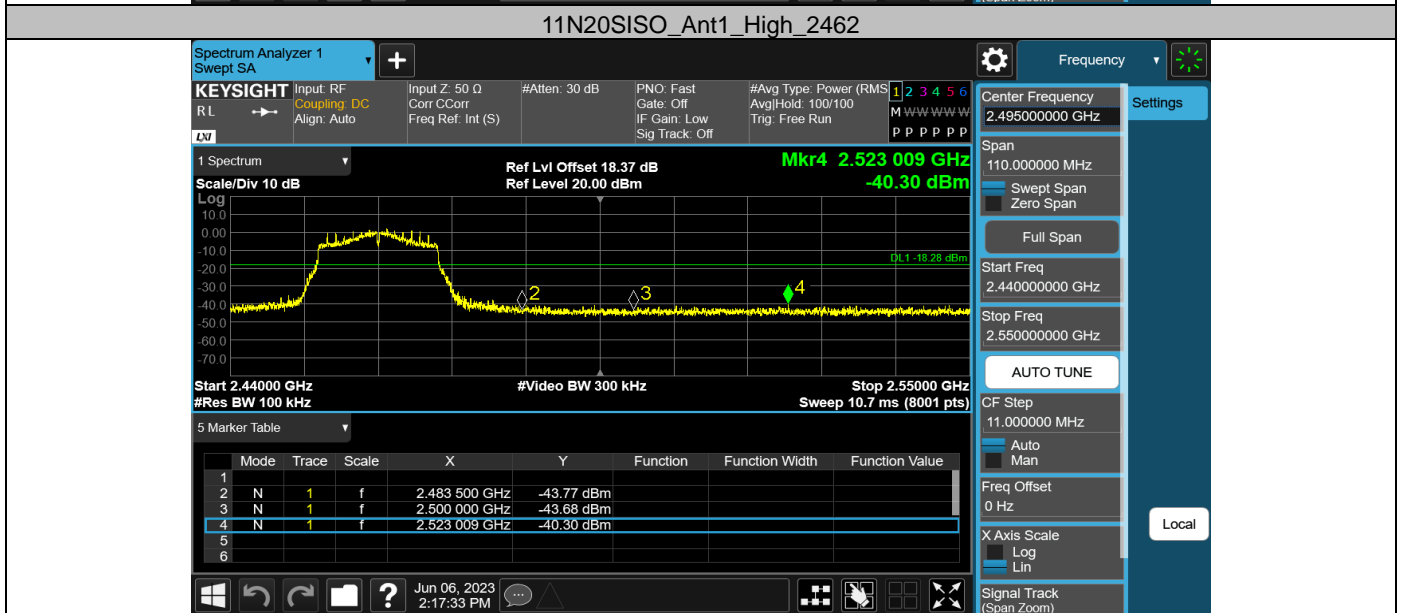
Test Graphs

Test Mode	Antenna	Frequency [MHz]	Freq Range [MHz]	Ref Level [dBm]	Result [dBm]	Limit [dBm]	Verdict
11B	Ant1	2412	30~26500	4.93	-42.2	≤-15.07	PASS
		2437	30~26500	5.26	-42.66	≤-14.74	PASS
		2462	30~26500	4.49	-42.78	≤-15.51	PASS
11G	Ant1	2412	30~26500	1.72	-42.14	≤-18.28	PASS
		2437	30~26500	1.70	-42.99	≤-18.3	PASS
		2462	30~26500	1.49	-42.38	≤-18.51	PASS
11N20SISO	Ant1	2412	30~26500	1.60	-41.94	≤-18.4	PASS
		2437	30~26500	1.37	-42.76	≤-18.63	PASS
		2462	30~26500	1.72	-42.39	≤-18.28	PASS
