Appendix H: Conducted Spurious Emission
Test Result

14. TEST SETUP PHOTO

15. EUT PHOTO

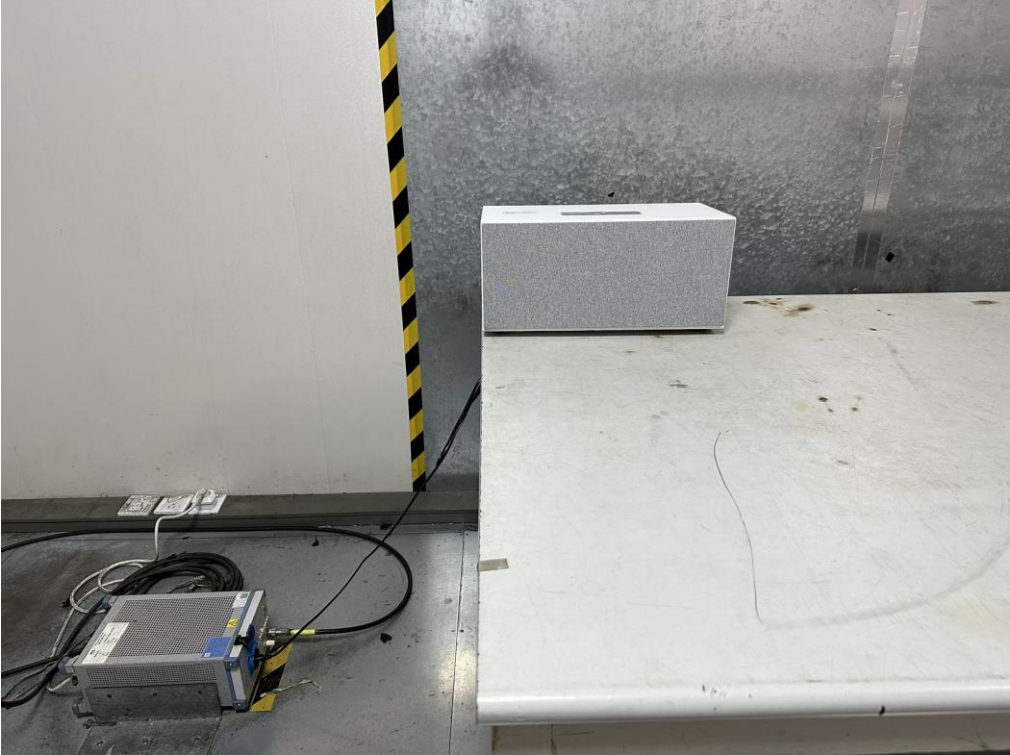
Conducted Test
