PHOTOGRAPHS OF TEST SETUP

Test model No.:CoreBook Pro

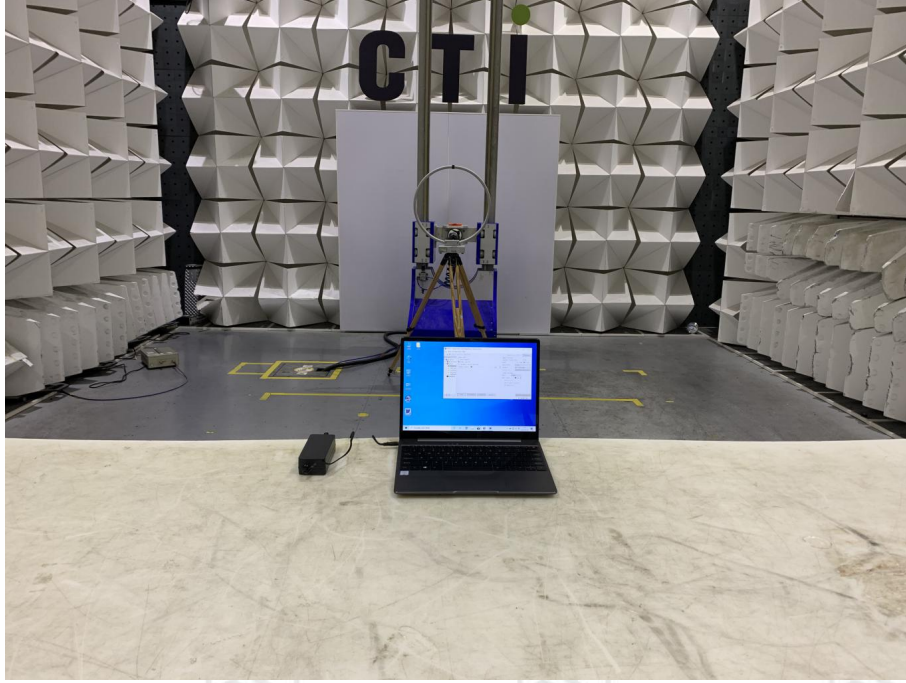
Radiated spurious emission Test Setup-1(Below 30MHz)

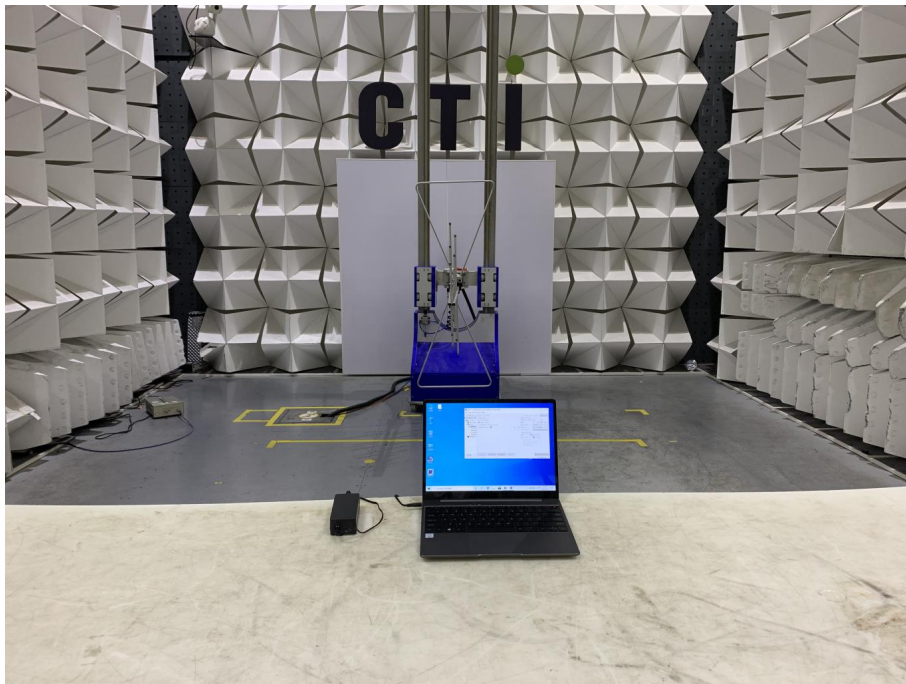
Radiated spurious emission Test Setup-2(Below 1GHz)

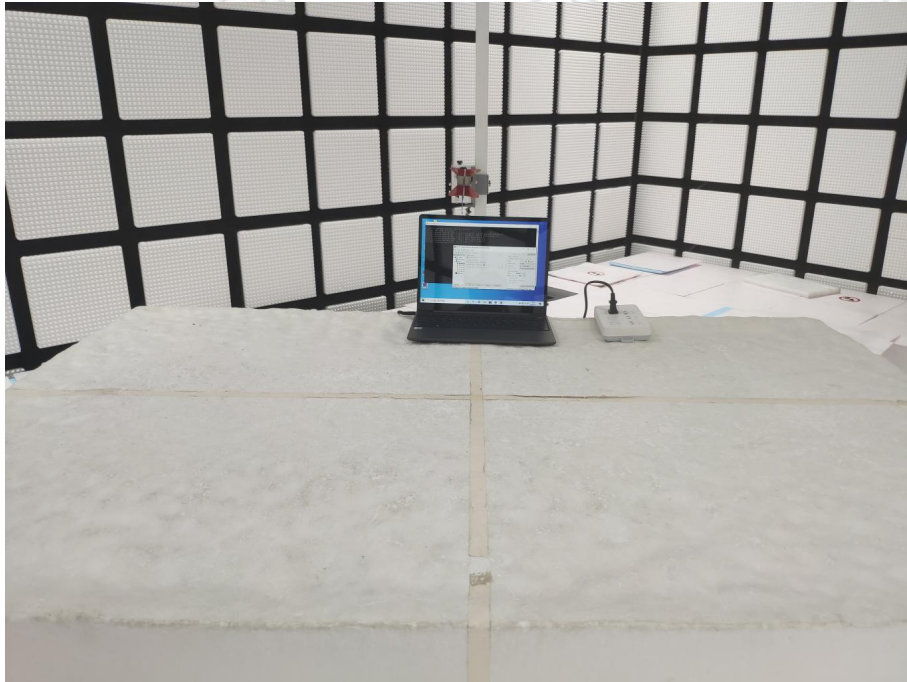
Radiated spurious emission Test Setup-3(Above 1GHz)

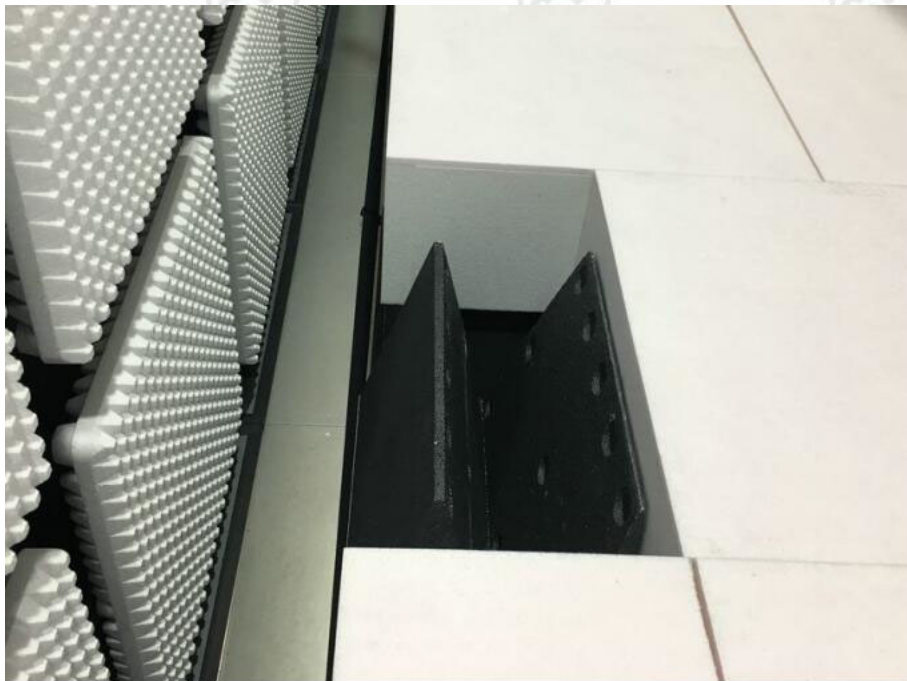
Radiated spurious emission Test Setup-4(Above 1GHz)
There are absorbing materials under the ground.

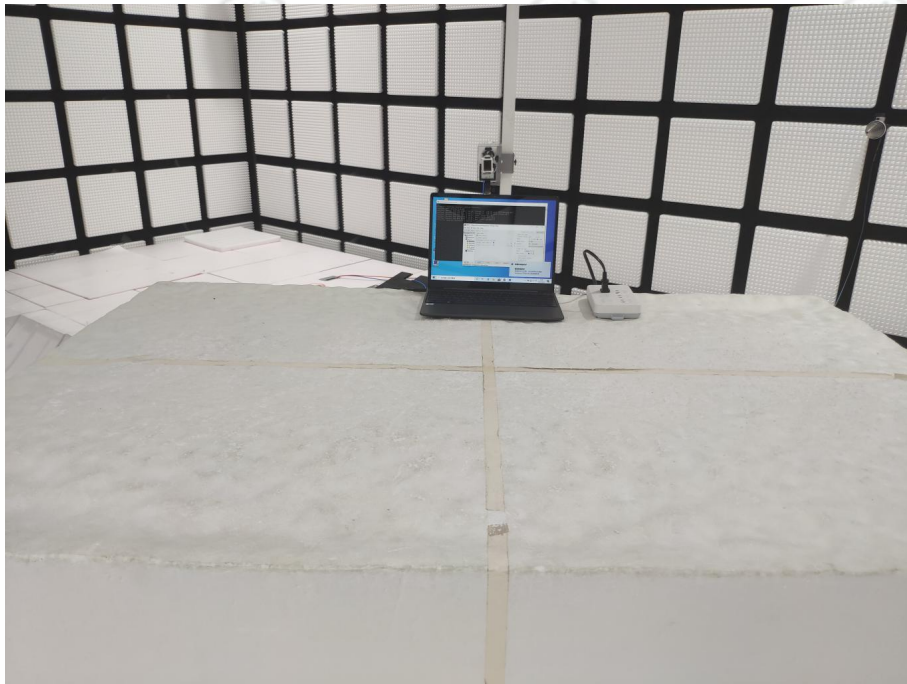
Radiated spurious emission Test Setup-5(Above 18GHz)

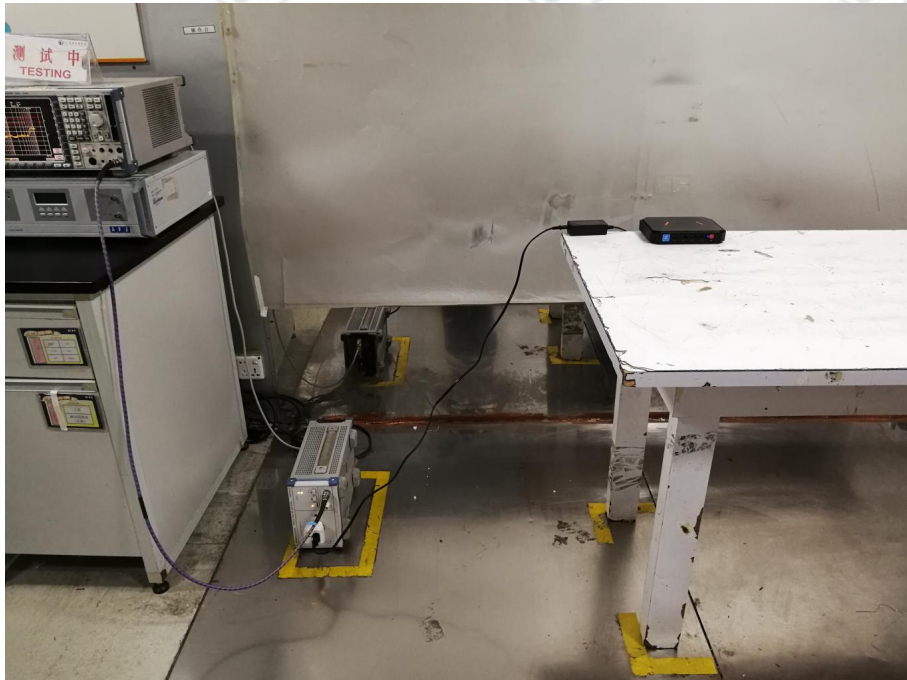
Conducted Emissions Test Setup
