APPENDIX A: PHOTOGRAPHS OF TEST SETUP

Reference to the test report No. BLA-EMC-202302-A4401

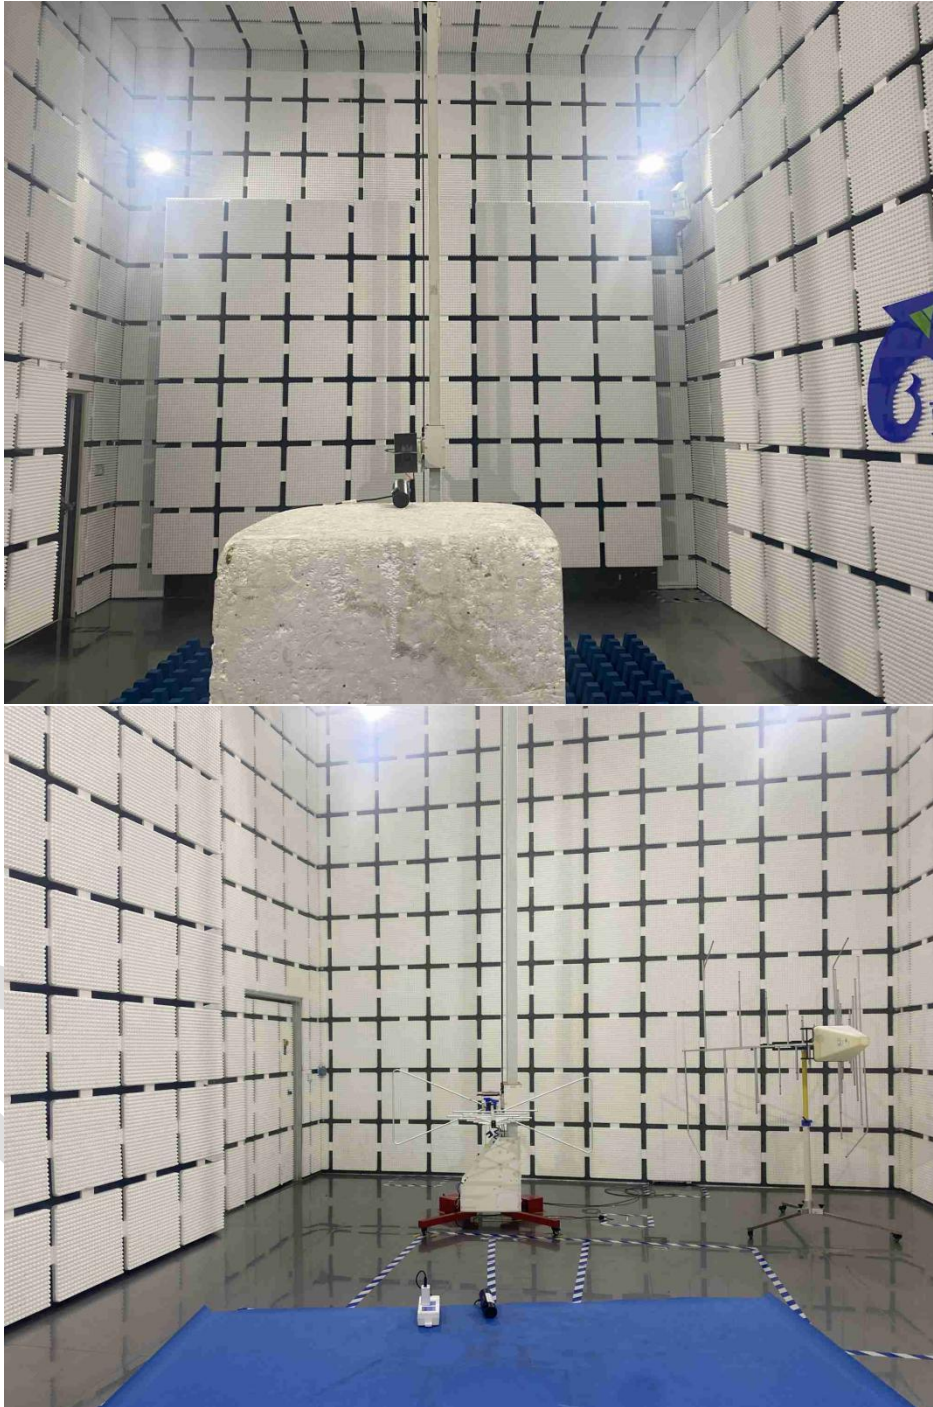
Radiated Spurious Emissions
