C SAR Test Report No. :FA241205

Appendix D. SAR Test Setup Photos Head Exposure Condition

FCC ID: 2AJOTTA-1496

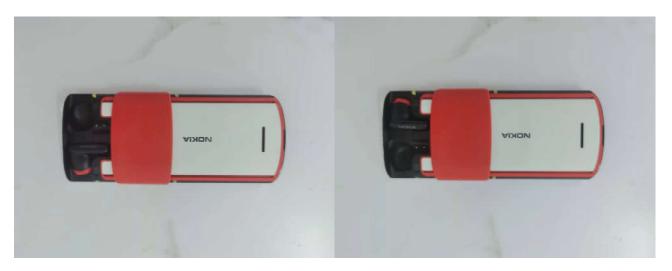
EUT Constructional Details with Back view

Left earphone

Note: The actual setups of left/right/couple of earphones during the testing were same as each position above three exposure conditions. Due to The phone has a back case with a box for putting in the earphones. When the back cover is sliding, during the test, it is slid on the back cover. The earphone is hidden inside and cannot be seen. Therefore, when shooting alone, the sliding cover is slid down and the actual internal earphone structure is seen. So we used plane presentation as instead.

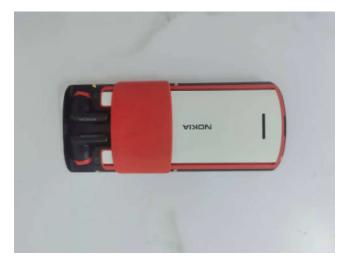
Right earphone

Couple of earphone

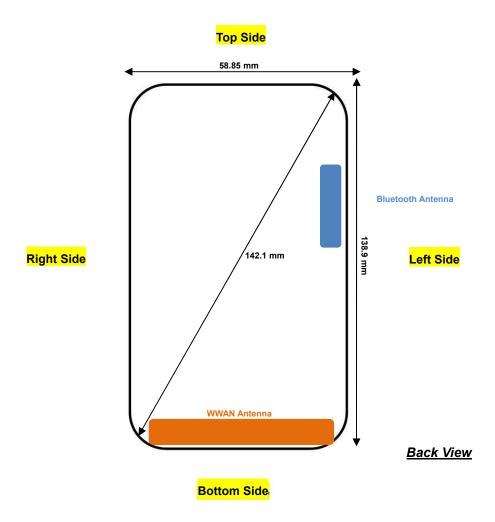
Antenna Location
