APPENDIX 3: Photographs of test setup

Radiated Emission

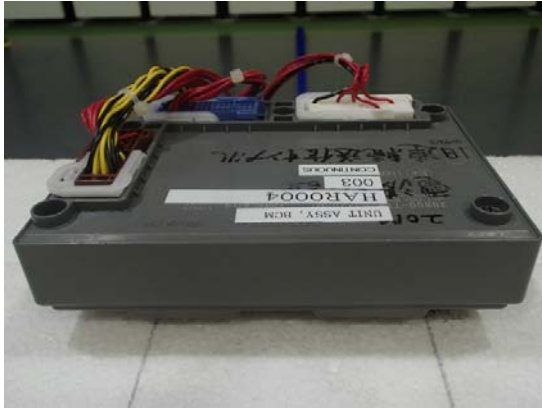
ECU
Below 30 MHz
X-axis
Above 30 MHz
Horizontal: X-axis / Vertical: X-axis
X-axis

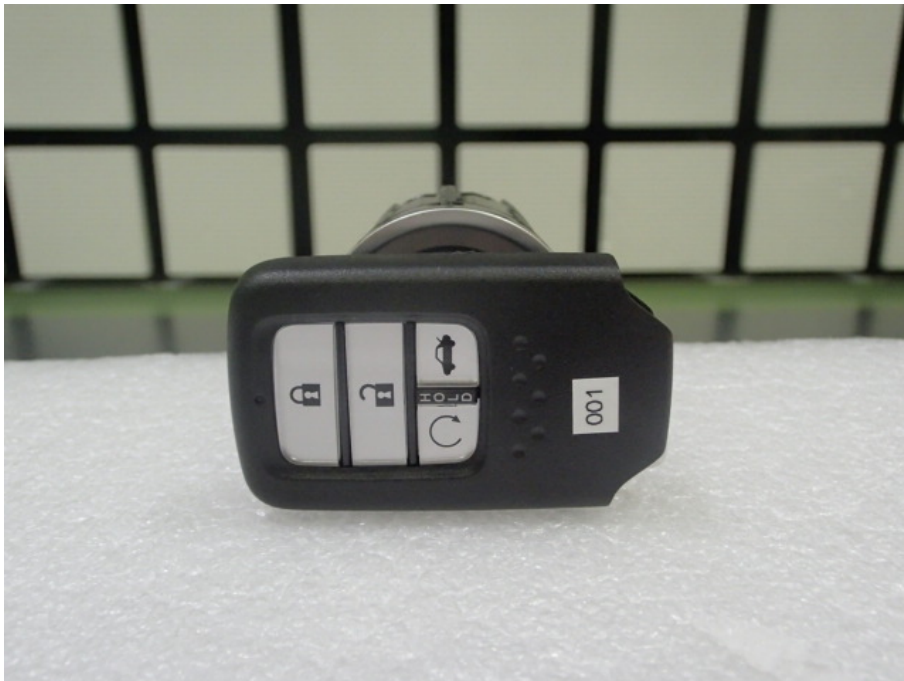
With Key
