Appendix B: photographs of test setup

Reference to the test report no. BLA-EMC-202404-A10901

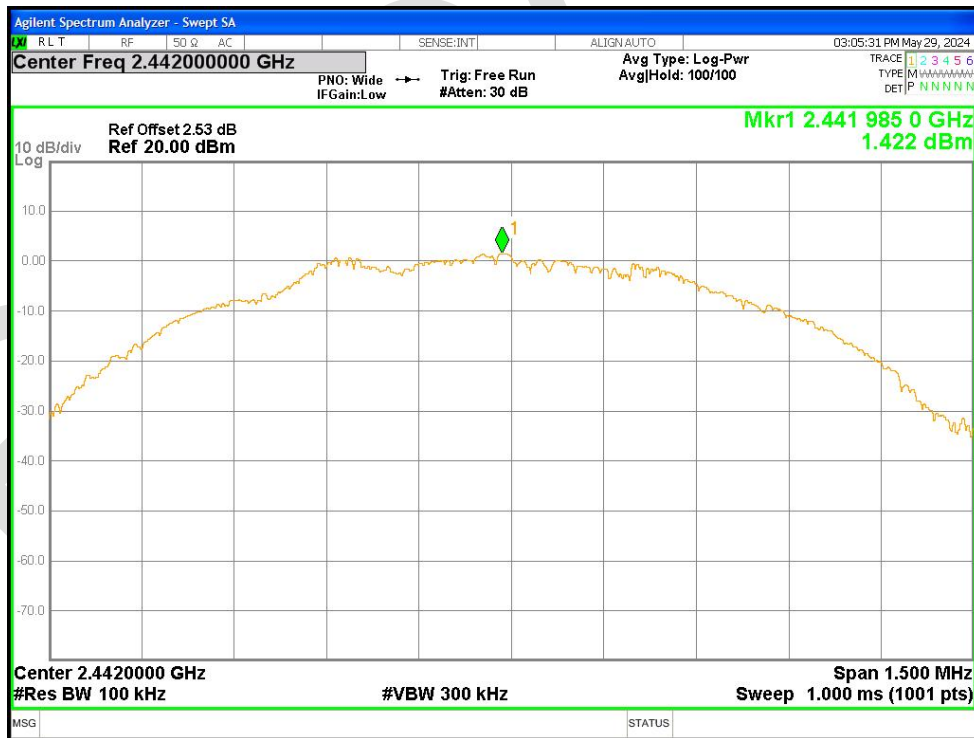
Tx. Spurious NVNT BLE 1M 2442MHz Ant1 Ref

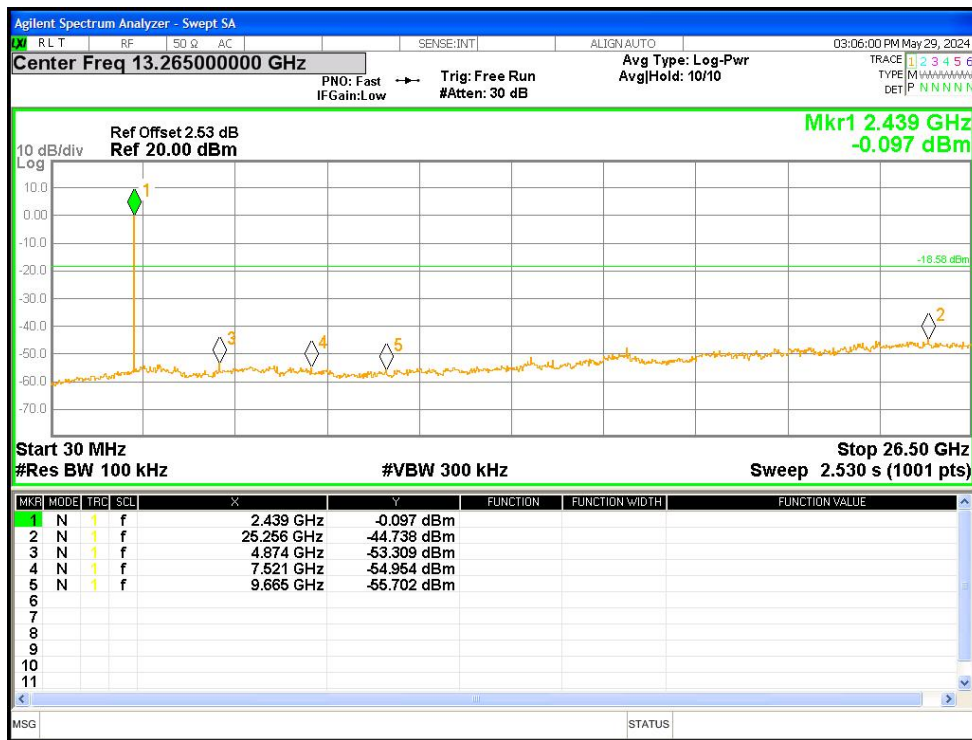
Tx. Spurious NVNT BLE 1M 2442MHz Ant1 Emission

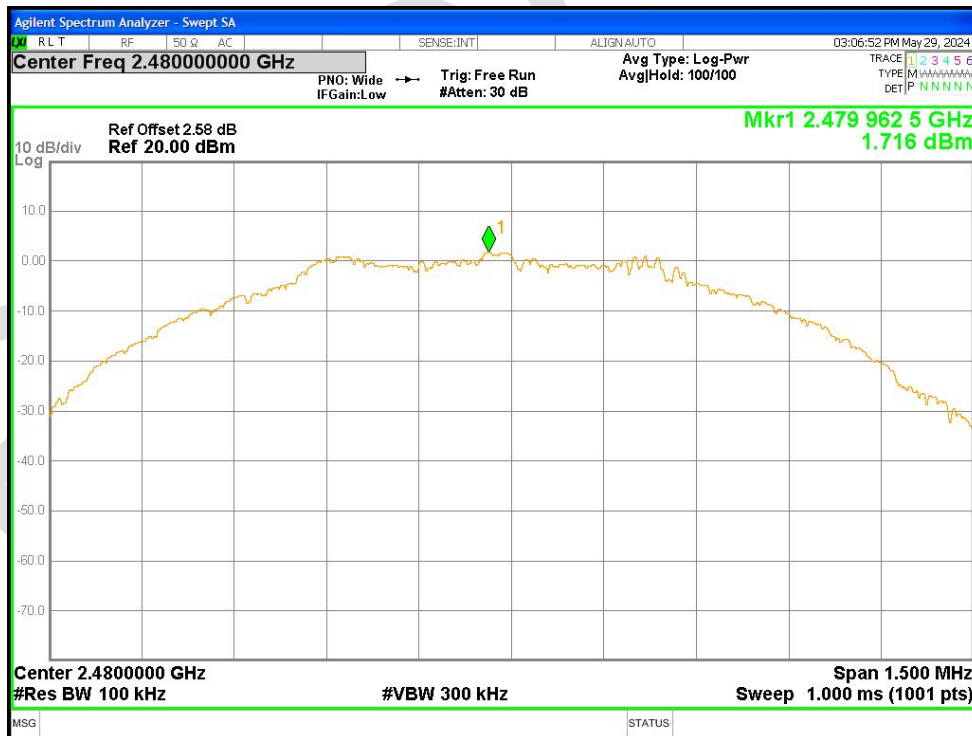
Tx. Spurious NVNT BLE 1M 2480MHz Ant1 Ref

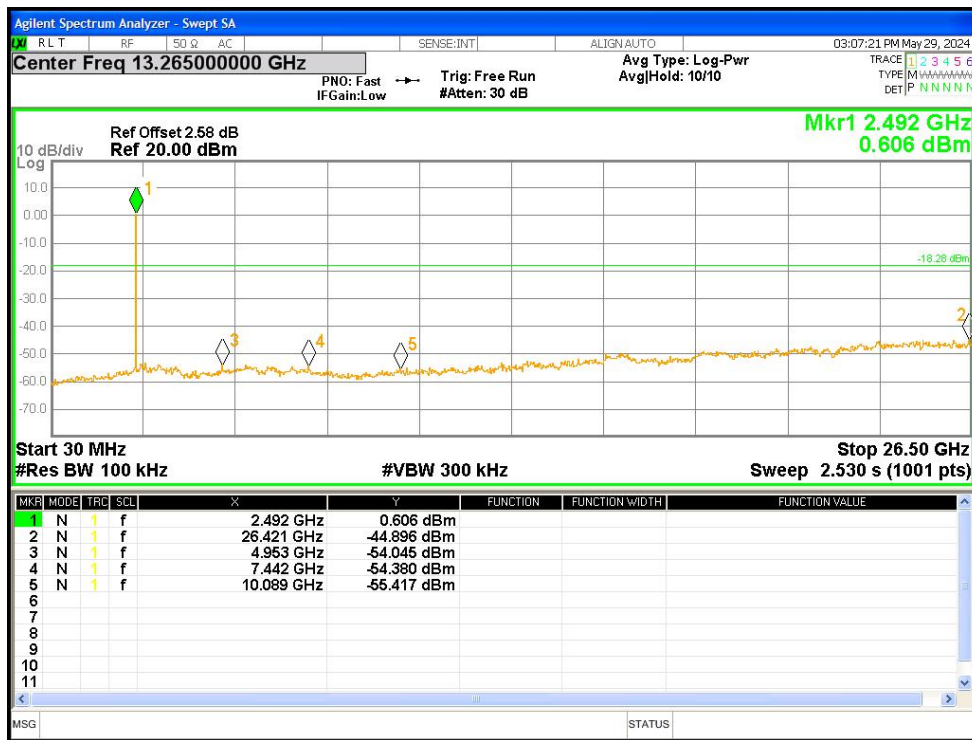
Tx. Spurious NVNT BLE 1M 2480MHz Ant1 Emission

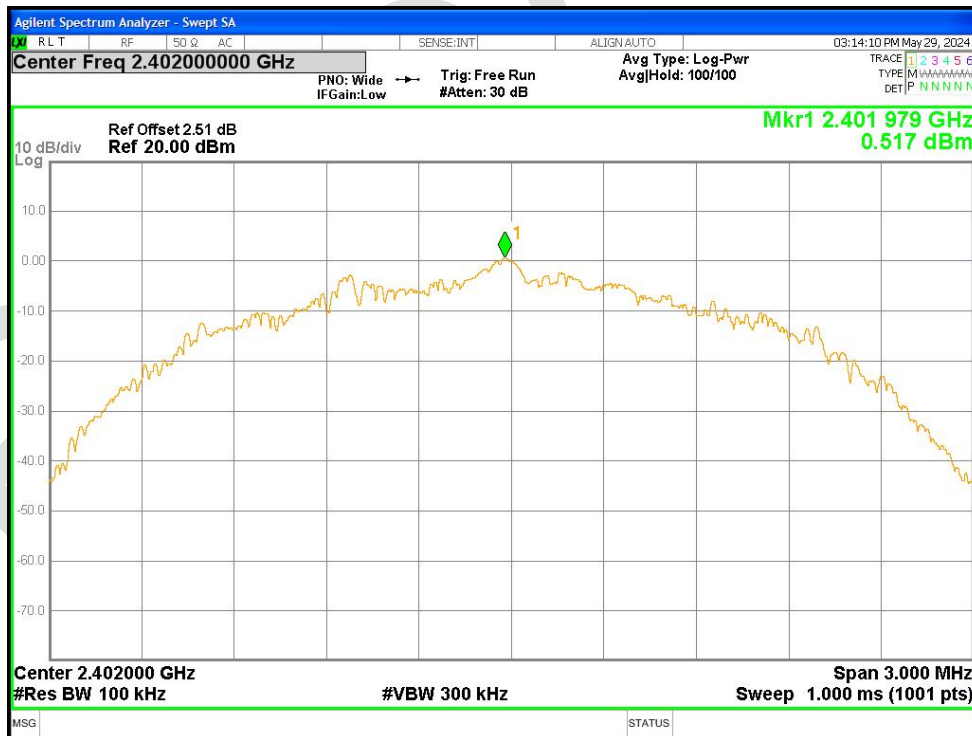
Tx. Spurious NVNT BLE 2M 2402MHz Ant1 Ref

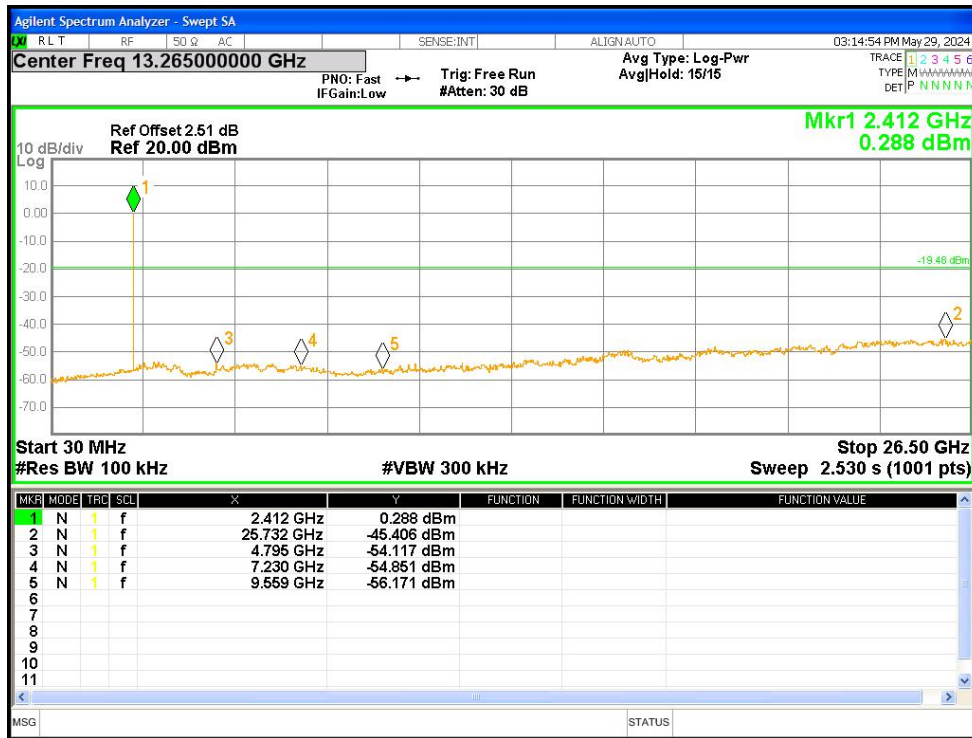
Tx. Spurious NVNT BLE 2M 2402MHz Ant1 Emission

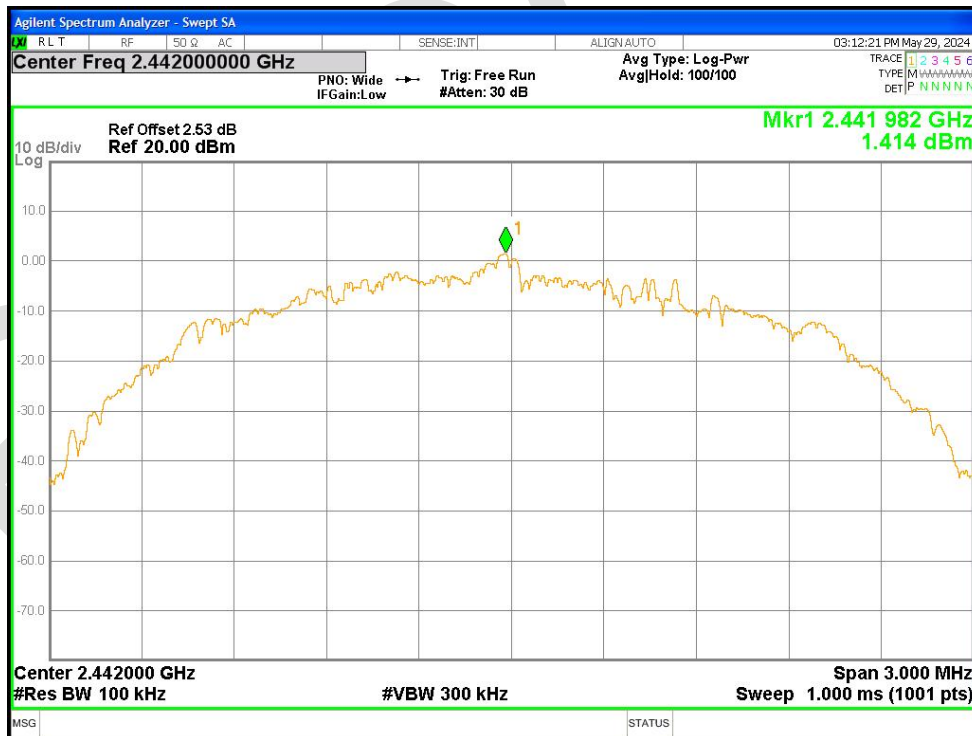
Tx. Spurious NVNT BLE 2M 2442MHz Ant1 Ref

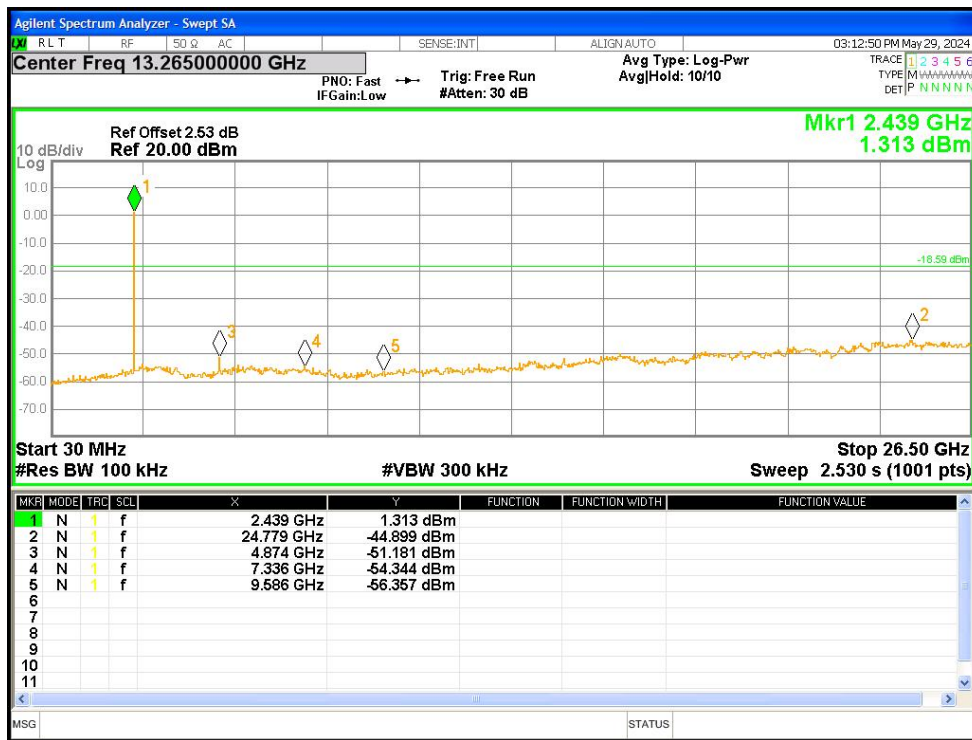
Tx. Spurious NVNT BLE 2M 2442MHz Ant1 Emission

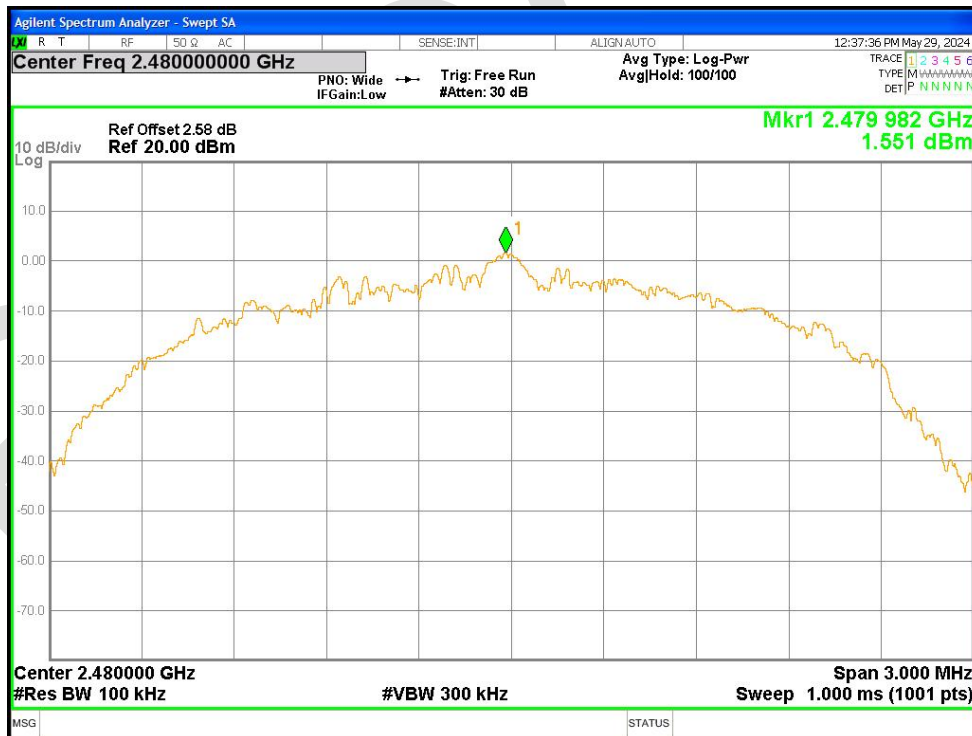
Tx. Spurious NVNT BLE 2M 2480MHz Ant1 Ref

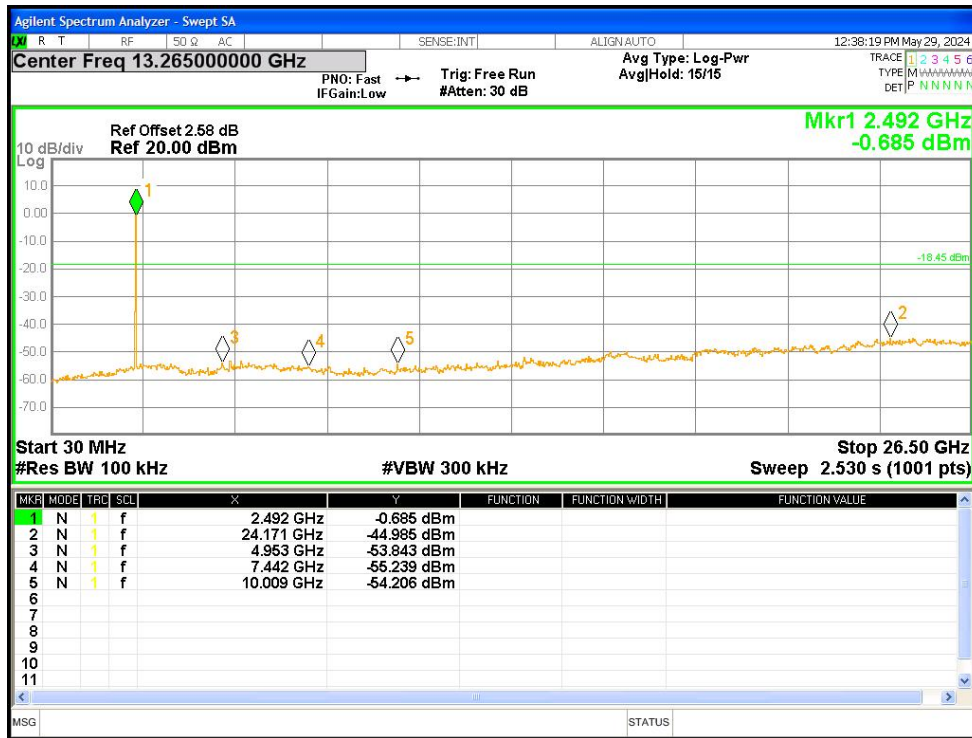
Tx. Spurious NVNT BLE 2M 2480MHz Ant1 Emission

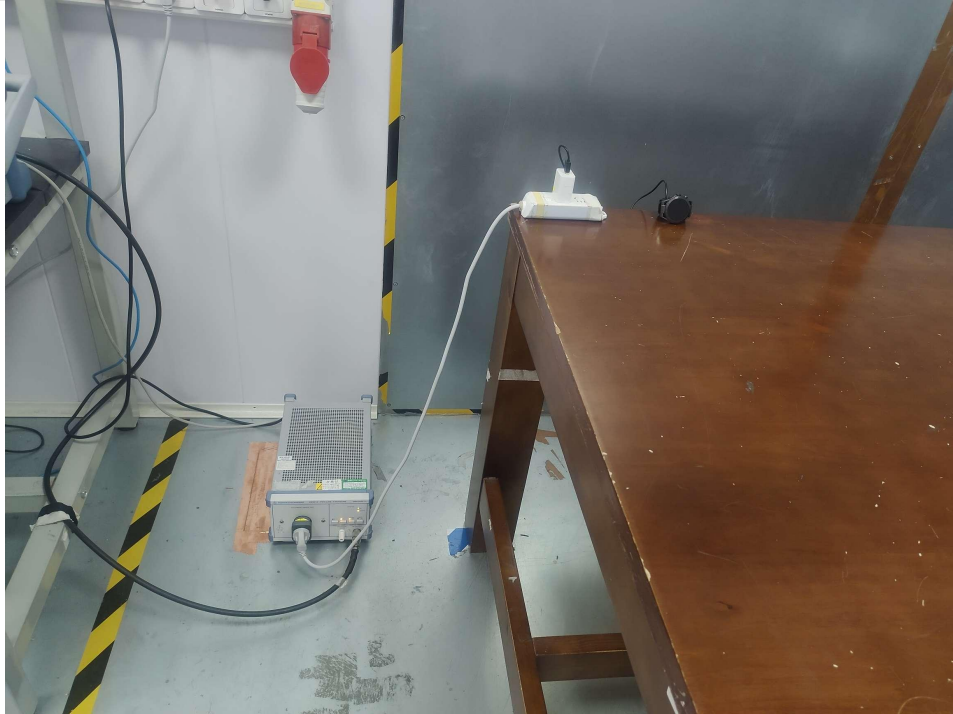
Conducted emissions at AC power line (150kHz-30MHz)

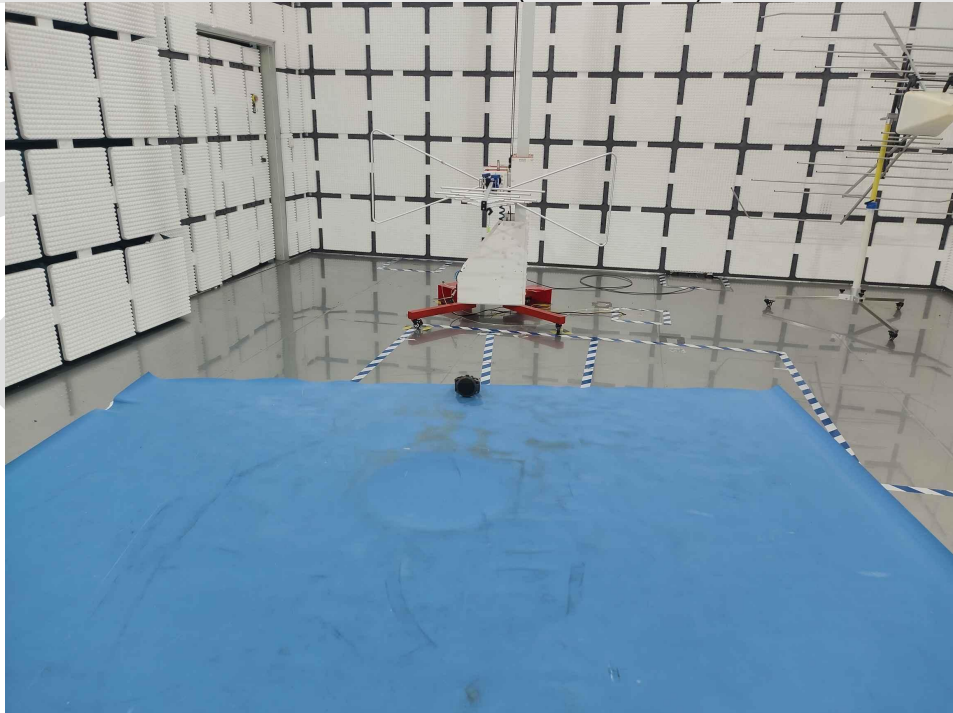
Radiated Emissions (30MHz-1GHz)

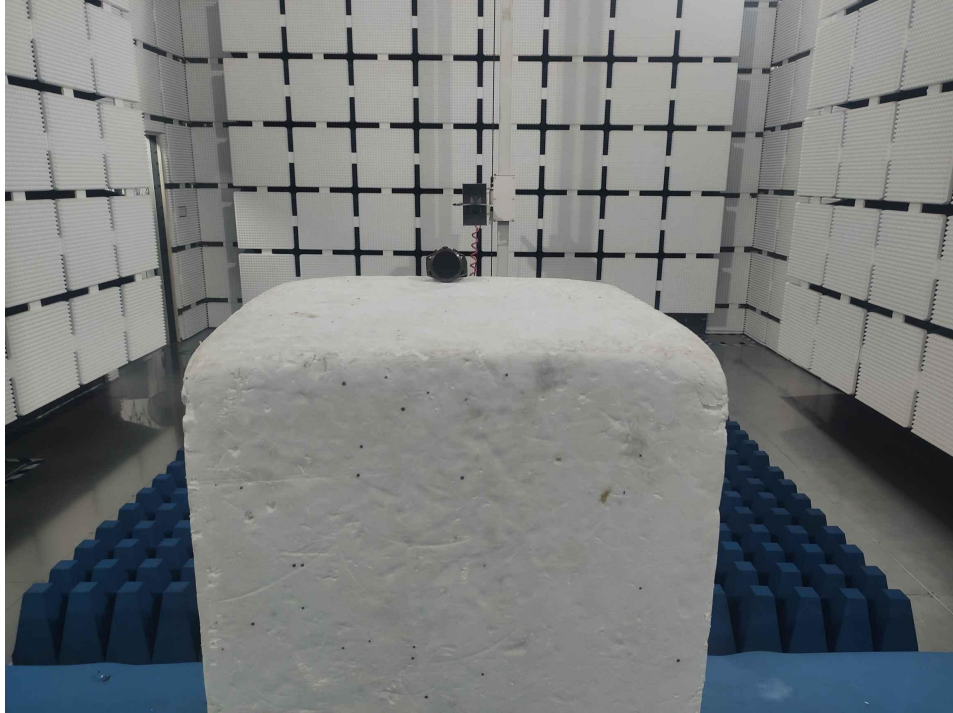
Radiated Emissions (above 1GHz)
