Radiated Emission Measurement

Condition : FCC\_part 15E RE\_Above 1GHz\_PK

EUT : W6M22311-23090

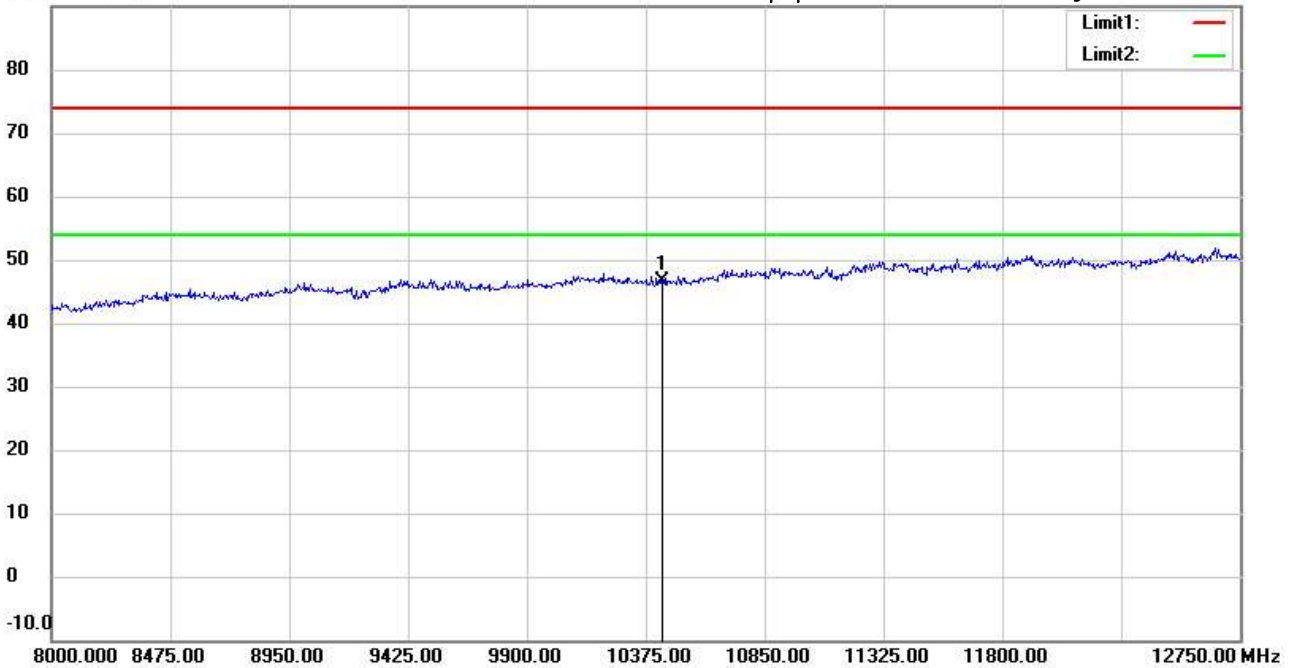
Data :#3

Polarization: *Horizontal*

Test Mode : TX 802.11a CH44

| Mk. | Frequency (MHz) | Reading (dBuV) | Detector | Corr. factor (dB/m) | Result (dBuV/m) | Limit (dBuV/m) | Ant.Pos (cm) | Tab.Pos (deg.) | Margin (dB) | Comment |
|---|---|---|---|---|---|---|---|---|---|---|
| * | 10440.000 | 32.54 | peak | 14.11 | 46.65 | 74.00 | 150 | 30 | -27.35 | |

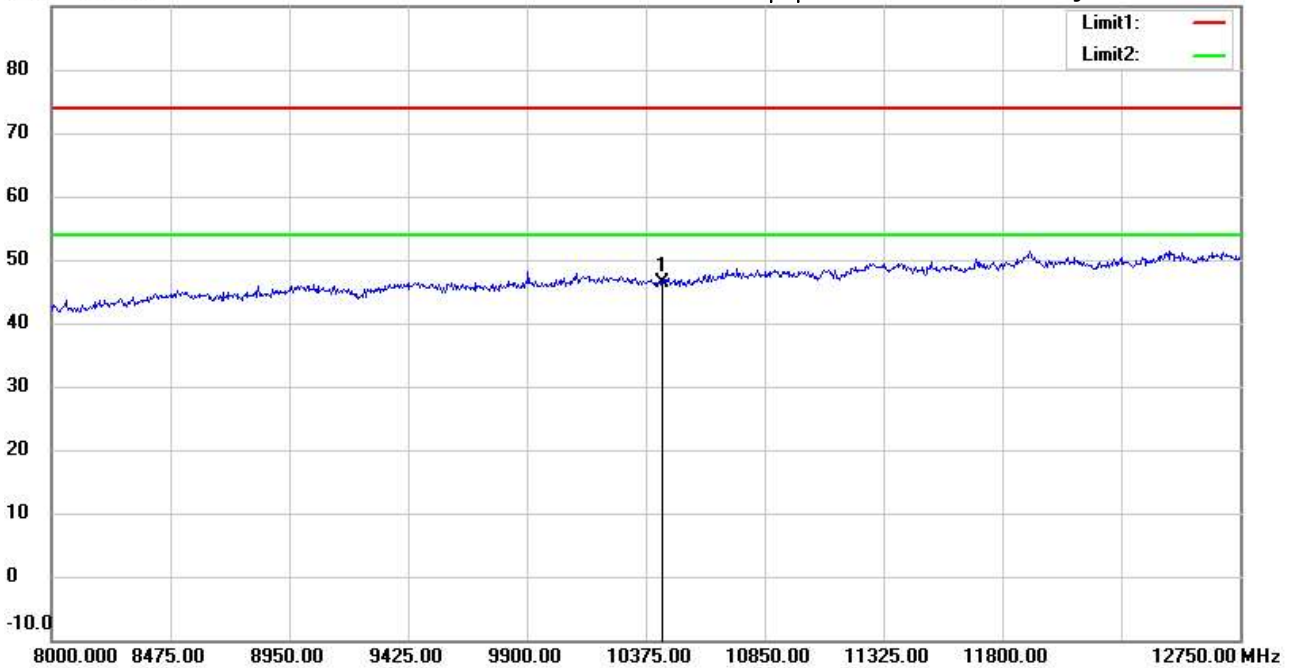
Data :#9

Polarization: *Vertical*

Test Mode : TX 802.11a CH44

| Mk. | Frequency (MHz) | Reading (dBuV) | Detector | Corr. factor (dB/m) | Result (dBuV/m) | Limit (dBuV/m) | Ant.Pos (cm) | Tab.Pos (deg.) | Margin (dB) | Comment |
|---|---|---|---|---|---|---|---|---|---|---|
| * | 10440.000 | 32.20 | peak | 14.11 | 46.31 | 74.00 | 150 | 132 | -27.69 | |

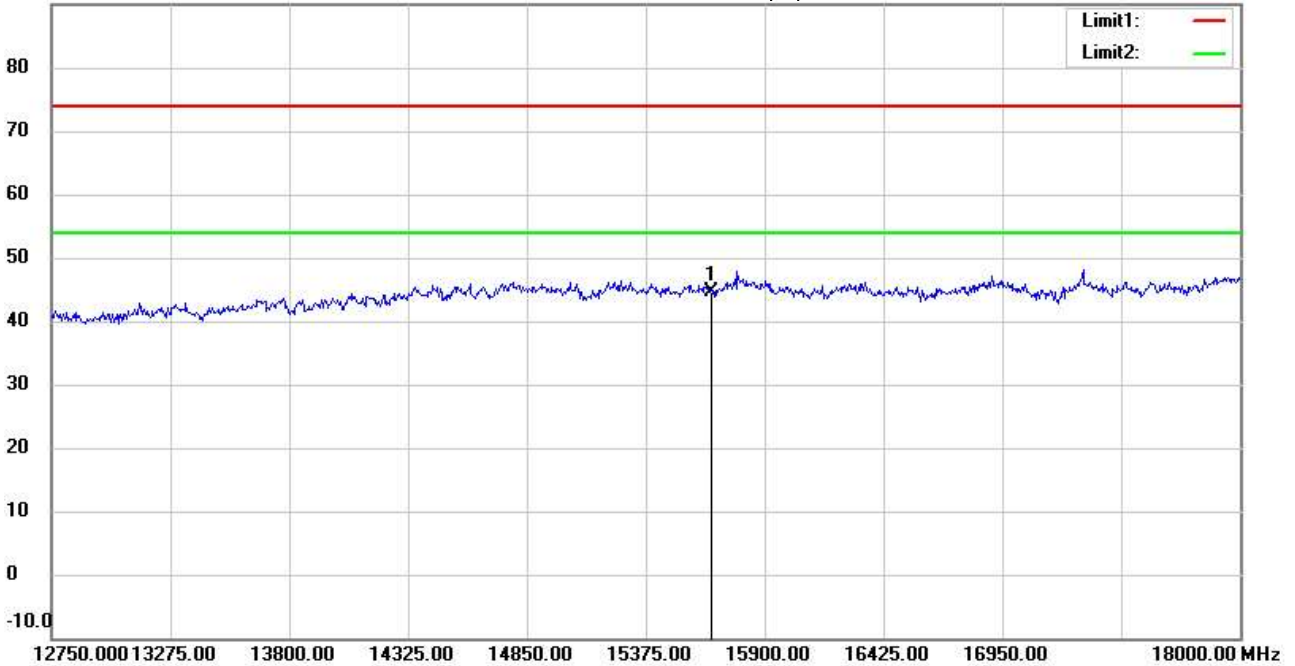
Data :#4

Polarization: *Horizontal*

Test Mode : TX 802.11a CH44

| Mk. | Frequency (MHz) | Reading (dBuV) | Detector | Corr. factor (dB/m) | Result (dBuV/m) | Limit (dBuV/m) | Ant.Pos (cm) | Tab.Pos (deg.) | Margin (dB) | Comment |
|---|---|---|---|---|---|---|---|---|---|---|
| * | 15660.000 | 21.53 | peak | 23.15 | 44.68 | 74.00 | 150 | 36 | -29.32 | |

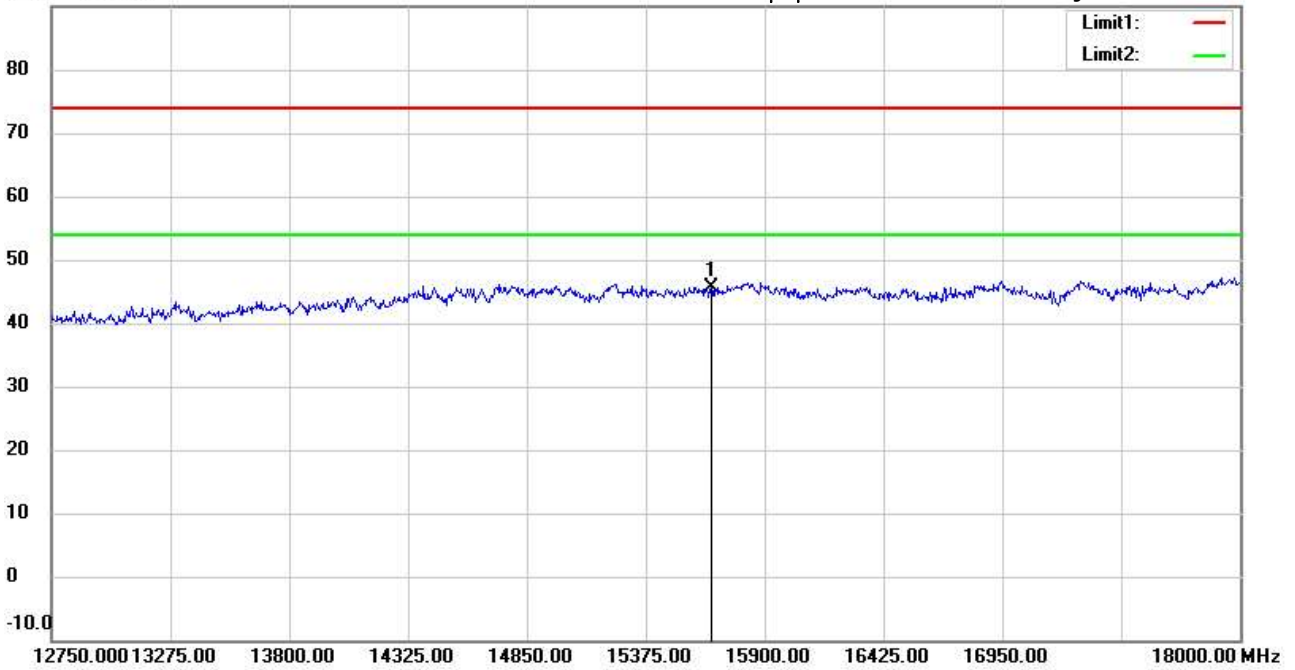
Data :#10

Polarization: **Vertical**

Test Mode : TX 802.11a CH44

| Mk. | Frequency (MHz) | Reading (dBuV) | Detector | Corr. factor (dB/m) | Result (dBuV/m) | Limit (dBuV/m) | Ant.Pos (cm) | Tab.Pos (deg.) | Margin (dB) | Comment |
|---|---|---|---|---|---|---|---|---|---|---|
| * | 15660.000 | 22.52 | peak | 23.15 | 45.67 | 74.00 | 150 | 288 | -28.33 | |

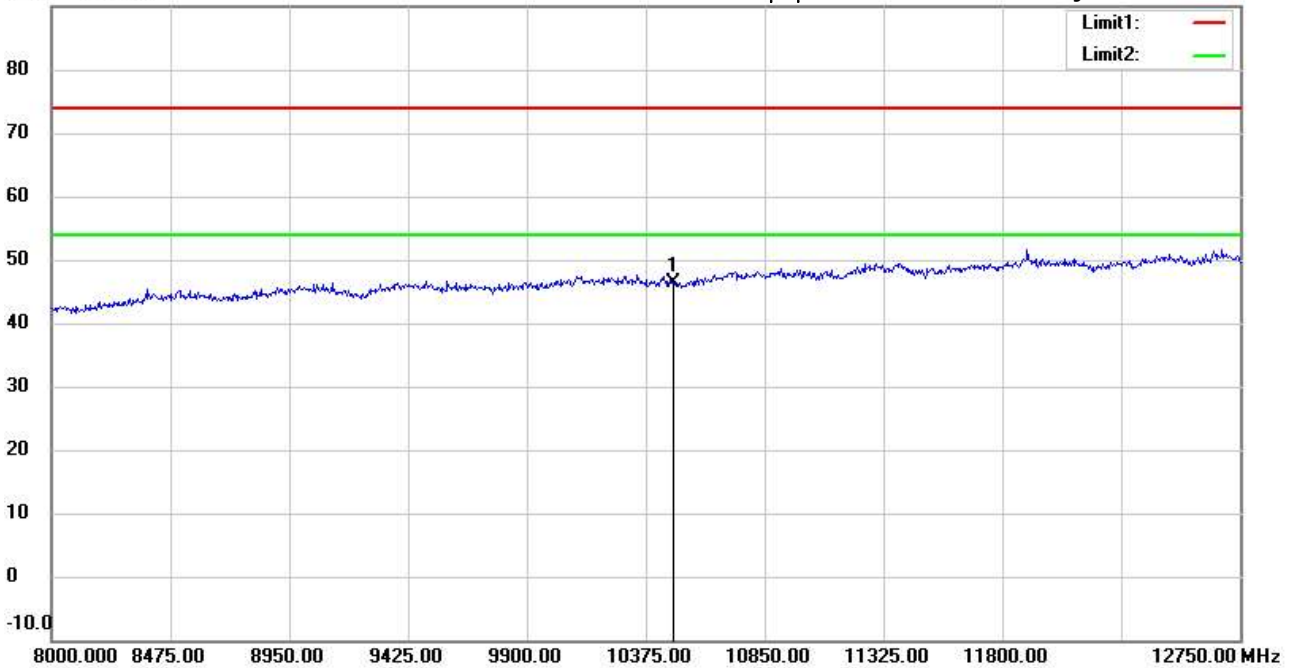
Data :#3

Polarization: *Horizontal*

Test Mode : TX 802.11a CH48

| Mk. | Frequency (MHz) | Reading (dBuV) | Detector | Corr. factor (dB/m) | Result (dBuV/m) | Limit (dBuV/m) | Ant.Pos (cm) | Tab.Pos (deg.) | Margin (dB) | Comment |
|---|---|---|---|---|---|---|---|---|---|---|
| * | 10480.000 | 32.23 | peak | 14.08 | 46.31 | 74.00 | 150 | 107 | -27.69 | |

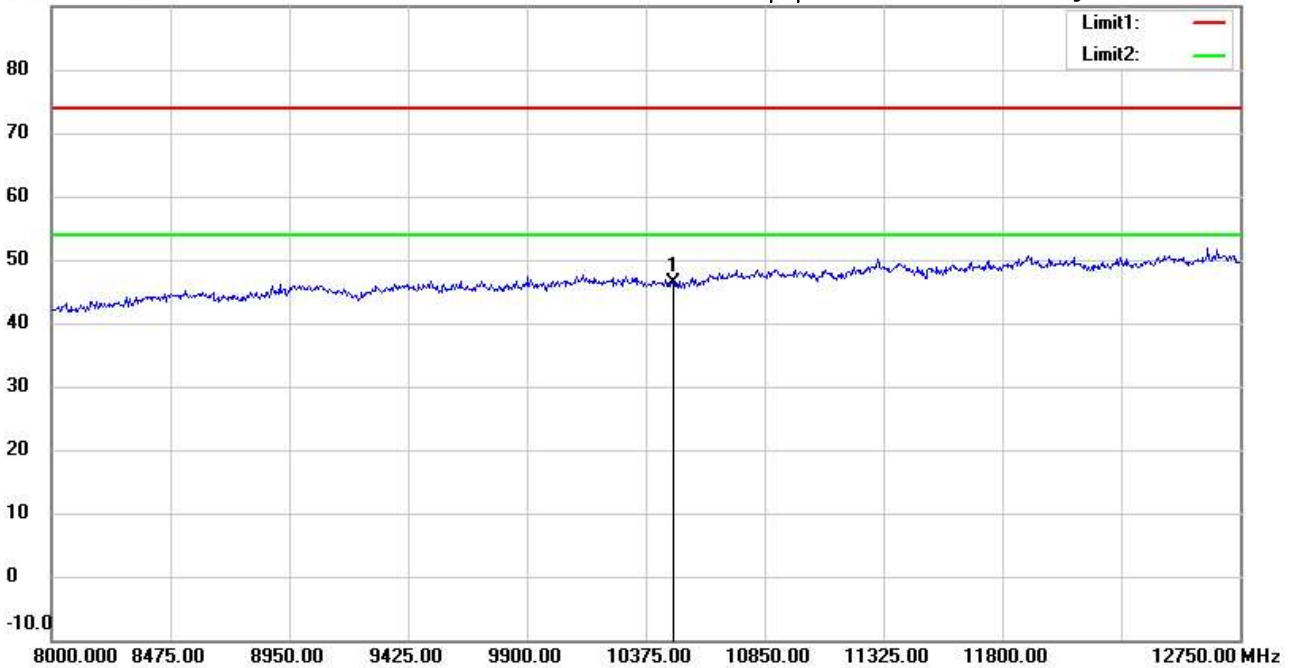
Data :#9

Polarization: *Vertical*

Test Mode : TX 802.11a CH48

| Mk. | Frequency (MHz) | Reading (dBuV) | Detector | Corr. factor (dB/m) | Result (dBuV/m) | Limit (dBuV/m) | Ant.Pos (cm) | Tab.Pos (deg.) | Margin (dB) | Comment |
|---|---|---|---|---|---|---|---|---|---|---|
| * | 10480.000 | 32.30 | peak | 14.08 | 46.38 | 74.00 | 150 | 306 | -27.62 | |

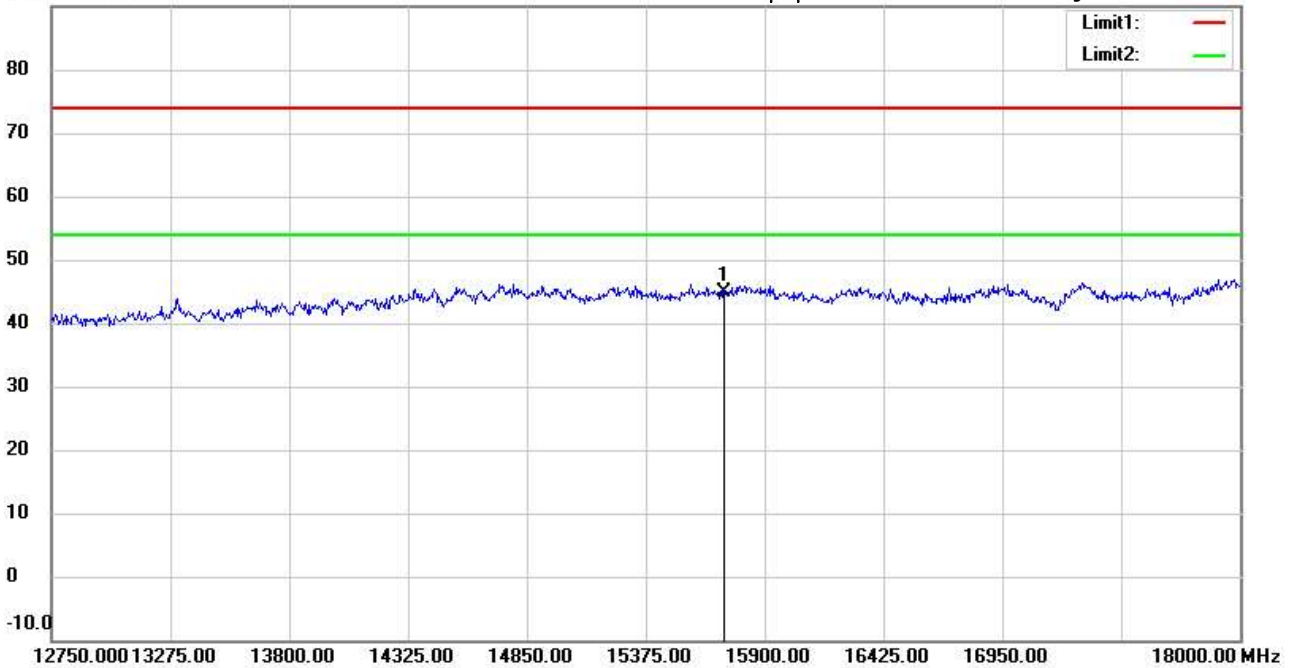
Data :#4

Polarization: **Horizontal**

Test Mode : TX 802.11a CH48

| Mk. | Frequency (MHz) | Reading (dBuV) | Detector | Corr. factor (dB/m) | Result (dBuV/m) | Limit (dBuV/m) | Ant.Pos (cm) | Tab.Pos (deg.) | Margin (dB) | Comment |
|---|---|---|---|---|---|---|---|---|---|---|
| * | 15720.000 | 21.72 | peak | 23.09 | 44.81 | 74.00 | 150 | 148 | -29.19 | |

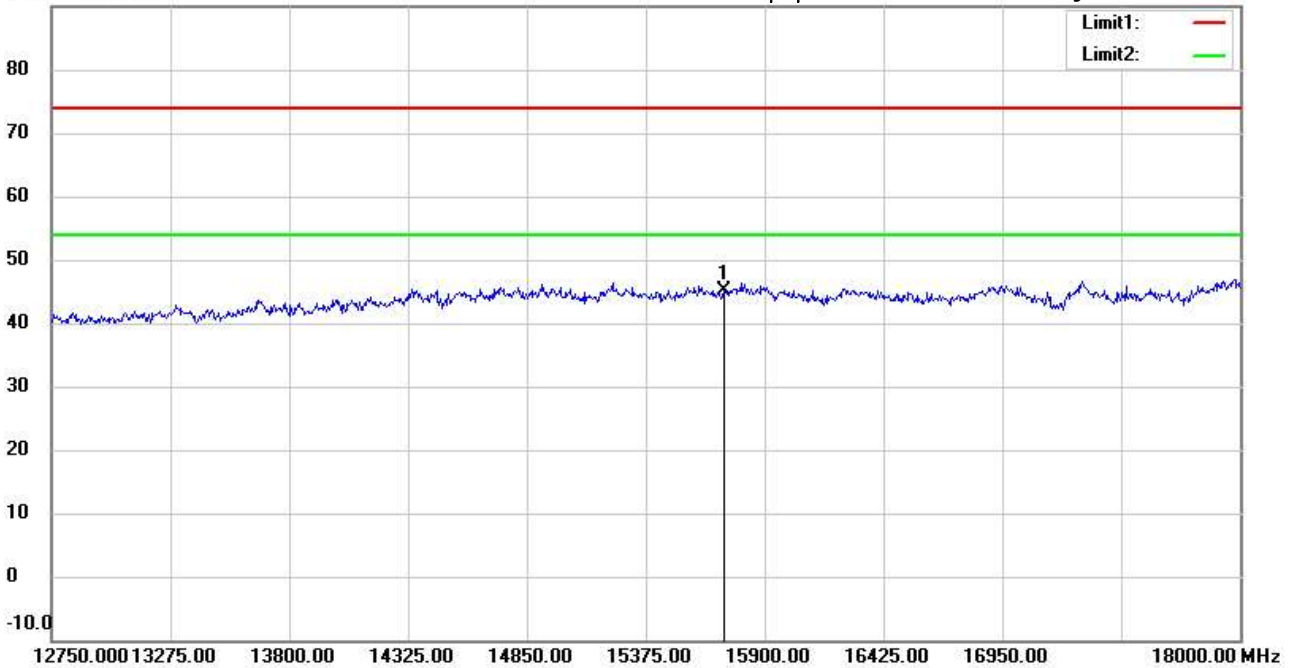
Data :#10

Polarization: *Vertical*

Test Mode : TX 802.11a CH48

| Mk. | Frequency (MHz) | Reading (dBuV) | Detector | Corr. factor (dB/m) | Result (dBuV/m) | Limit (dBuV/m) | Ant.Pos (cm) | Tab.Pos (deg.) | Margin (dB) | Comment |
|---|---|---|---|---|---|---|---|---|---|---|
| * | 15720.000 | 21.97 | peak | 23.09 | 45.06 | 74.00 | 150 | 285 | -28.94 | |
