Radiated Emission Measurement

Condition : FCC\_part 15E RE\_Above 1GHz\_PK

EUT : W6M22311-23090

Test Mode : TX 802.11a CH149

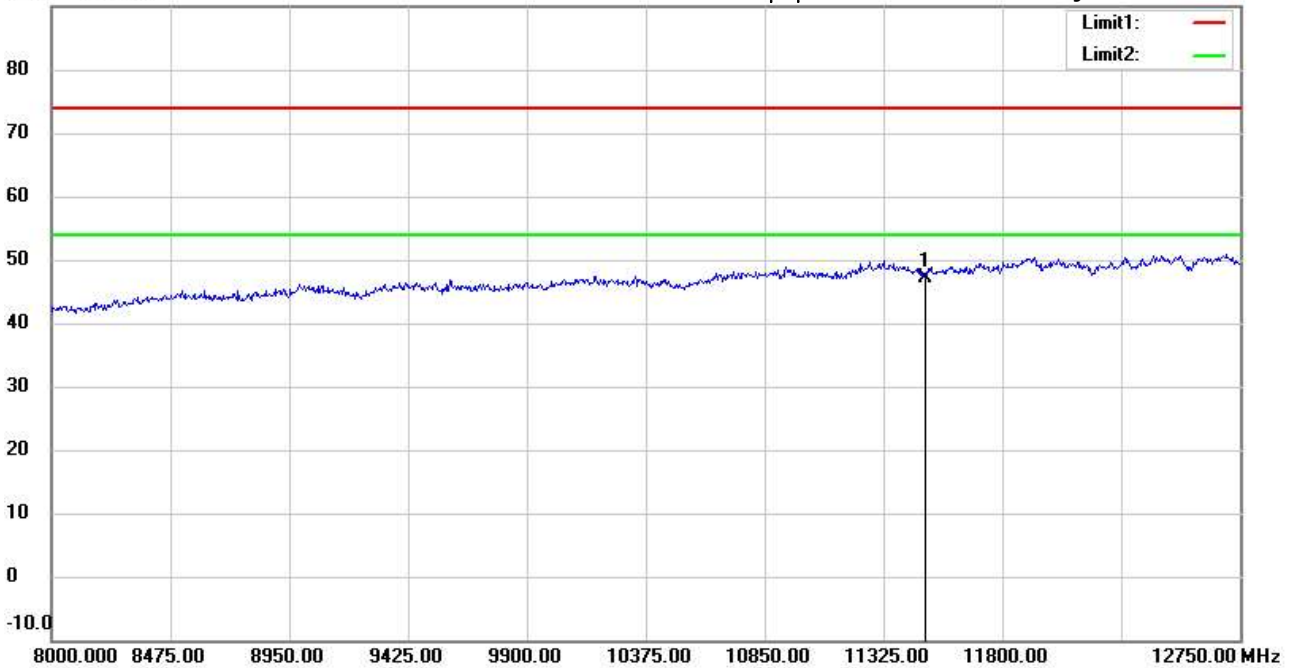
Polarization: *Horizontal*

Mk.	Frequency (MHz)	Reading (dBuV)	Detector	Corr. factor (dB/m)	Result (dBuV/m)	Limit (dBuV/m)	Ant.Pos (cm)	Tab.Pos (deg.)	Margin (dB)	Comment
*	11490.000	30.78	peak	16.42	47.20	74.00	150	317	-26.80

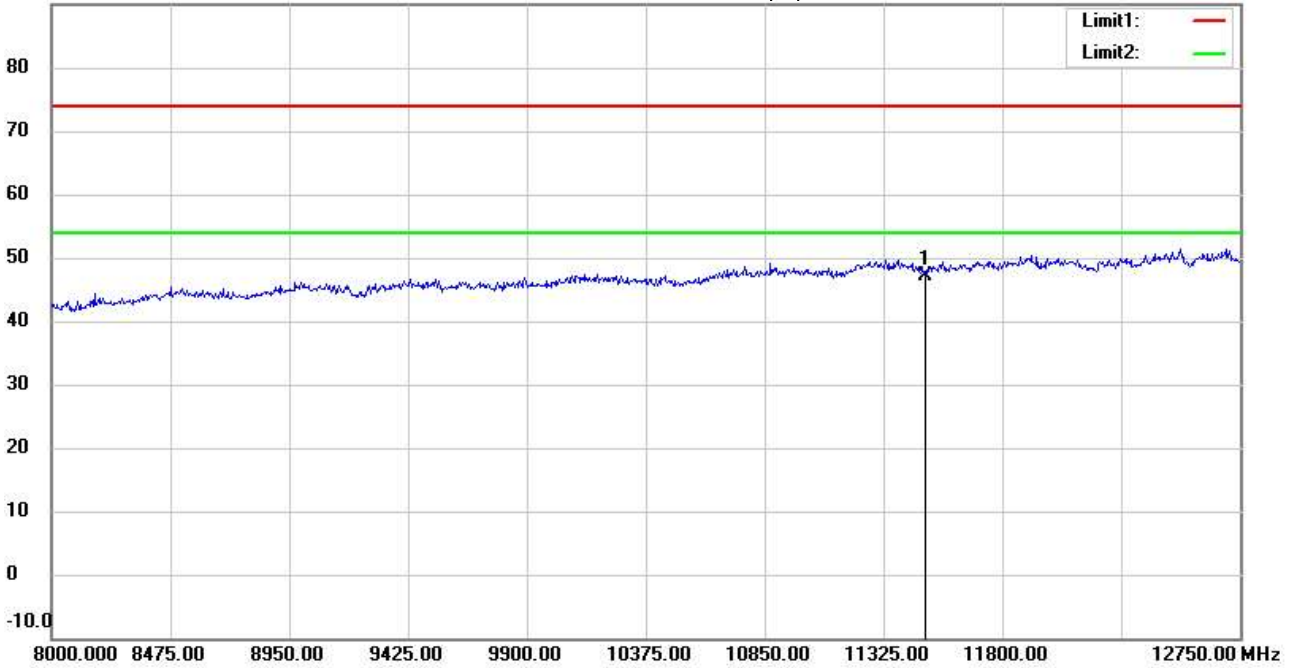
Condition : FCC\_part 15E RE\_Above 1GHz\_PK

Polarization: *Vertical*

Test Mode : TX 802.11a CH149

Mk.	Frequency (MHz)	Reading (dBuV)	Detector	Corr. factor (dB/m)	Result (dBuV/m)	Limit (dBuV/m)	Ant.Pos (cm)	Tab.Pos (deg.)	Margin (dB)	Comment
*	11490.000	30.72	peak	16.42	47.14	74.00	150	187	-26.86

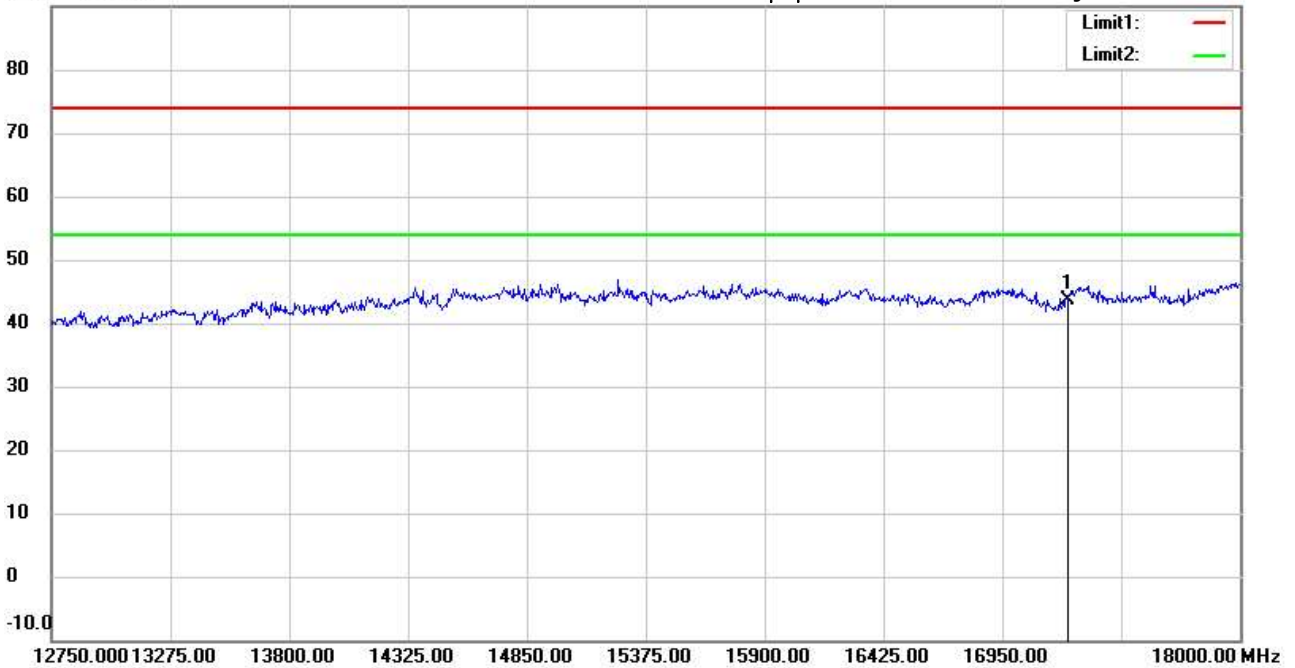
Condition : FCC\_part 15E RE\_Above 1GHz\_PK

Polarization: *Horizontal*

Test Mode : TX 802.11a CH149

Mk.	Frequency (MHz)	Reading (dBuV)	Detector	Corr. factor (dB/m)	Result (dBuV/m)	Limit (dBuV/m)	Ant.Pos (cm)	Tab.Pos (deg.)	Margin (dB)	Comment
*	17235.000	19.85	peak	23.74	43.59	74.00	150	336	-30.41

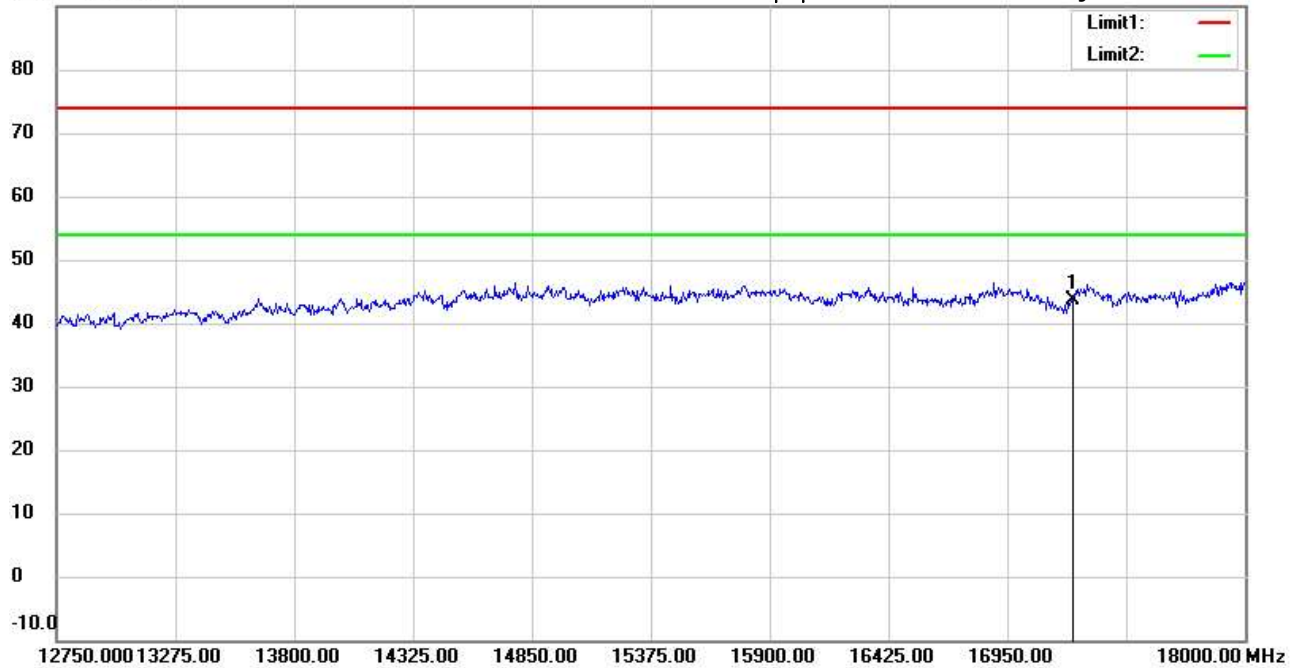
Condition : FCC\_part 15E RE\_Above 1GHz\_PK

Polarization: **Vertical**

Test Mode : TX 802.11a CH149

Mk.	Frequency (MHz)	Reading (dBuV)	Detector	Corr. factor (dB/m)	Result (dBuV/m)	Limit (dBuV/m)	Ant.Pos (cm)	Tab.Pos (deg.)	Margin (dB)	Comment
*	17235.000	19.80	peak	23.74	43.54	74.00	150	28	-30.46

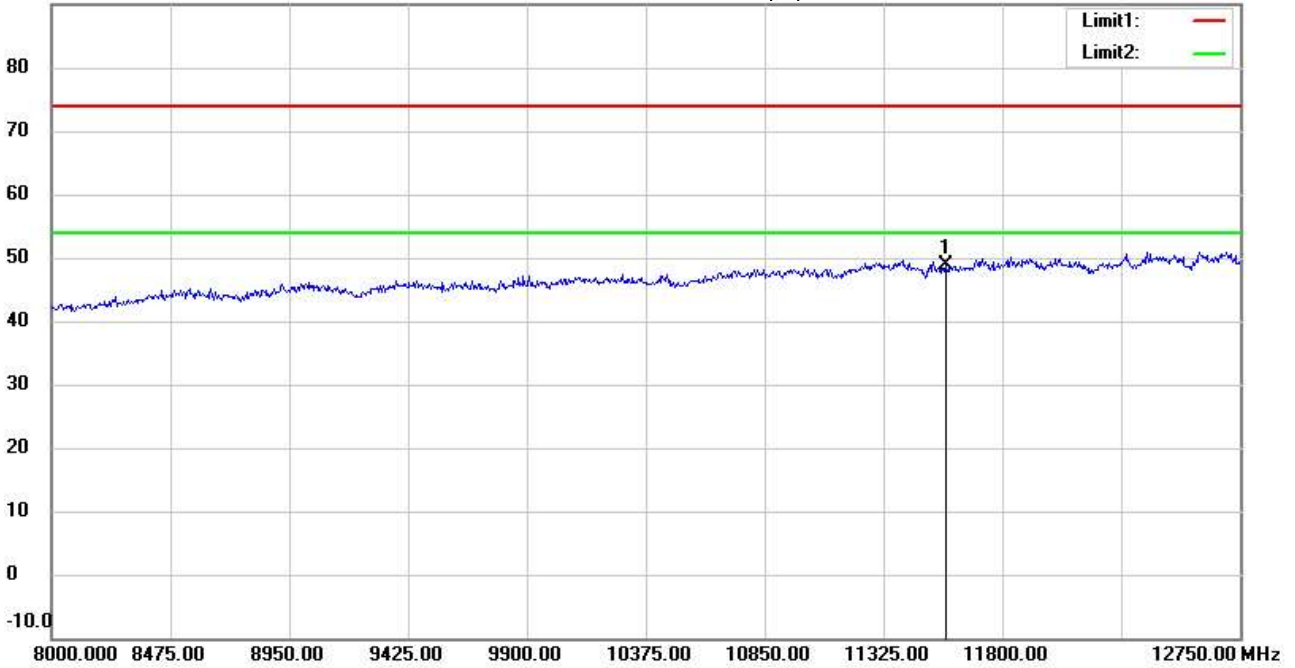
Condition : FCC\_part 15E RE\_Above 1GHz\_PK

Polarization: *Horizontal*

Test Mode : TX 802.11a CH157

Mk.	Frequency (MHz)	Reading (dBuV)	Detector	Corr. factor (dB/m)	Result (dBuV/m)	Limit (dBuV/m)	Ant.Pos (cm)	Tab.Pos (deg.)	Margin (dB)	Comment
*	11570.000	32.30	peak	16.60	48.90	74.00	150	94	-25.10

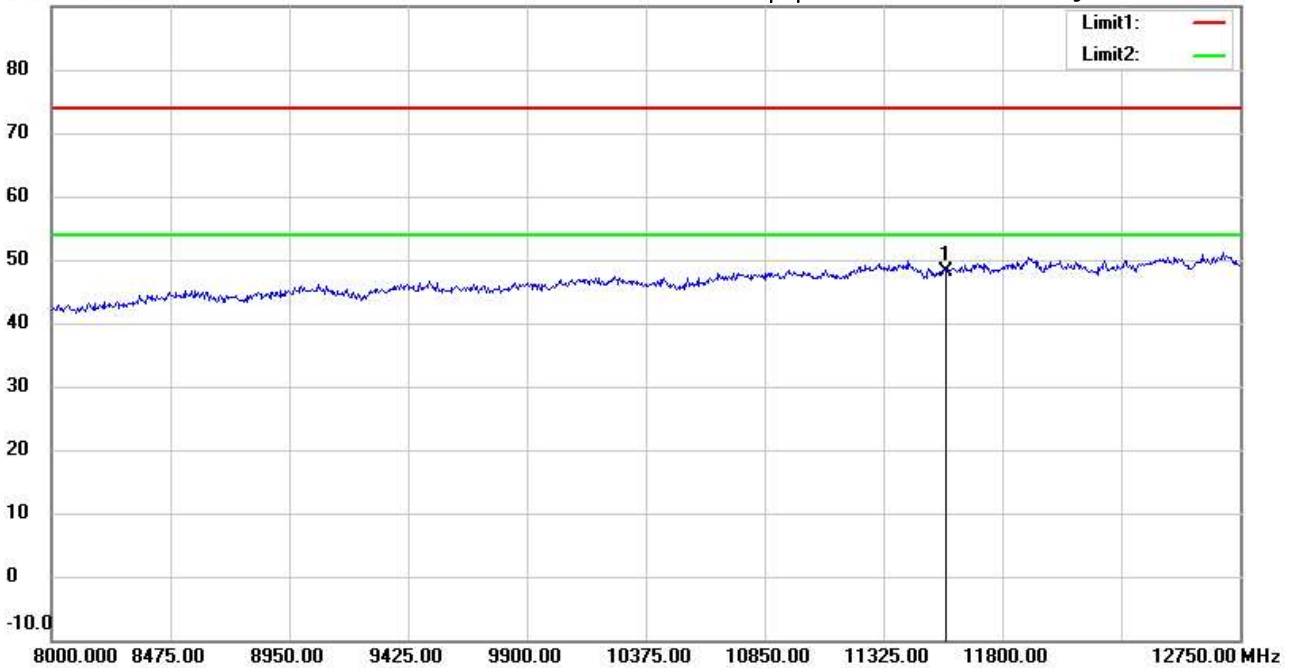
Condition : FCC\_part 15E RE\_Above 1GHz\_PK

Polarization: *Vertical*

Test Mode : TX 802.11a CH157

Mk.	Frequency (MHz)	Reading (dBuV)	Detector	Corr. factor (dB/m)	Result (dBuV/m)	Limit (dBuV/m)	Ant.Pos (cm)	Tab.Pos (deg.)	Margin (dB)	Comment
*	11570.000	31.52	peak	16.60	48.12	74.00	150	11	-25.88

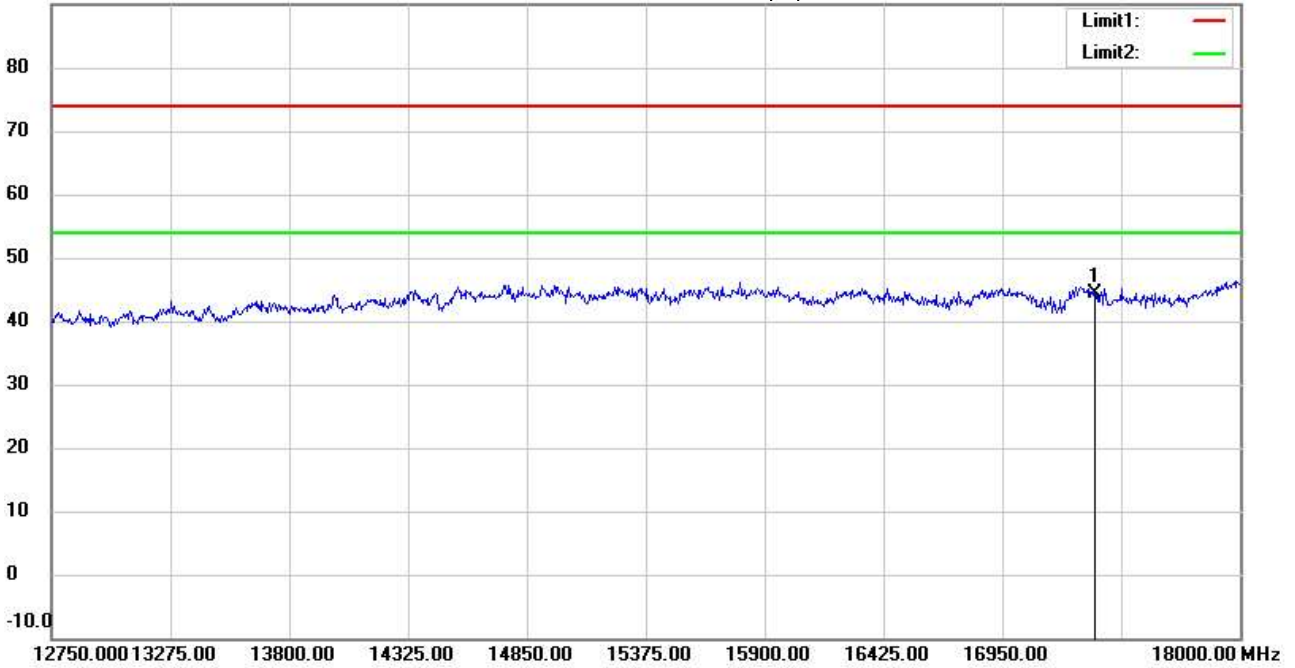
Condition : FCC\_part 15E RE\_Above 1GHz\_PK

Polarization: *Horizontal*

Test Mode : TX 802.11a CH157

Mk.	Frequency (MHz)	Reading (dBuV)	Detector	Corr. factor (dB/m)	Result (dBuV/m)	Limit (dBuV/m)	Ant.Pos (cm)	Tab.Pos (deg.)	Margin (dB)	Comment
*	17355.000	20.36	peak	23.97	44.33	74.00	1520	84	-29.67

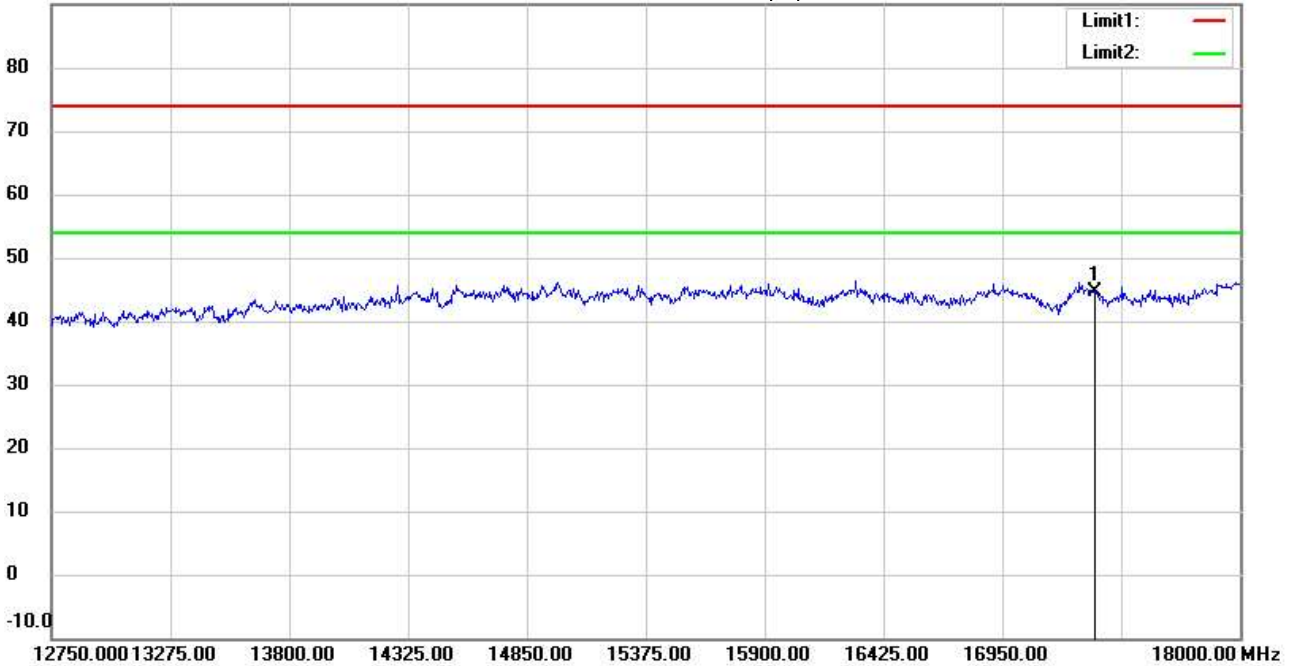
Condition : FCC\_part 15E RE\_Above 1GHz\_PK

Polarization: *Vertical*

Test Mode : TX 802.11a CH157

Mk.	Frequency (MHz)	Reading (dBuV)	Detector	Corr. factor (dB/m)	Result (dBuV/m)	Limit (dBuV/m)	Ant.Pos (cm)	Tab.Pos (deg.)	Margin (dB)	Comment
*	17355.000	20.60	peak	23.97	44.57	74.00	150	37	-29.43

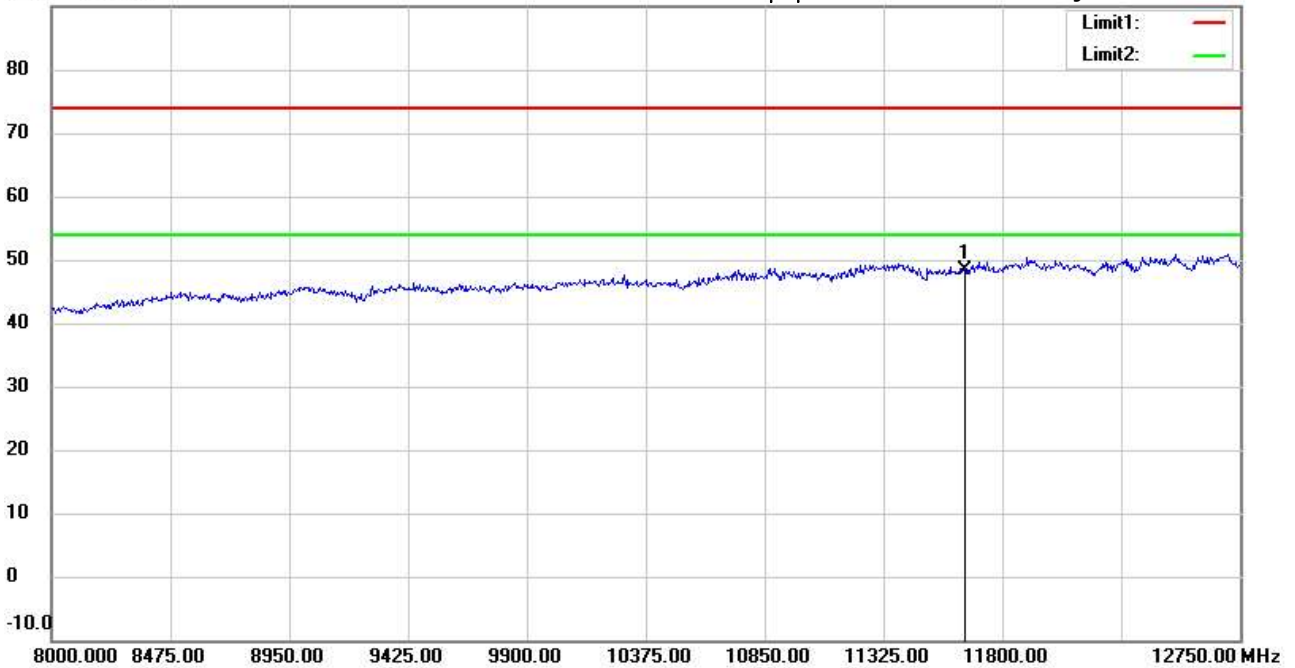
Condition : FCC\_part 15E RE\_Above 1GHz\_PK

Polarization: *Horizontal*

Test Mode : TX 802.11a CH165

Mk.	Frequency (MHz)	Reading (dBuV)	Detector	Corr. factor (dB/m)	Result (dBuV/m)	Limit (dBuV/m)	Ant.Pos (cm)	Tab.Pos (deg.)	Margin (dB)	Comment
*	11650.000	31.79	peak	16.48	48.27	74.00	150	322	-25.73

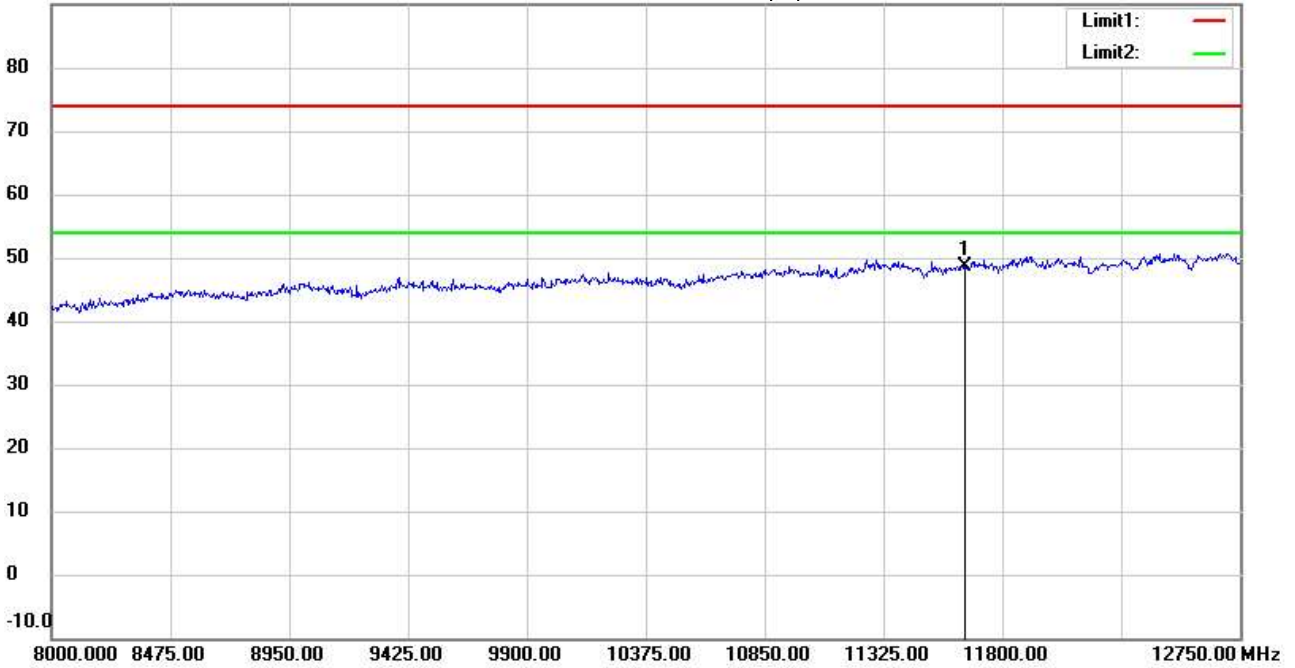
Condition : FCC\_part 15E RE\_Above 1GHz\_PK

Polarization: **Vertical**

Test Mode : TX 802.11a CH165

Mk.	Frequency (MHz)	Reading (dBuV)	Detector	Corr. factor (dB/m)	Result (dBuV/m)	Limit (dBuV/m)	Ant.Pos (cm)	Tab.Pos (deg.)	Margin (dB)	Comment
*	11650.000	32.25	peak	16.48	48.73	74.00	150	248	-25.27

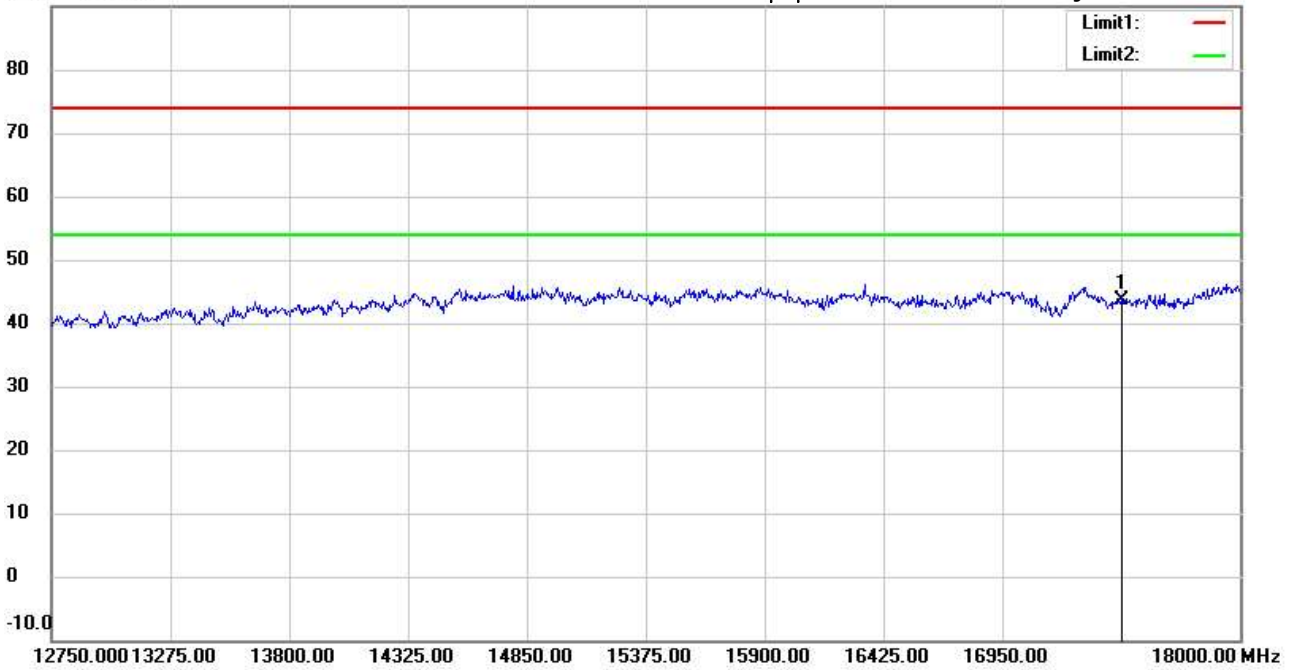
Condition : FCC\_part 15E RE\_Above 1GHz\_PK

Polarization: **Horizontal**

Test Mode : TX 802.11a CH165

Mk.	Frequency (MHz)	Reading (dBuV)	Detector	Corr. factor (dB/m)	Result (dBuV/m)	Limit (dBuV/m)	Ant.Pos (cm)	Tab.Pos (deg.)	Margin (dB)	Comment
*	17475.000	20.54	peak	23.21	43.75	74.00	150	307	-30.25
