Radiated Emission Measurement

Condition : FCC_part 15E RE_Above 1GHz_PK

EUT : W6M22311-23090

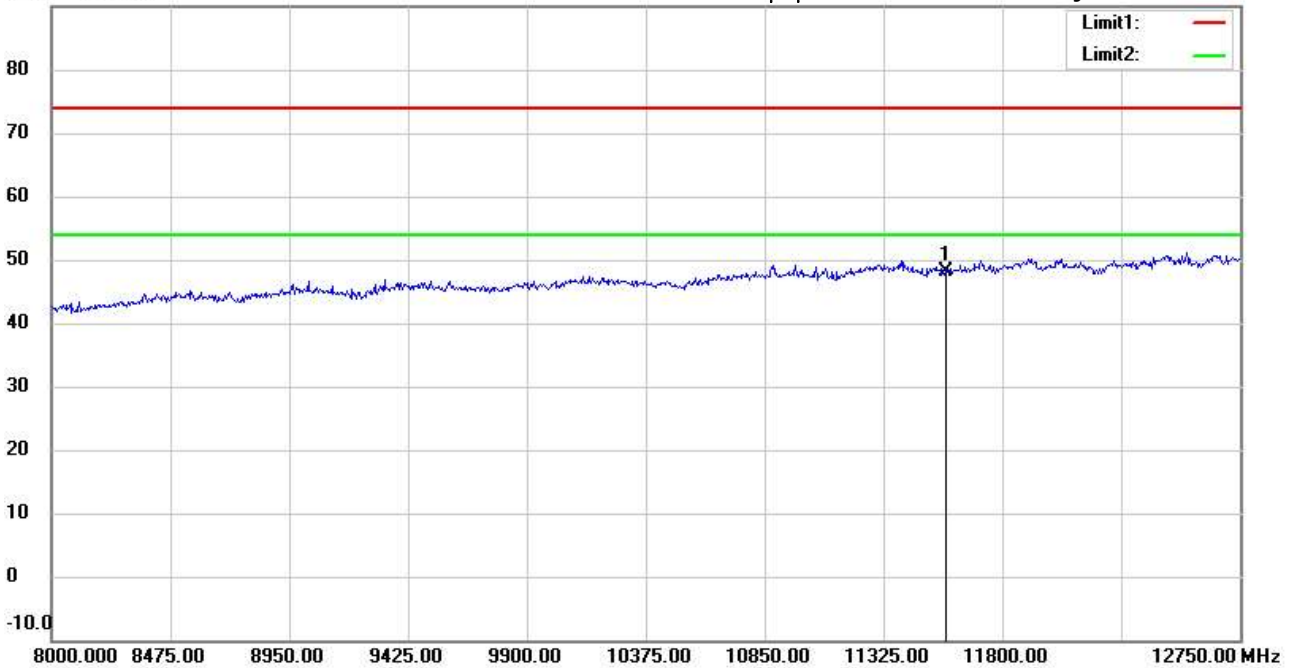
Condition : FCC_part 15E RE_Above 1GHz_PK

Polarization: *Horizontal*

Test Mode : TX 802.11n20 CH157

Mk.	Frequency (MHz)	Reading (dBuV)	Detector	Corr. factor (dB/m)	Result (dBuV/m)	Limit (dBuV/m)	Ant.Pos (cm)	Tab.Pos (deg.)	Margin (dB)	Comment
*	11570.000	31.43	peak	16.60	48.03	74.00	150	337	-25.97

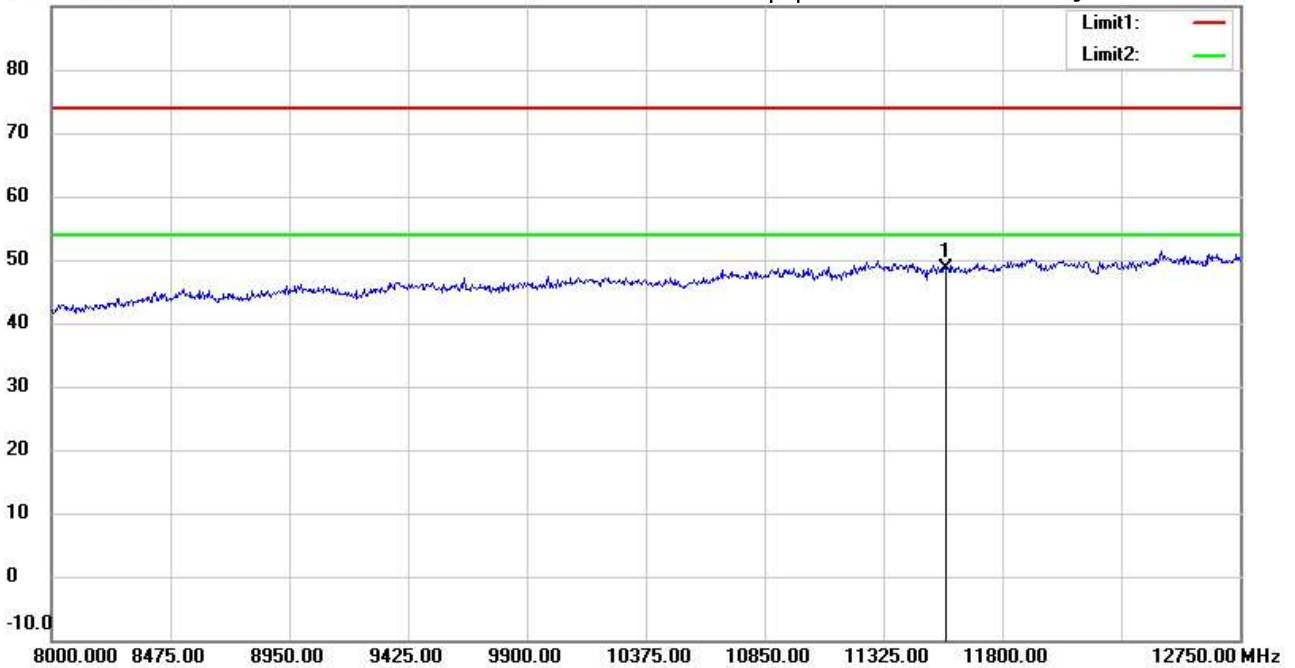
Condition : FCC_part 15E RE_Above 1GHz_PK

Polarization: *Vertical*

Test Mode : TX 802.11n20 CH157

Mk.	Frequency (MHz)	Reading (dBuV)	Detector	Corr. factor (dB/m)	Result (dBuV/m)	Limit (dBuV/m)	Ant.Pos (cm)	Tab.Pos (deg.)	Margin (dB)	Comment
*	11570.000	32.00	peak	16.60	48.60	74.00	150	10	-25.40

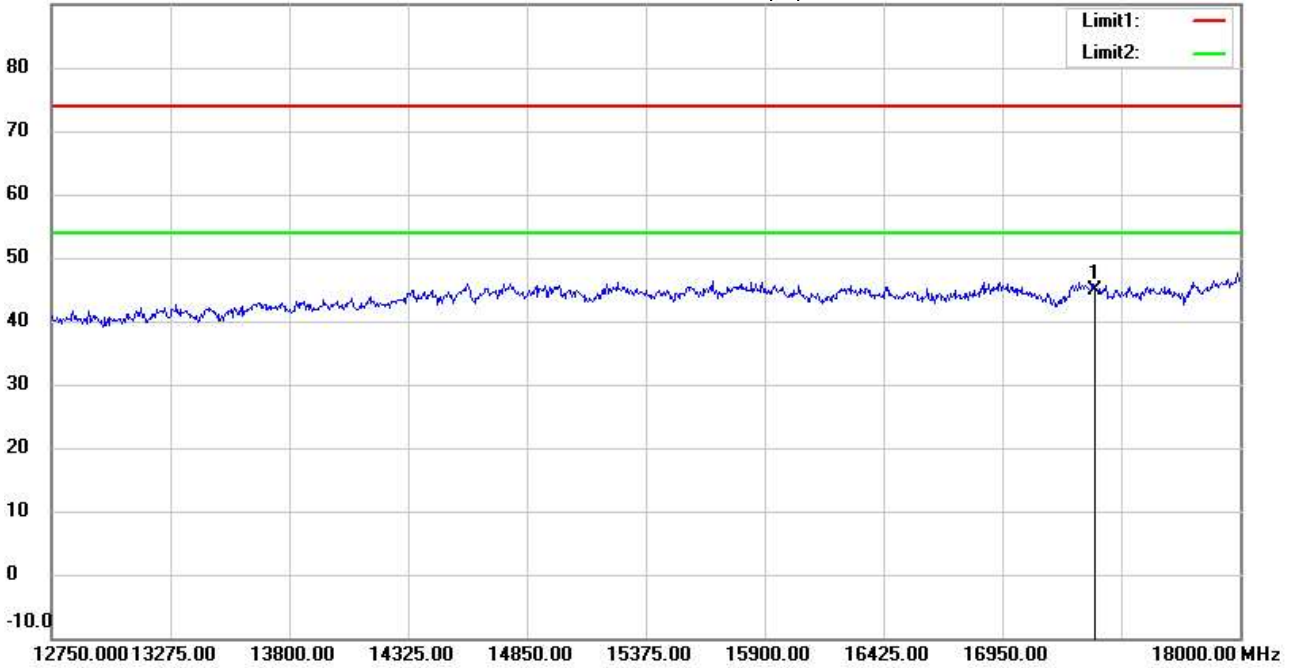
Condition : FCC_part 15E RE_Above 1GHz_PK

Polarization: *Horizontal*

Test Mode : TX 802.11n20 CH157

Mk.	Frequency (MHz)	Reading (dBuV)	Detector	Corr. factor (dB/m)	Result (dBuV/m)	Limit (dBuV/m)	Ant.Pos (cm)	Tab.Pos (deg.)	Margin (dB)	Comment
*	17355.000	20.92	peak	23.97	44.89	74.00	150	12	-29.11

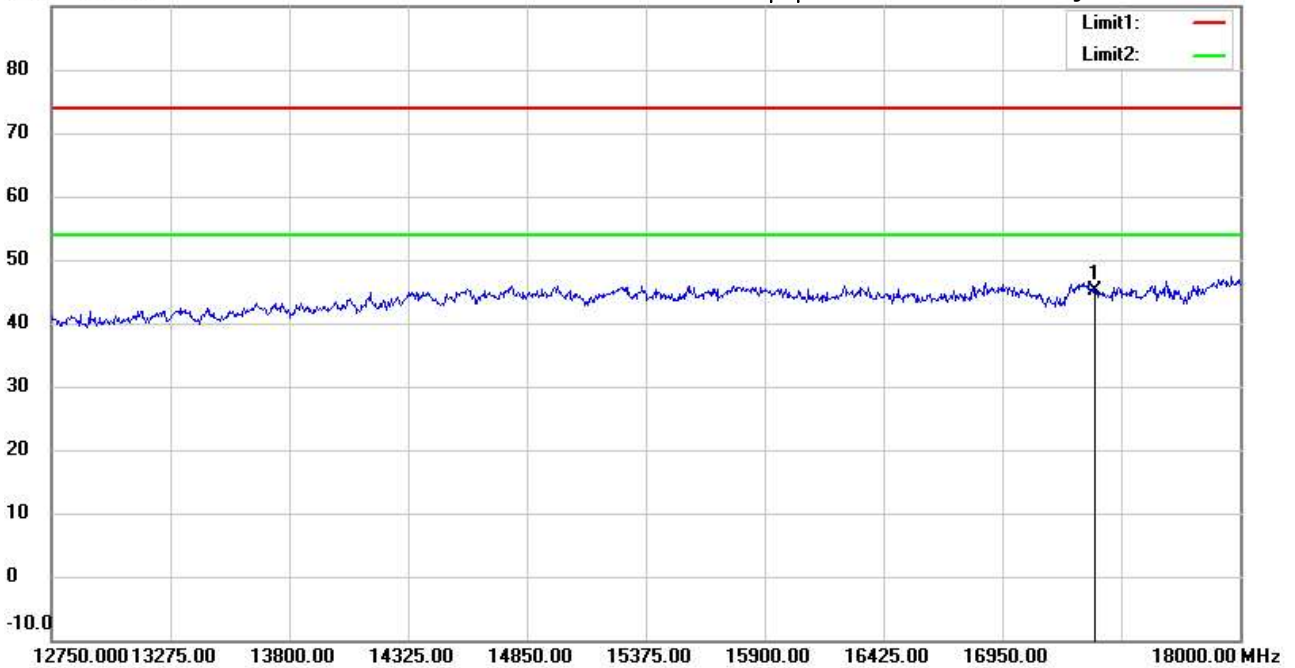
Condition : FCC_part 15E RE_Above 1GHz_PK

Polarization: **Vertical**

Test Mode : TX 802.11n20 CH157

Mk.	Frequency (MHz)	Reading (dBuV)	Detector	Corr. factor (dB/m)	Result (dBuV/m)	Limit (dBuV/m)	Ant.Pos (cm)	Tab.Pos (deg.)	Margin (dB)	Comment
*	17355.000	21.07	peak	23.97	45.04	74.00	150	27	-28.96

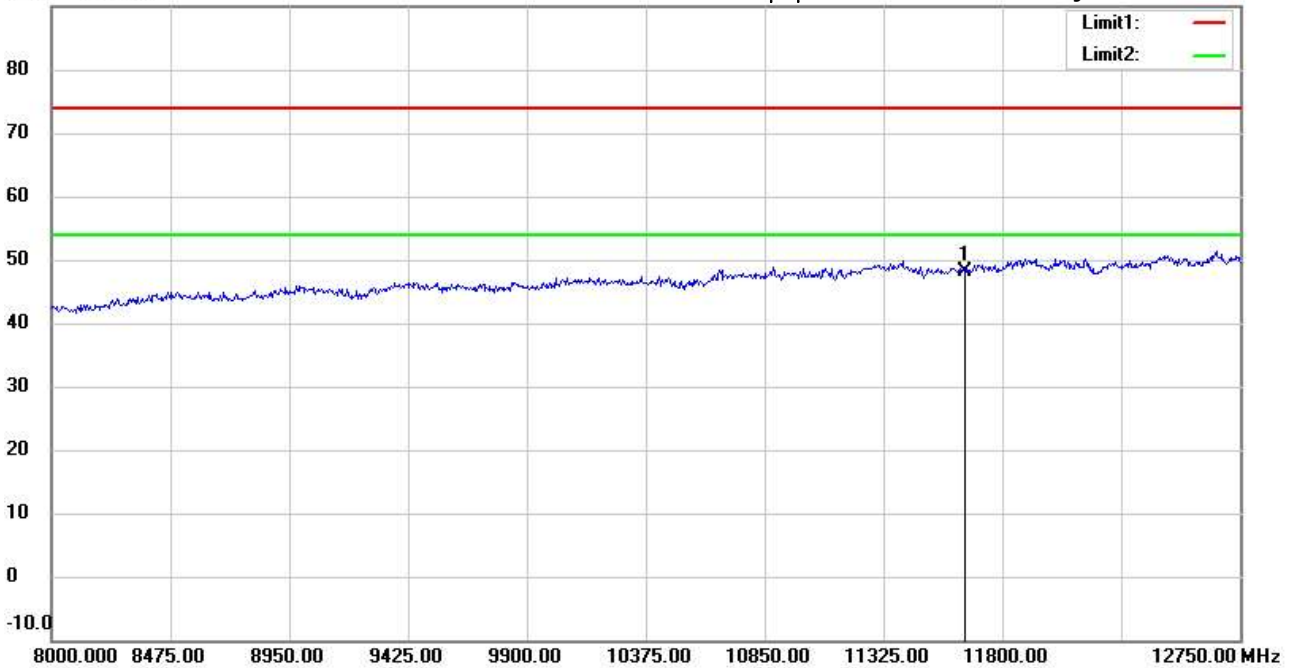
Condition : FCC_part 15E RE_Above 1GHz_PK

Polarization: *Horizontal*

Test Mode : TX 802.11n20 CH165

Mk.	Frequency (MHz)	Reading (dBuV)	Detector	Corr. factor (dB/m)	Result (dBuV/m)	Limit (dBuV/m)	Ant.Pos (cm)	Tab.Pos (deg.)	Margin (dB)	Comment
*	11650.000	31.73	peak	16.48	48.21	74.00	150	260	-25.79

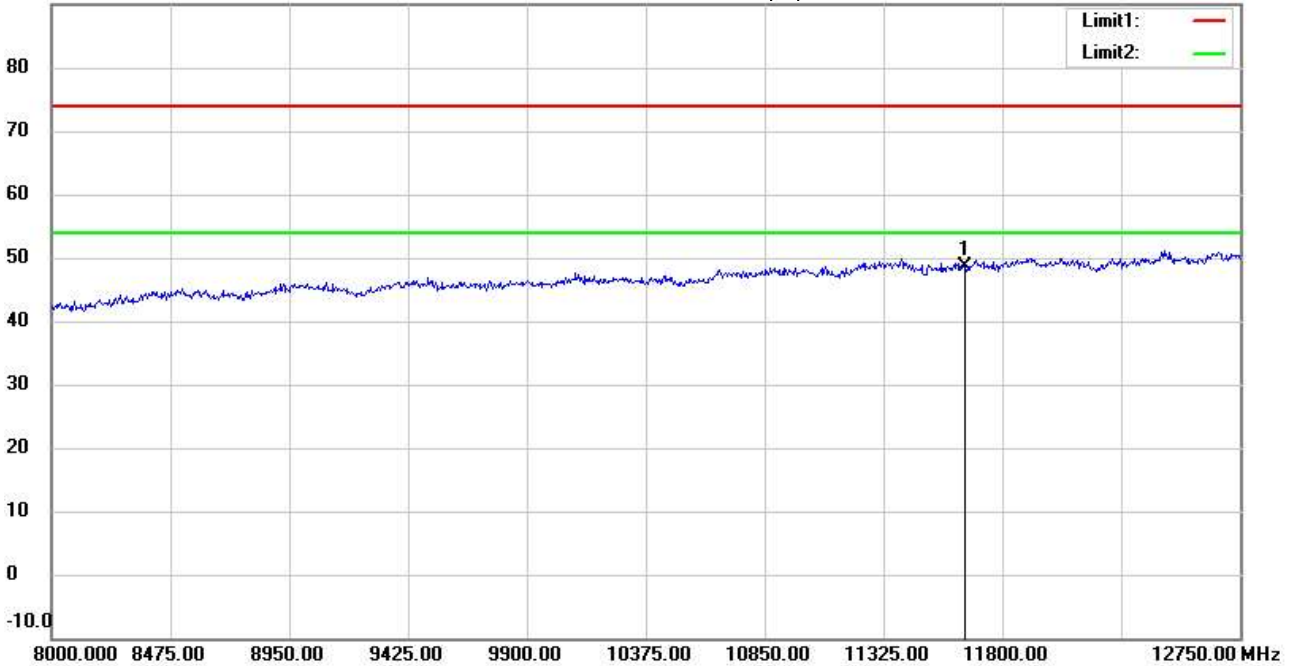
Condition : FCC_part 15E RE_Above 1GHz_PK

Polarization: **Vertical**

Test Mode : TX 802.11n20 CH165

Mk.	Frequency (MHz)	Reading (dBuV)	Detector	Corr. factor (dB/m)	Result (dBuV/m)	Limit (dBuV/m)	Ant.Pos (cm)	Tab.Pos (deg.)	Margin (dB)	Comment
*	11650.000	32.07	peak	16.48	48.55	74.00	150	254	-25.45

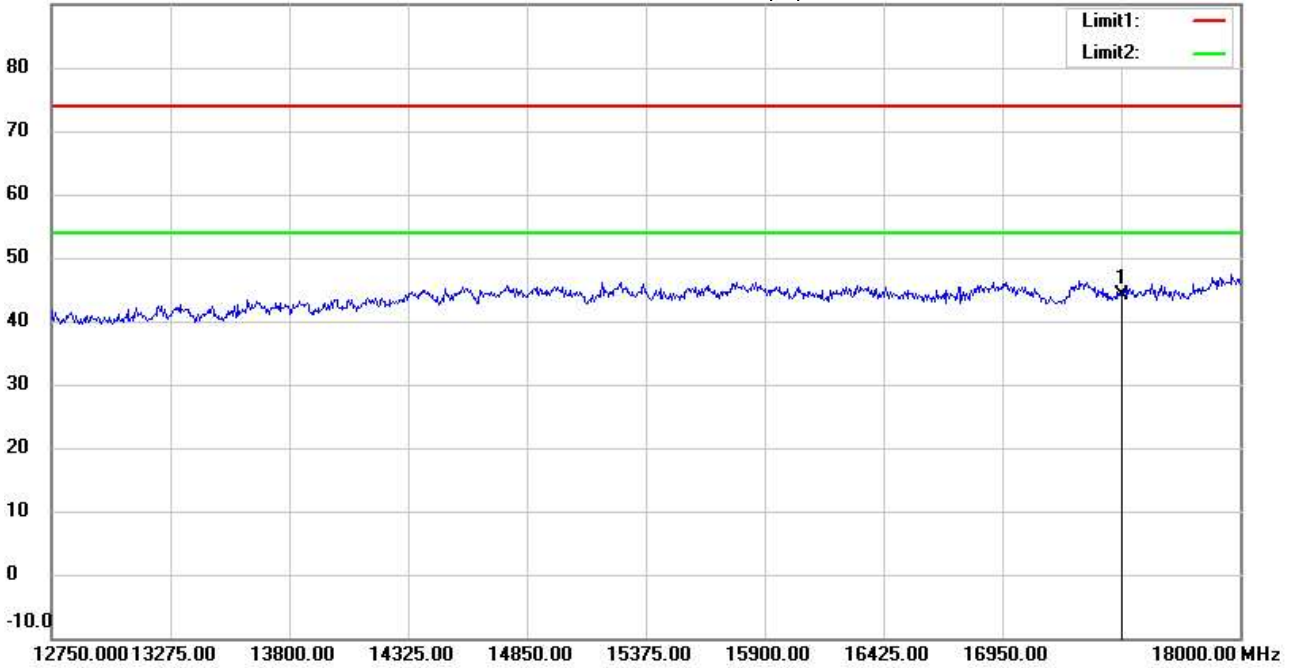
Condition : FCC_part 15E RE_Above 1GHz_PK

Polarization: *Horizontal*

Test Mode : TX 802.11n20 CH165

Mk.	Frequency (MHz)	Reading (dBuV)	Detector	Corr. factor (dB/m)	Result (dBuV/m)	Limit (dBuV/m)	Ant.Pos (cm)	Tab.Pos (deg.)	Margin (dB)	Comment
*	17475.000	20.87	peak	23.21	44.08	74.00	150	83	-29.92

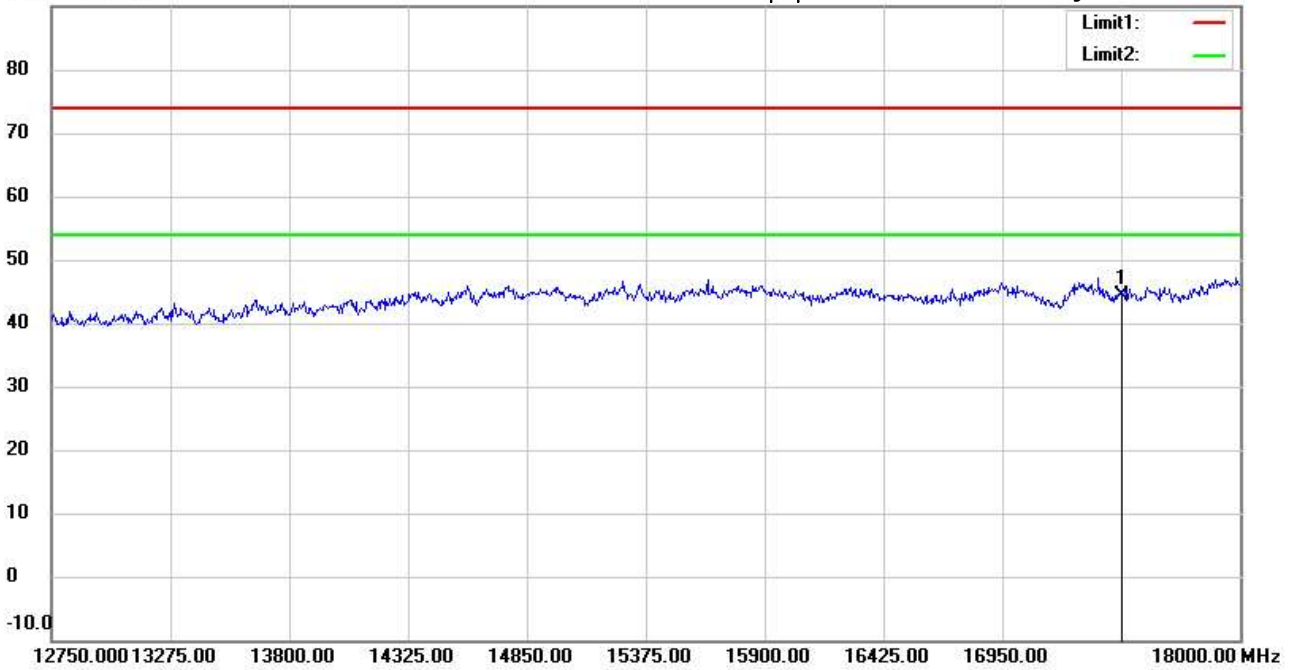
Condition : FCC_part 15E RE_Above 1GHz_PK

Polarization: *Vertical*

Test Mode : TX 802.11n20 CH165

Mk.	Frequency (MHz)	Reading (dBuV)	Detector	Corr. factor (dB/m)	Result (dBuV/m)	Limit (dBuV/m)	Ant.Pos (cm)	Tab.Pos (deg.)	Margin (dB)	Comment
*	17475.000	21.14	peak	23.21	44.35	74.00	150	168	-29.65
