Photos from test of Smart Box Link, 200612

Project no.: 618-20125

Photos from test report 618-20125-10-R2

31 August 2018

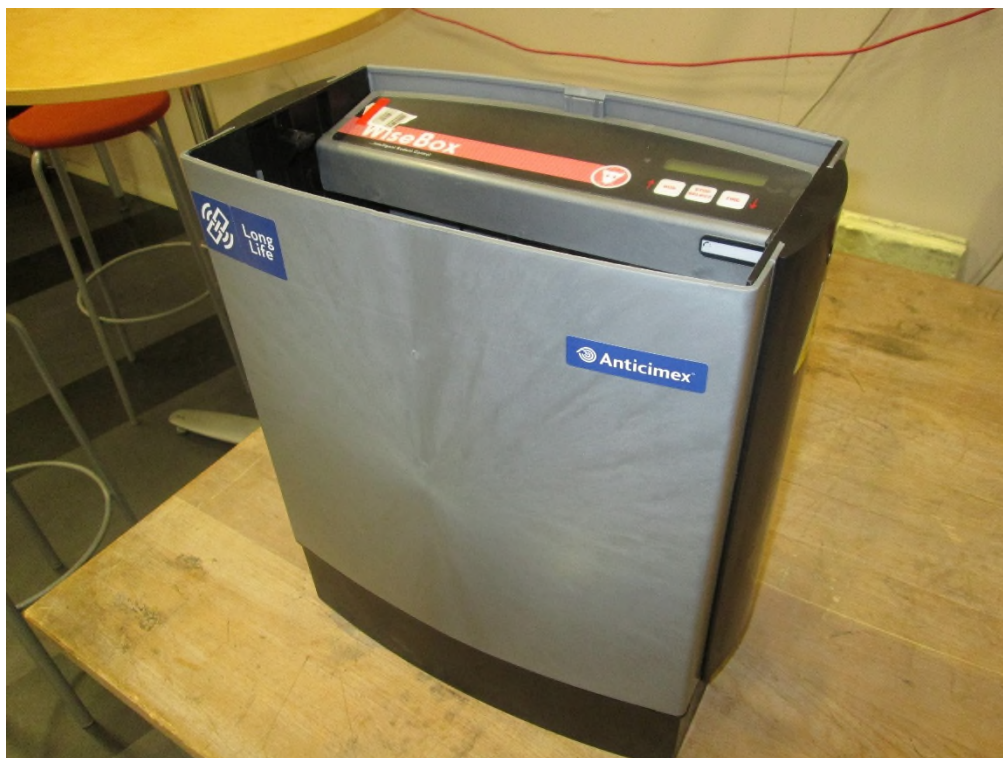
Photo 1.1 Test object.

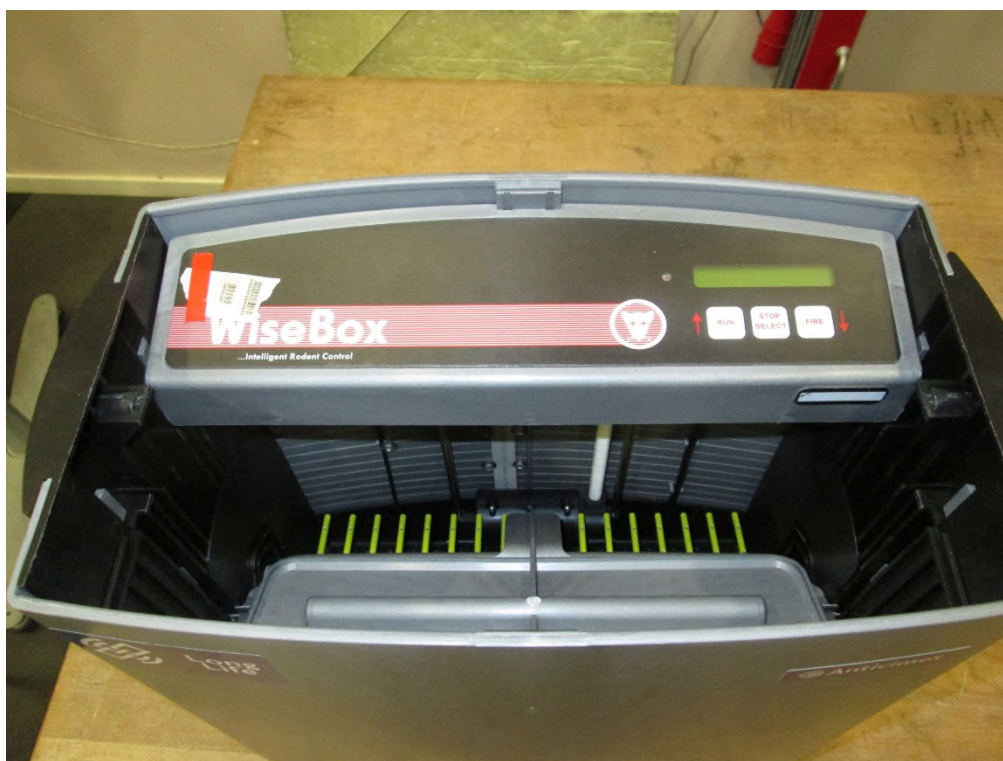
Photo 1.2 Test object.

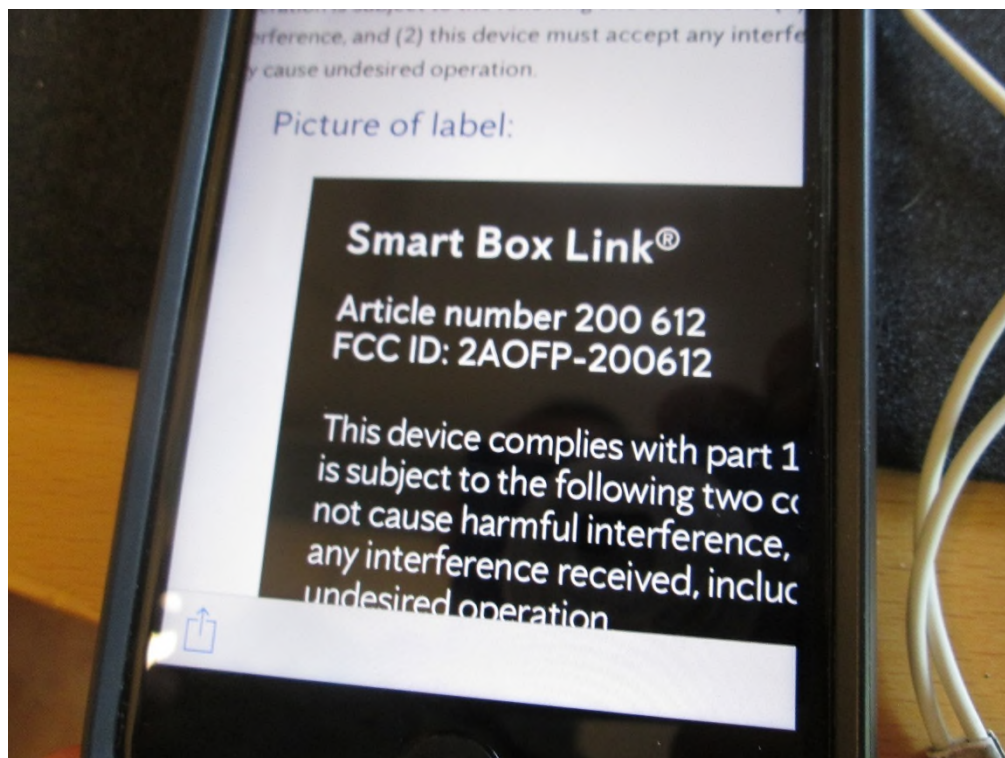
Photo 1.3 Photo taken on client document showing label intended to be placed on test object.

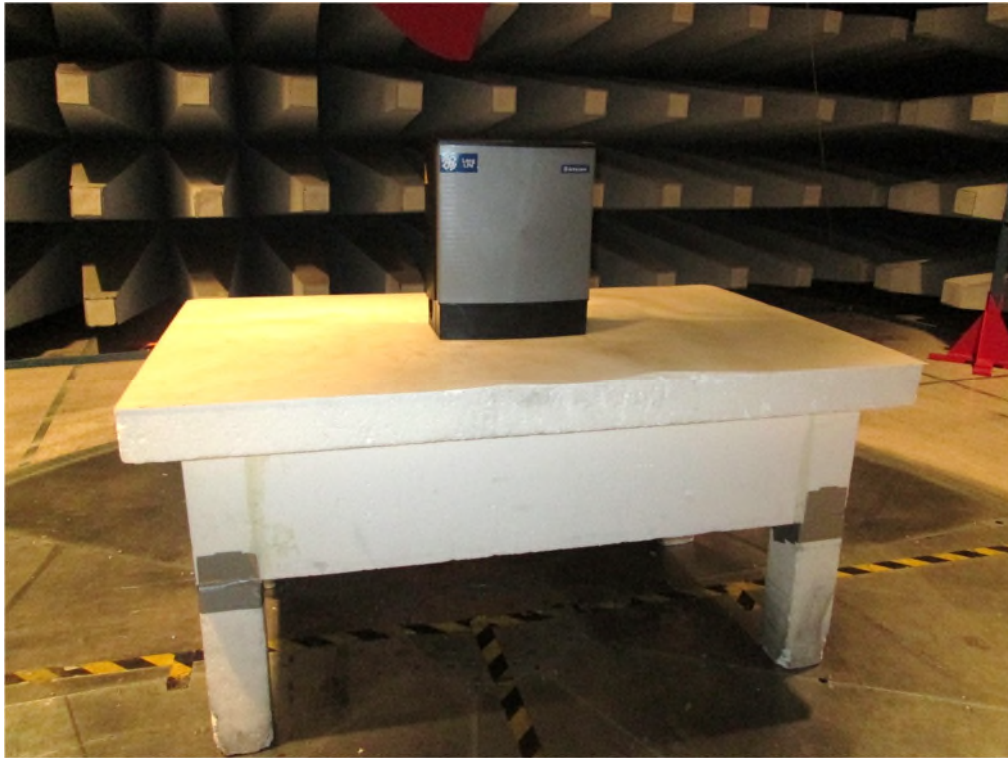
Photo 2.1 Test set up regarding measurement of radio frequency electromagnetic field below 1 GHz.

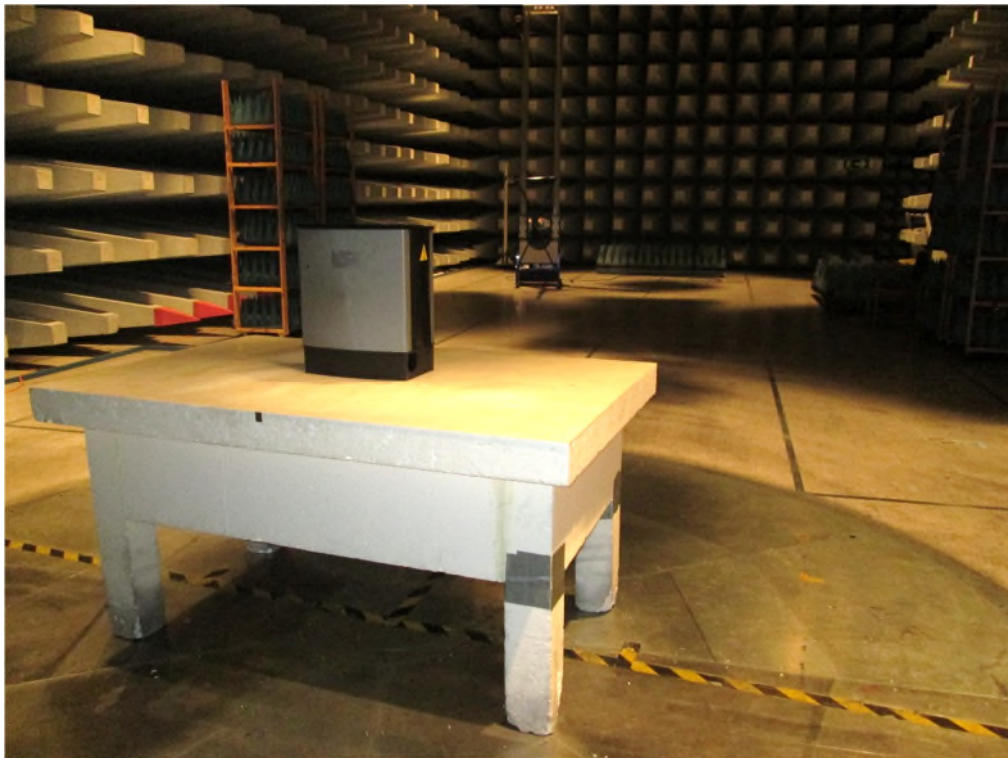
Photo 2.2 Test set up regarding measurement of radio frequency electromagnetic field below 1 GHz

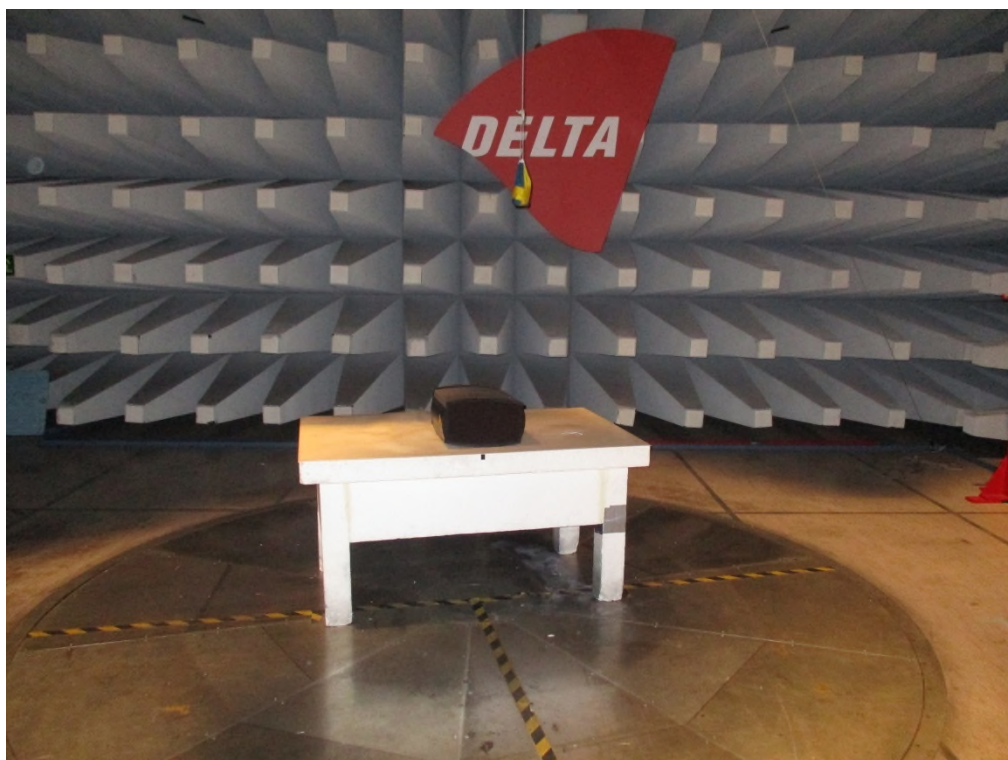
Photo 2.3 Test set up regarding measurement of radio frequency electromagnetic field below 1 GHz. Horizontal orientation

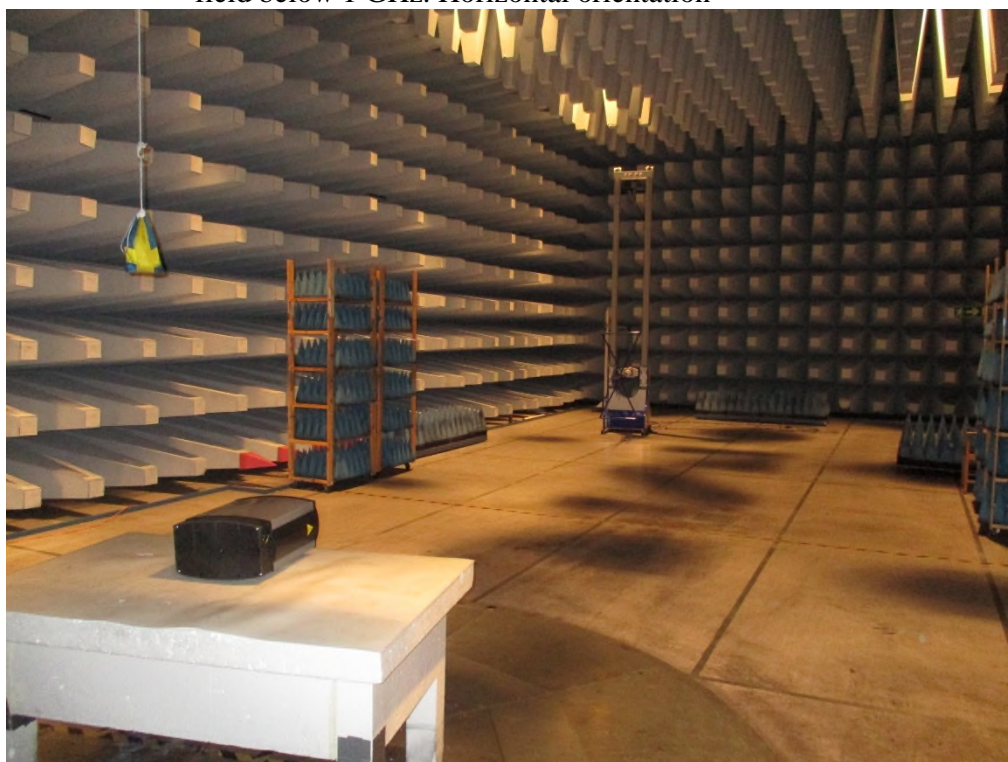
Photo 2.4 Test set up regarding measurement of radio frequency electromagnetic field below 1 GHz. Horizontal orientation

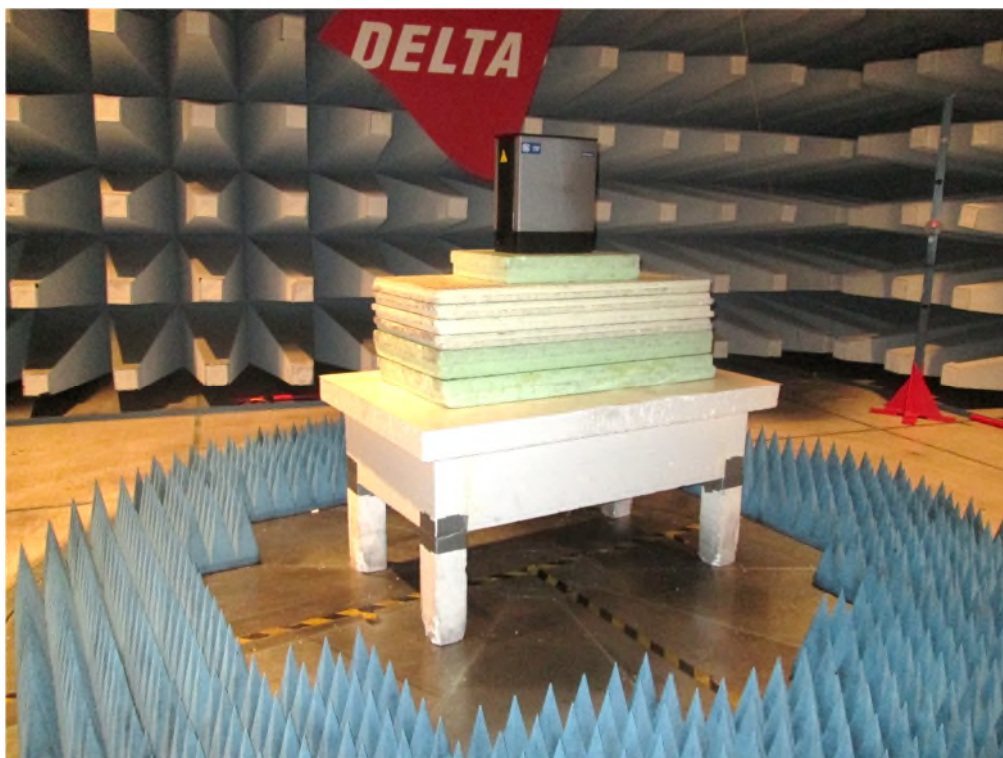
Photo 2.5 Test set up regarding measurement of radio frequency electromagnetic field above 1 GHz.

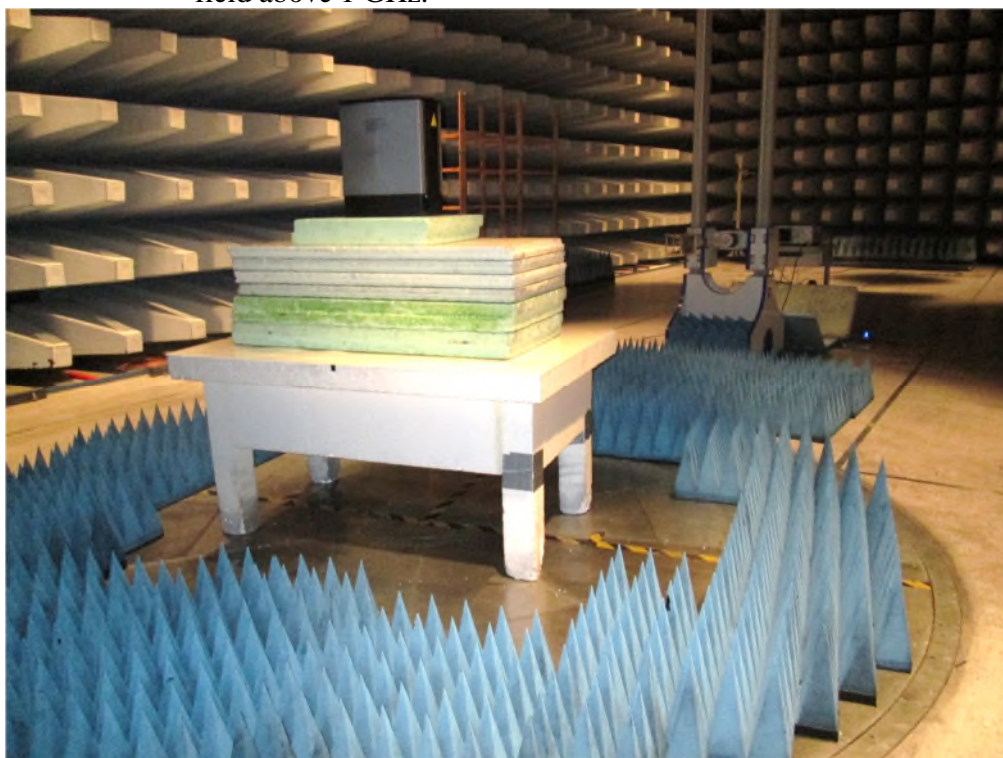
Photo 2.6 Test set up regarding measurement of radio frequency electromagnetic field above 1 GHz

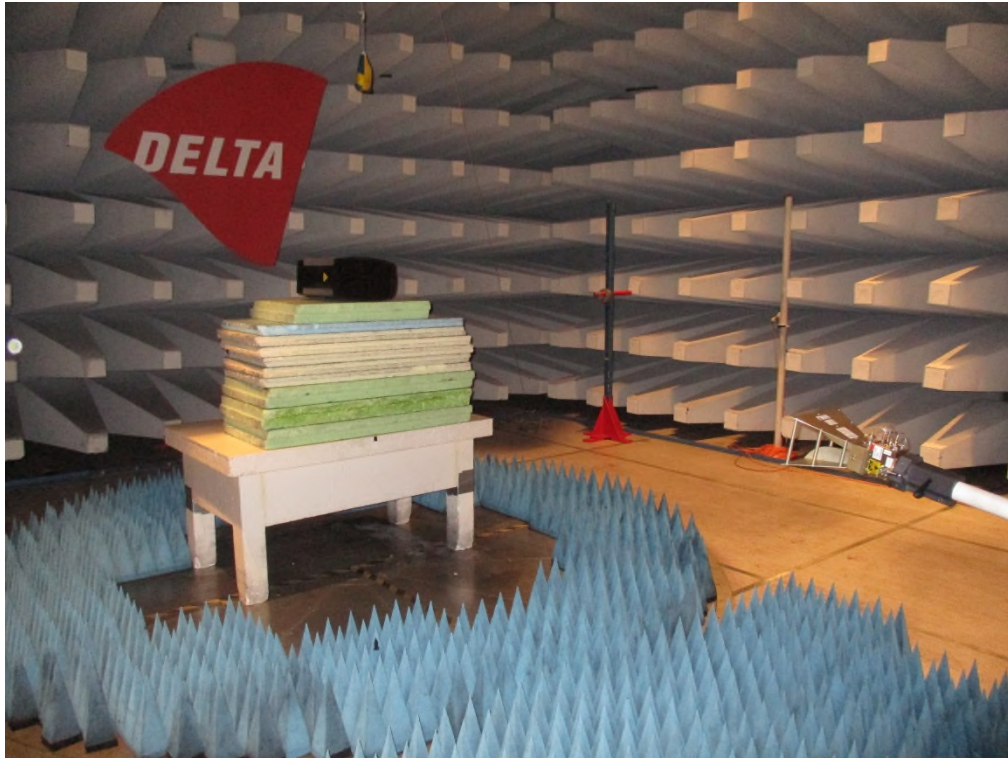
Photo 2.7 Test set up regarding measurement of radio frequency electromagnetic field above 1 GHz. Horizontal orientation

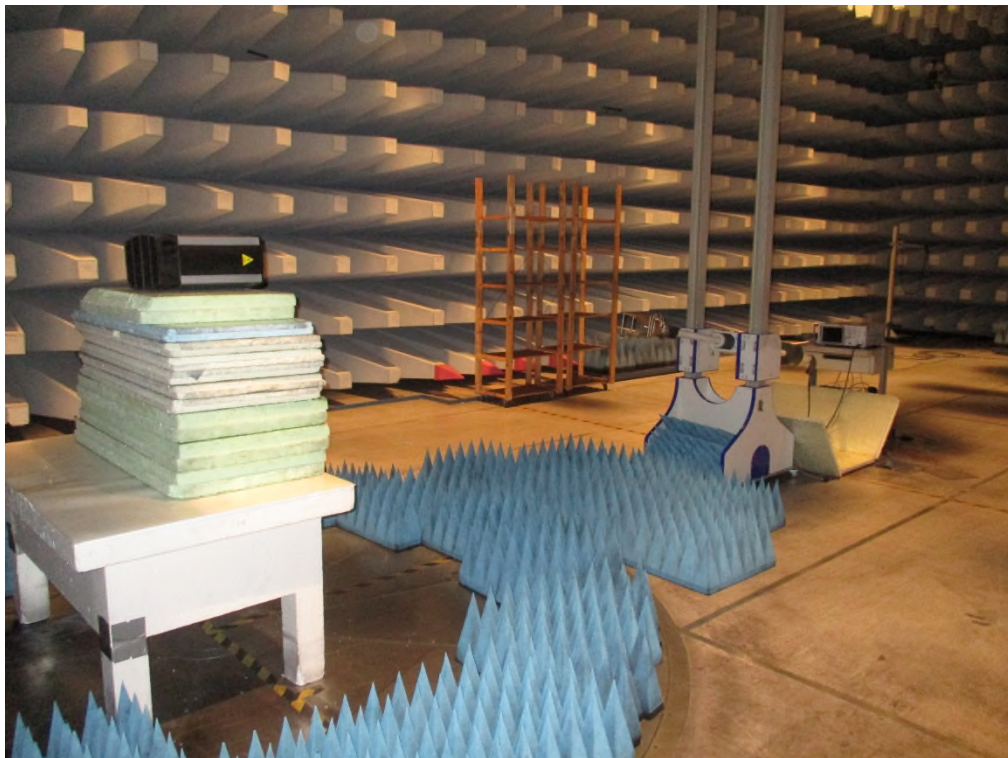
Photo 2.8 Test set up regarding measurement of radio frequency electromagnetic field above 1 GHz. Horizontal orientation

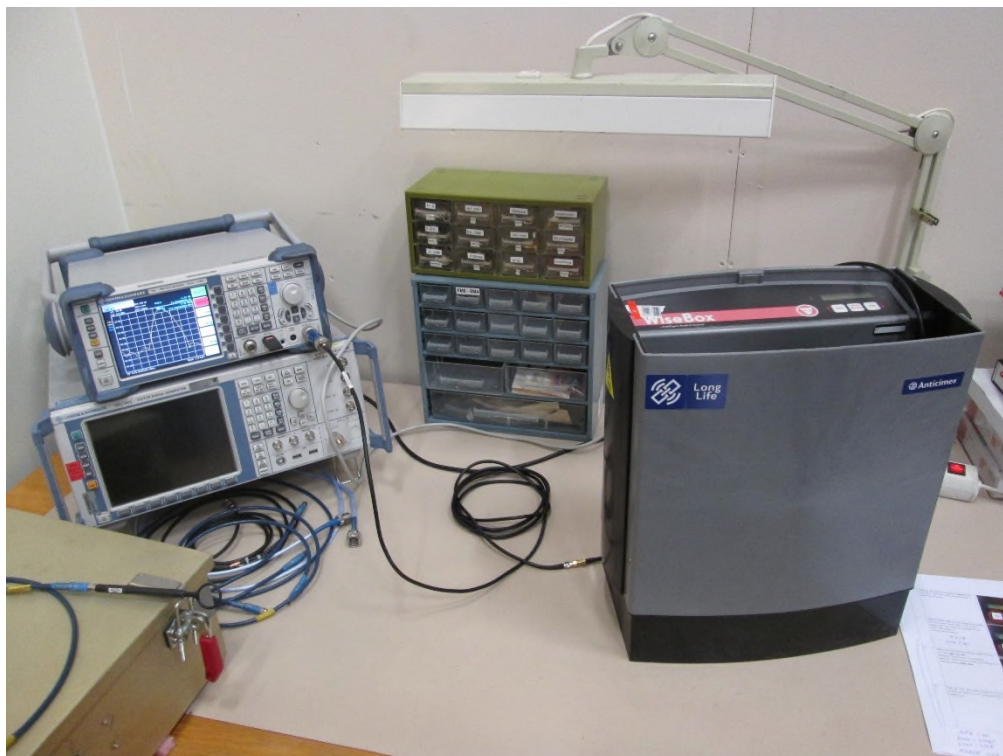
Photo 2.9 Test set up regarding radio parameter tests in chapter 4.3, 4.6 and 4.7 in test report.

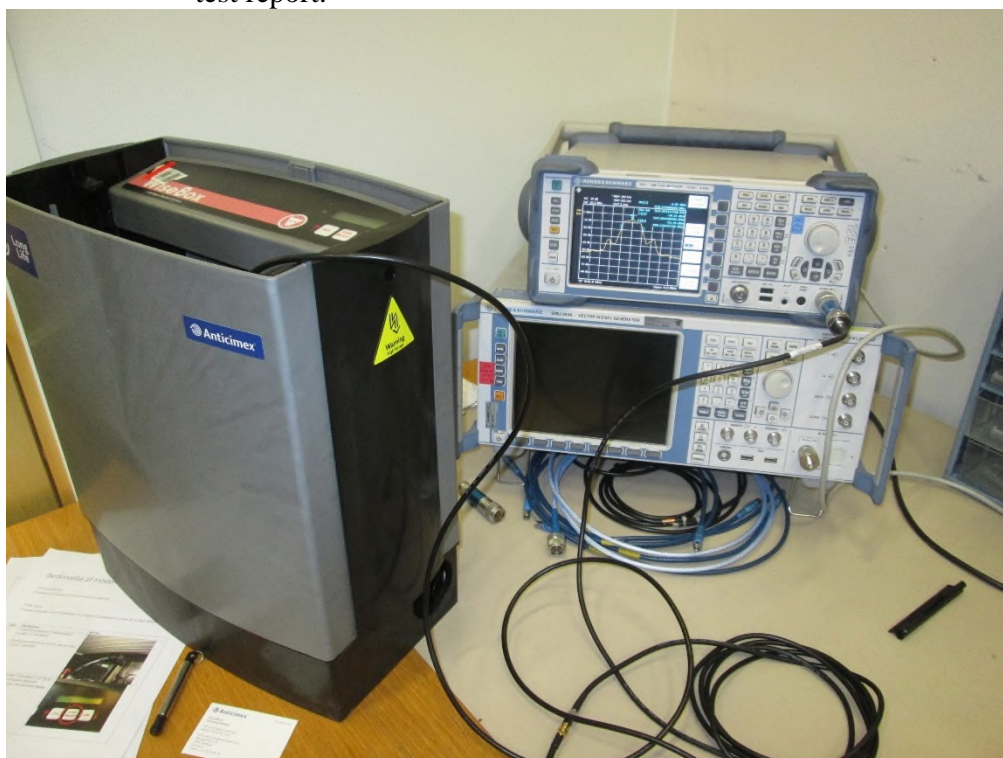
Photo 2.10 Test set up regarding radio parameter tests in chapter 4.3, 4.6 and 4.7 in test report.

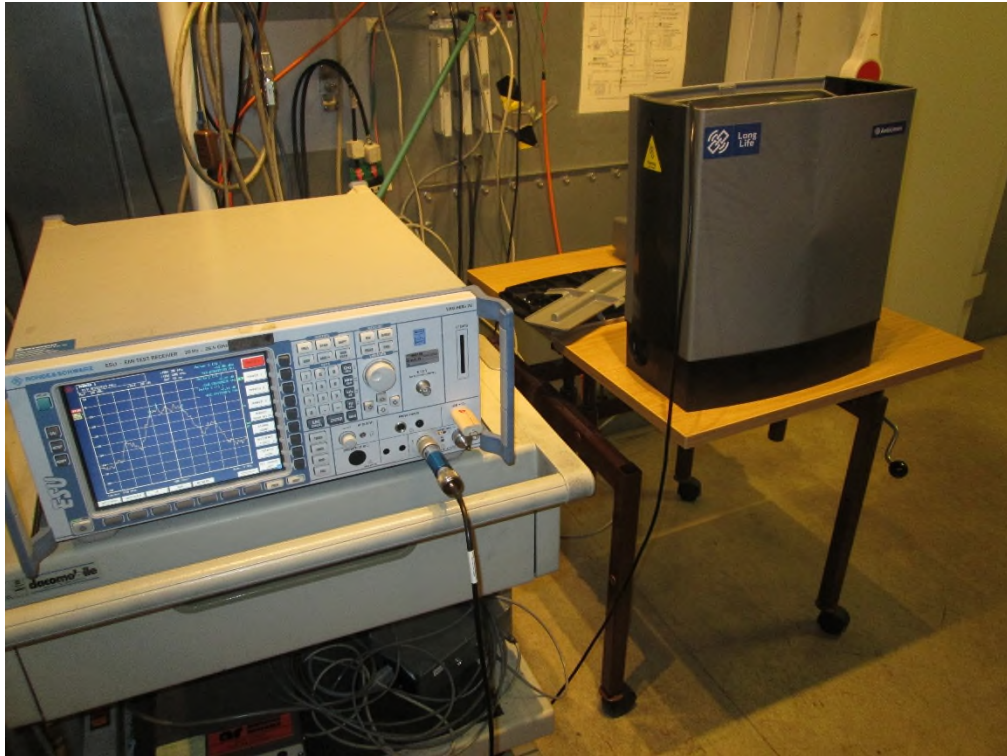
Photo 2.11 Test set up regarding radio parameter tests in chapter 4.4 and 4.5 in test report.
