Internal photos of Smart Box Link

To document all the internal parts the Smart Box Link for FCC approval via pictures.

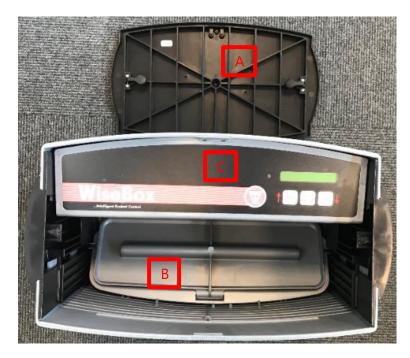
Figure 1: Main parts of the Smart Box Link. A) Shows the top lid B) The top of the bucket/lid and C) The control panel.

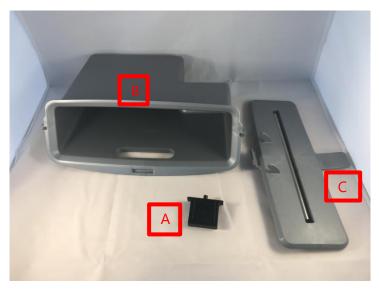
Figure 2: Internal parts accessible for the end user. A) Shows the bait box. B) Is the bucket. C) Is the lid for the bucket.

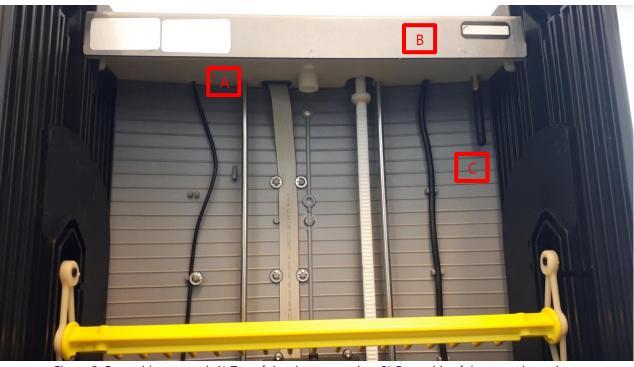
Figure 3: Front side removed. A) Top of the elevator section. B) Front side of the control panel. C) Antenna.

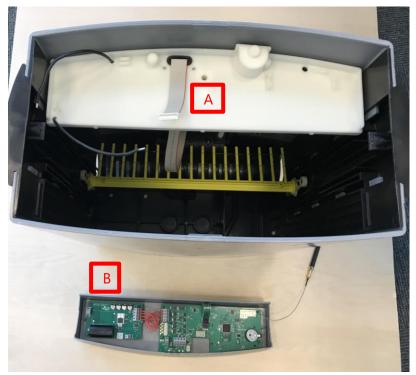
Figure 4: With the control panel removed. A) Top of the elevator section. B) Bottom side of the control panel.

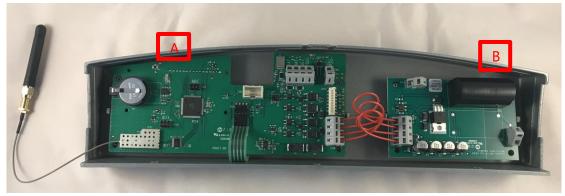
Figure 5: Inside of control panel. A) Is the control PCB. B) Is the separated high voltage generating PCB.

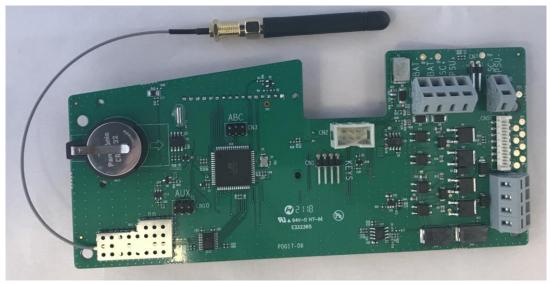
Figure 7: Shows the front side of the control PCBA.

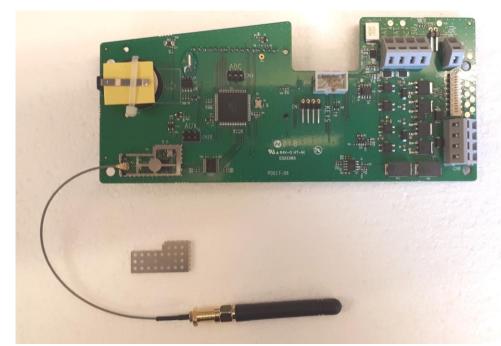
Figure 8: Shows the front side of the control PCBA, without EMI shield top.

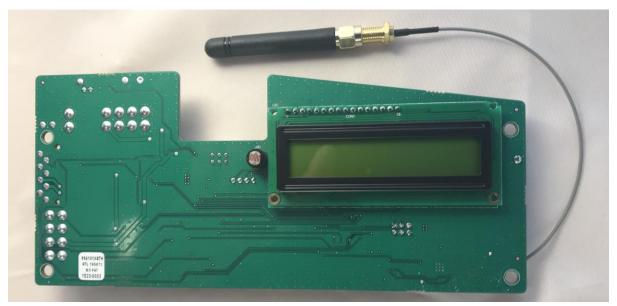
Figure 9: Shows the back side of the control PCBA.

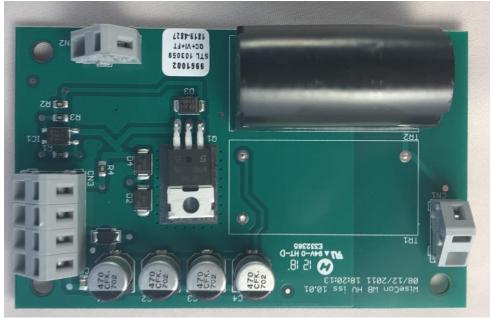
Figure 10: Shows the front side of the high voltage PCBA.

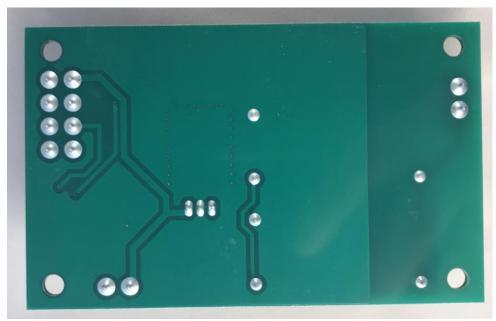
Figure 11: Shows the backside of the high voltage PCBA.

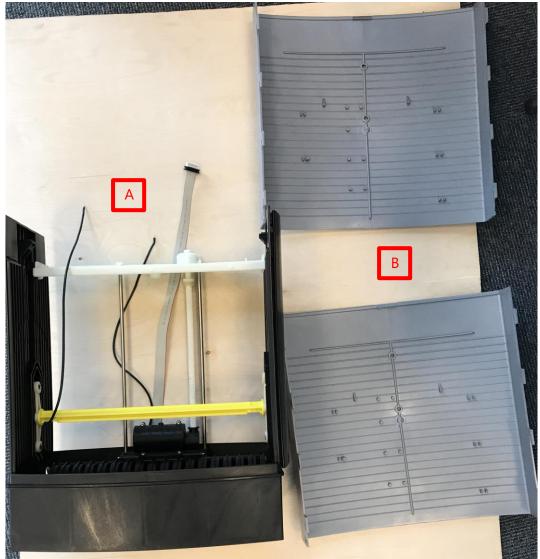
Figure 12: Outer box elements seen from the front. A) Outer box enclosure. B) Front and back panel for the box.

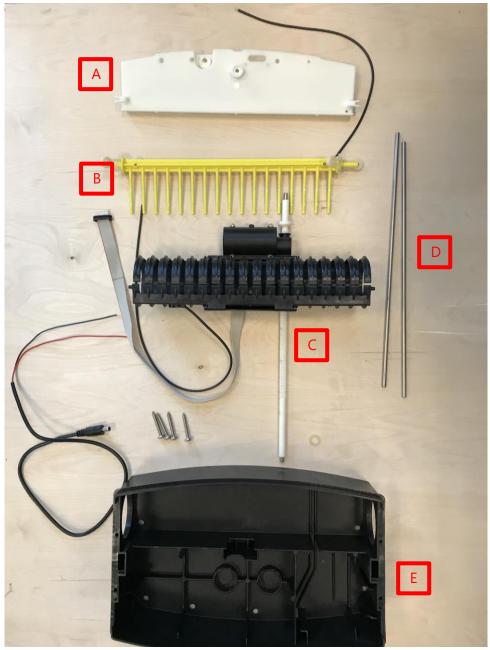
Figure 13: Box disassembled. A) The top of the elevator. B) Rake for applying high voltage through elevator tunnel. C) Elevator tunnel seen from the front, mounted on shaft with motor. D) Elevator guide poles. E) Bottom of box seen from above.

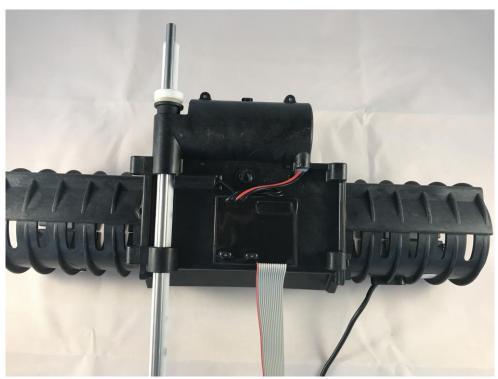
Figure 14: Elevator tunnel as seen from the back.

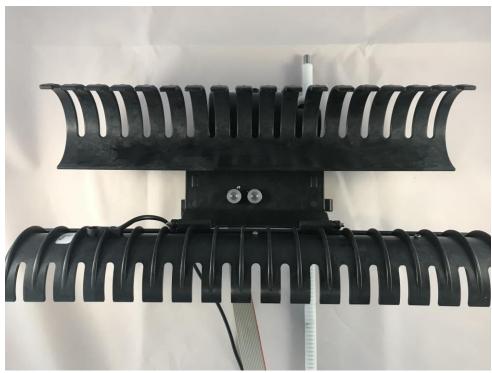
Figure 15: Elevator tunnel seen from the front in open display.

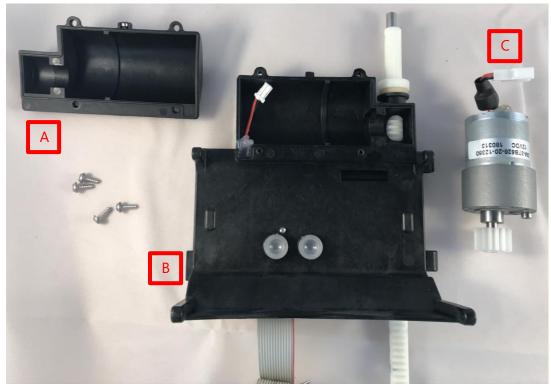
Figure 16: Elevator without tunnel. A) Half of motor enclosure. B) Elevator frame seen from the front. C) Elevator motor.

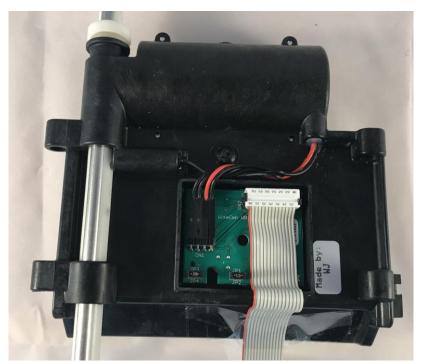
Figure 17: Elevator seen from the back before elevator PCB is enclosed in Iso-pur k 760 epoxy.
