IEC 60945:2002 +C1:2008 Testing of the LT-3100S GMDSS System  
on behalf of LARS THRANE A/S

Document 75946681 Report 07 Issue 1

| Equipment Under Test (EUT) | A Lars Thrane LT-3100S GMDSS System |

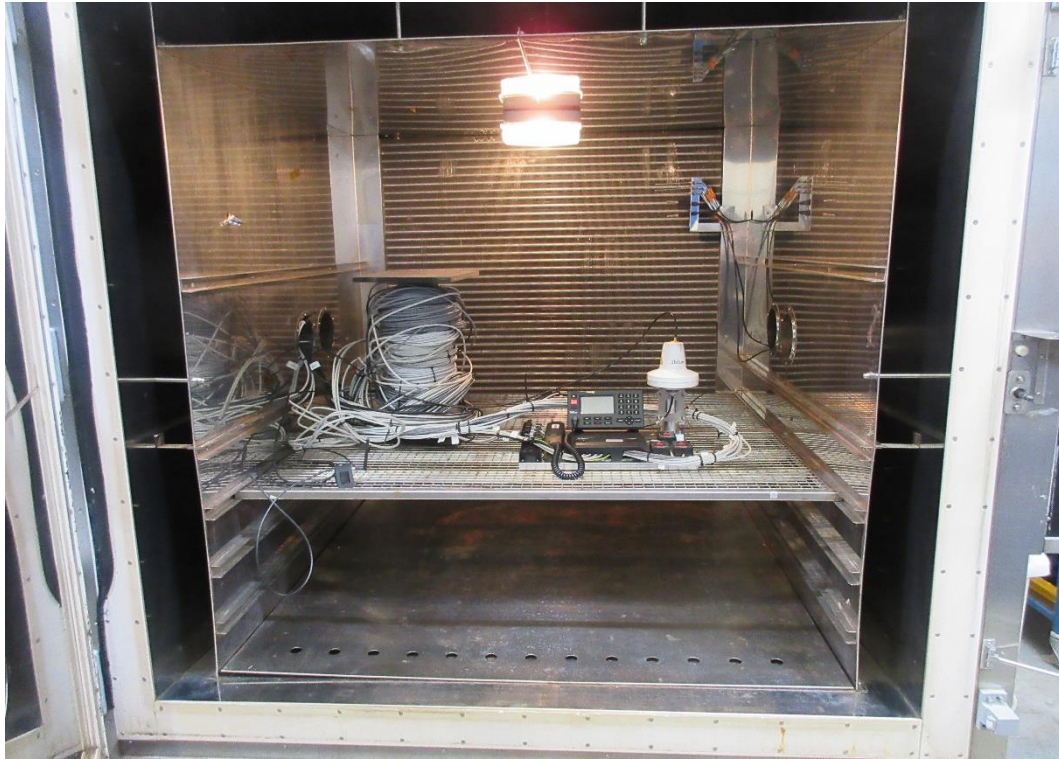
Figure 2.1.1 EUT test setup

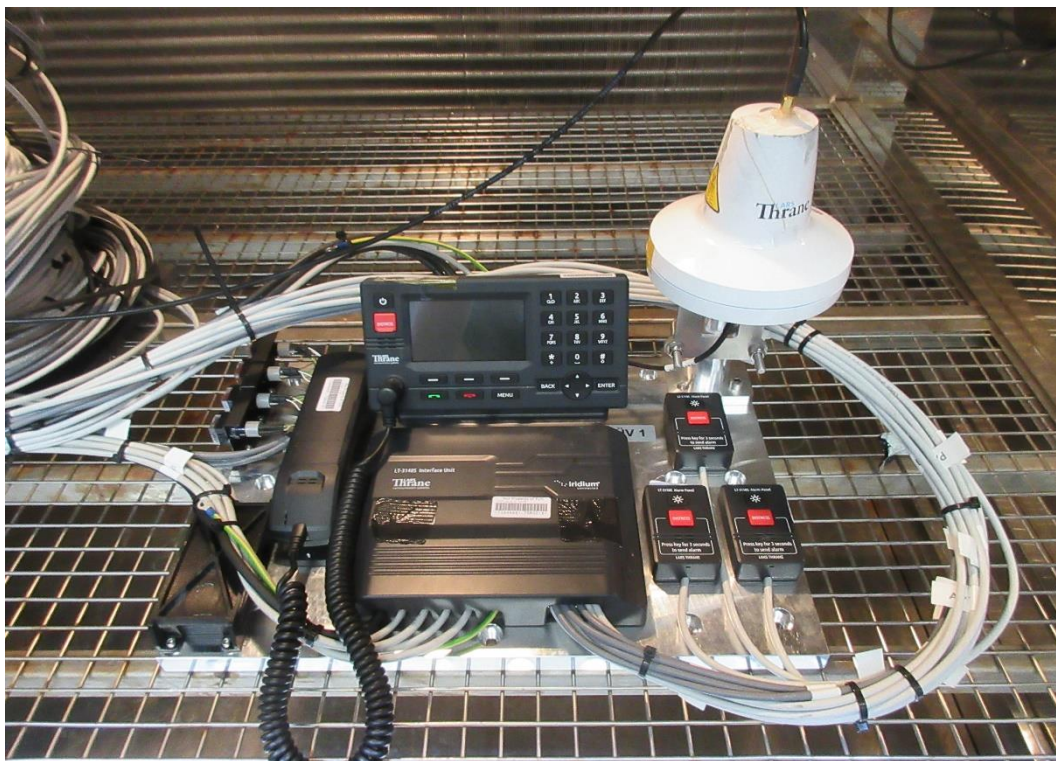
Figure 2.2.1 EUT test setup

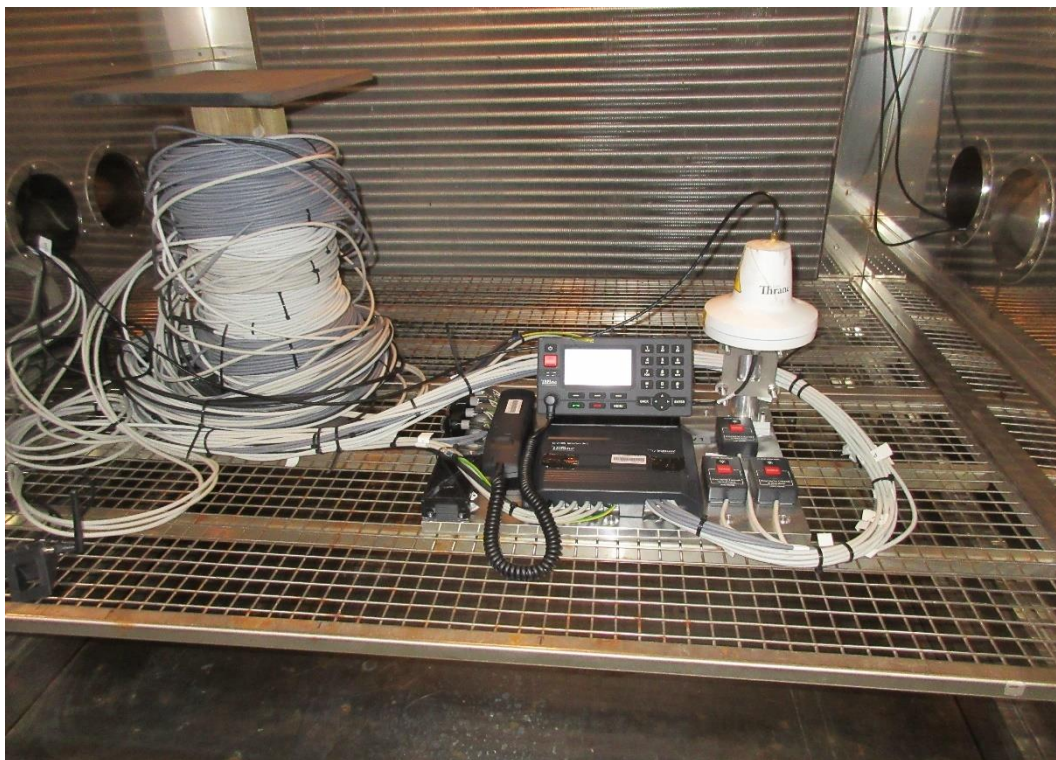
Figure 2.3.1 EUT test setup

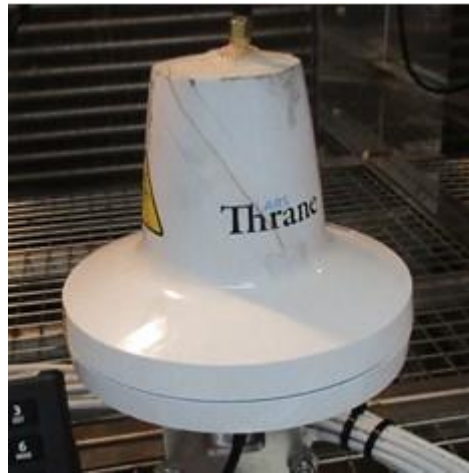
Figure 2.5.1 EUT test setup

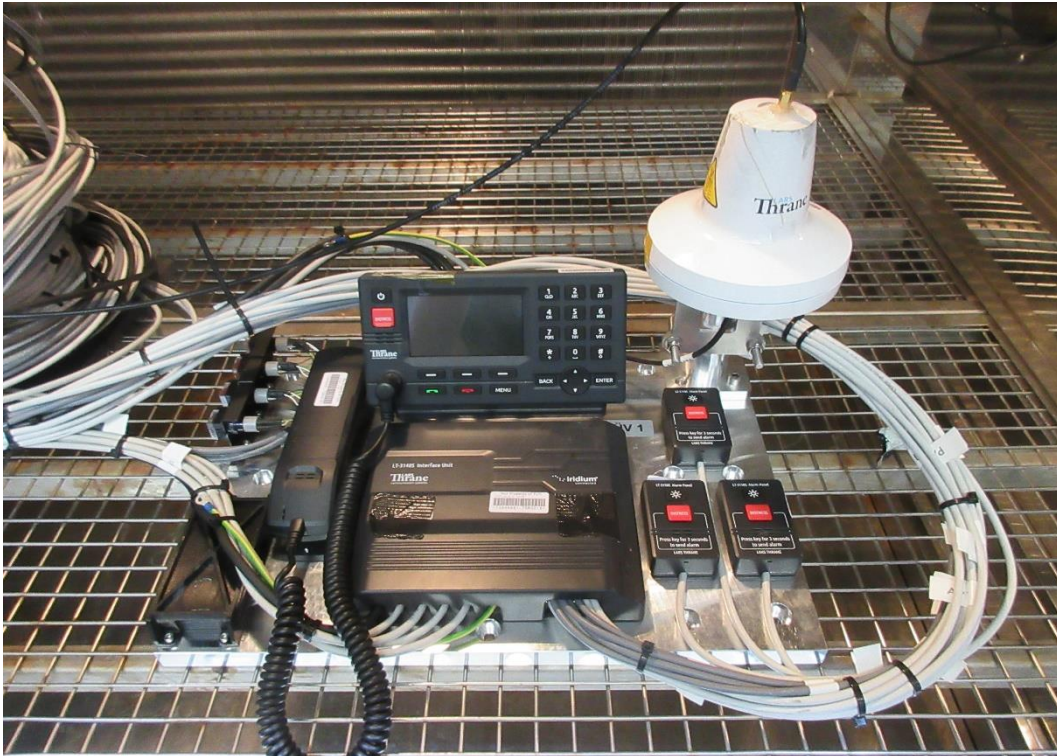
The Antenna although in the picture is not part of this test.

Figure 2.6.1 EUT test setup

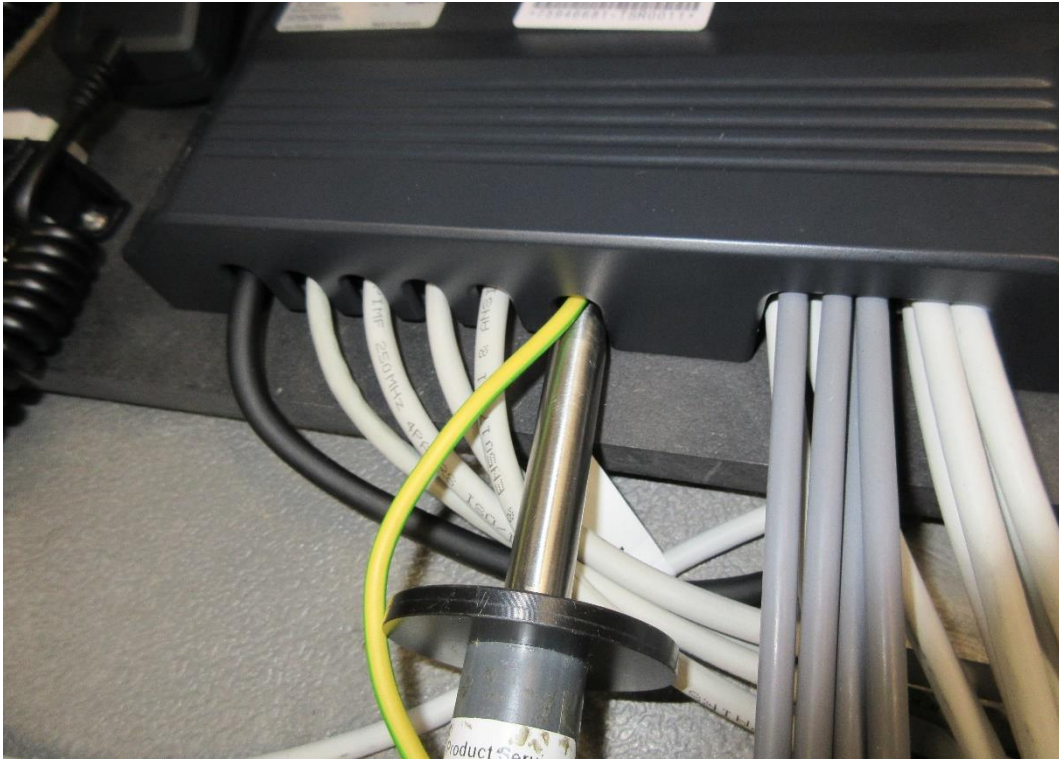
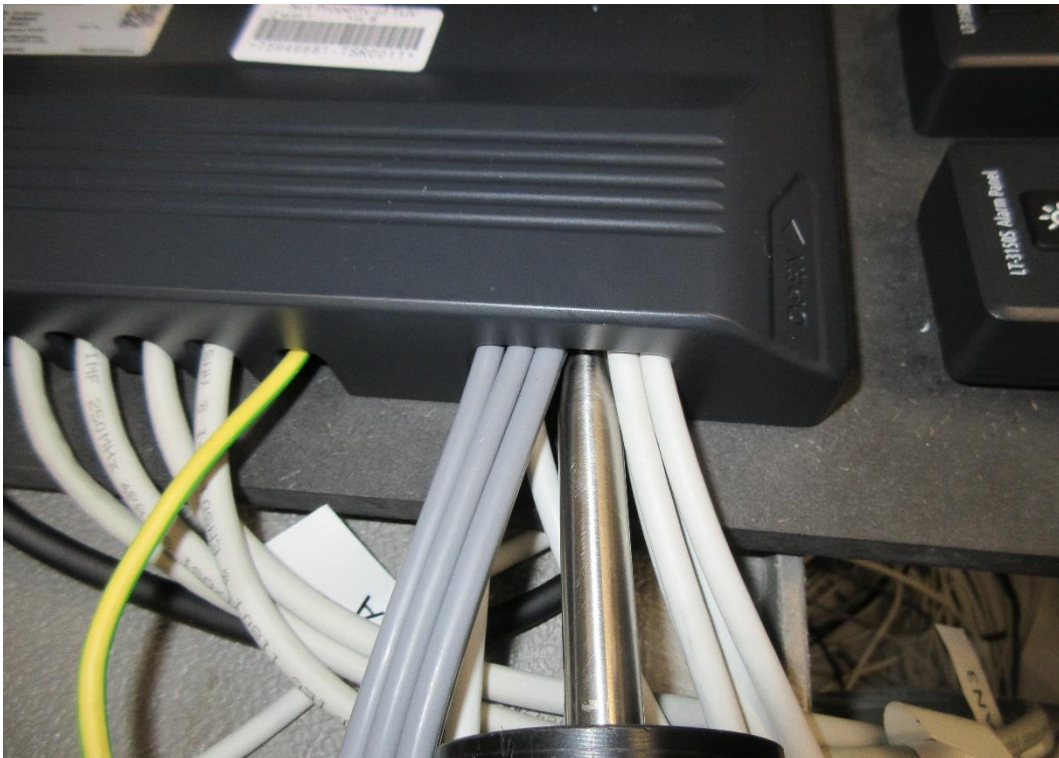
Figure 2.11.1 Test setup

The un-jointed test finger was unable to touch any hazardous parts and the stop face of the test finger could not be inserted into any of the openings

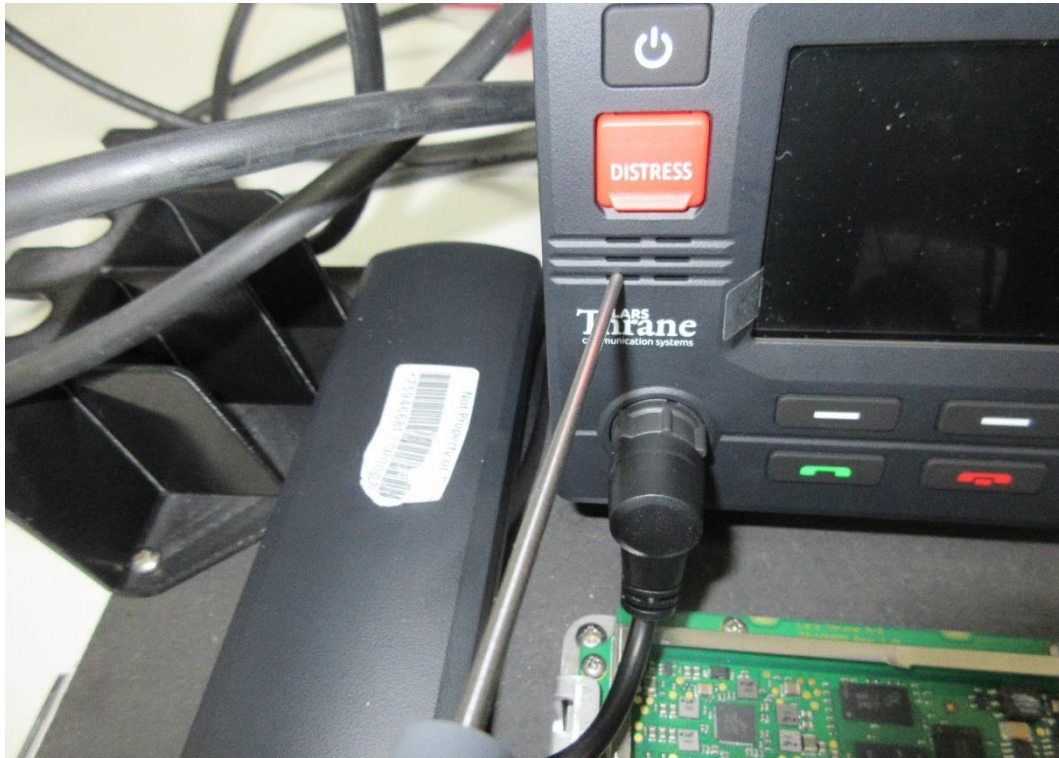
The protection is satisfactory if the full diameter of the probe does not pass through any opening.

Figure 2.12.1 Test setup

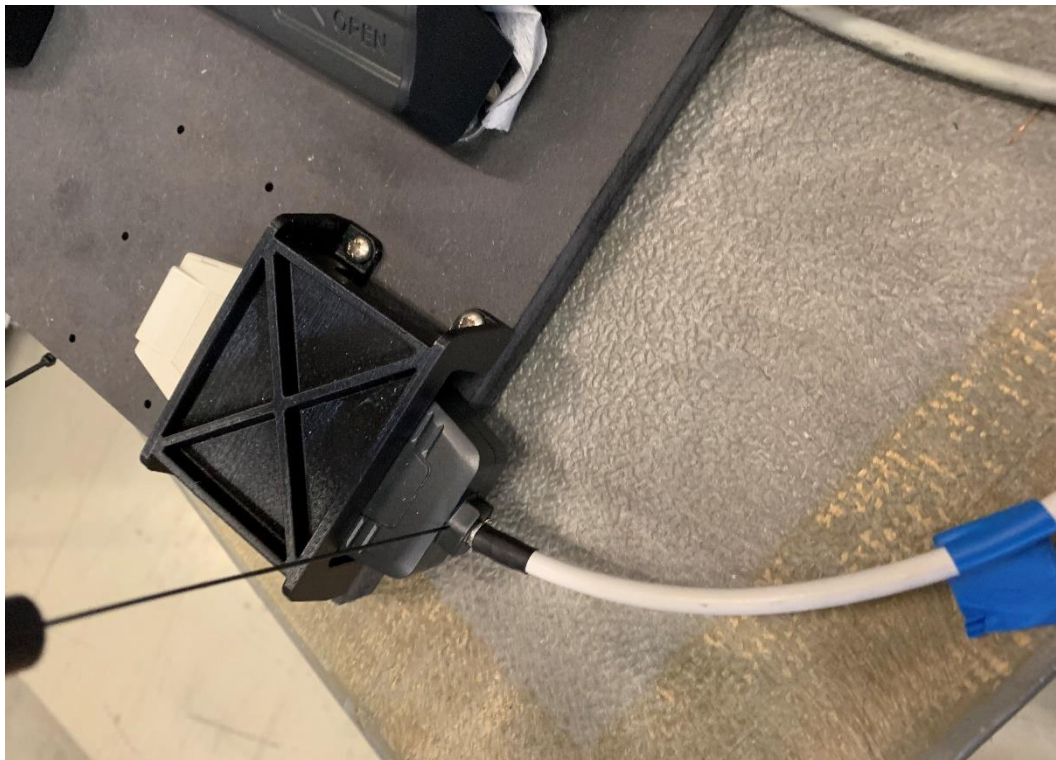
Figure 2.13.1 Printer Adaptor under test
