APPENDIX A: PHOTOGRAPHS OF TEST SETUP

Reference to the test report No. BLA-EMC-202303-A10001

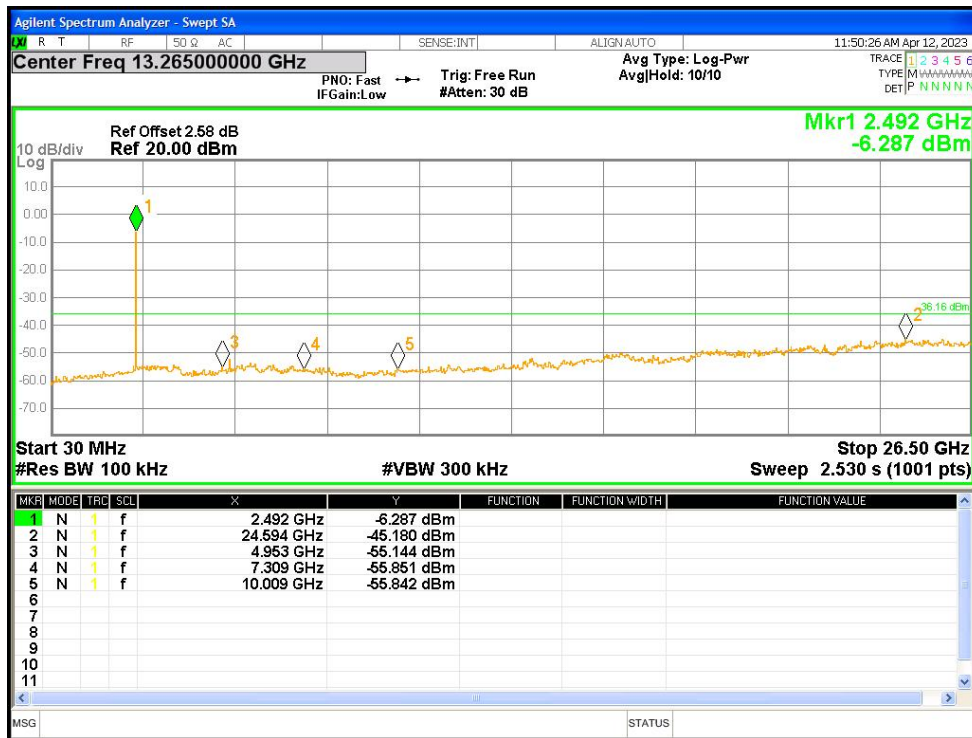
Tx. Spurious NVNT BLE 2M 2402MHz Ant1 Ref

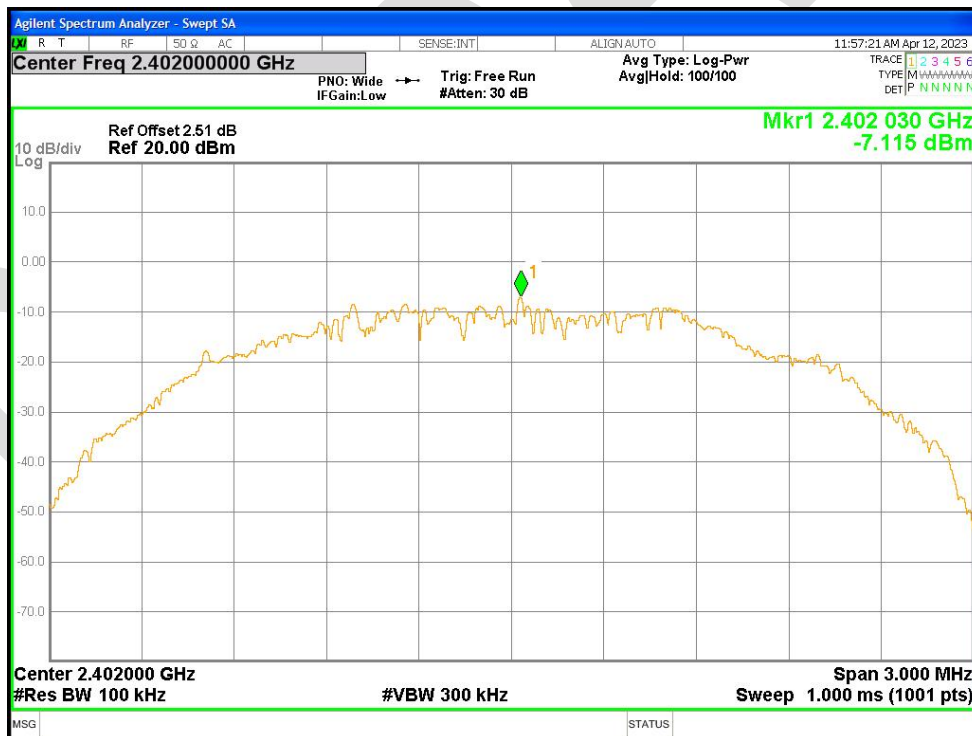
Tx. Spurious NVNT BLE 2M 2402MHz Ant1 Emission

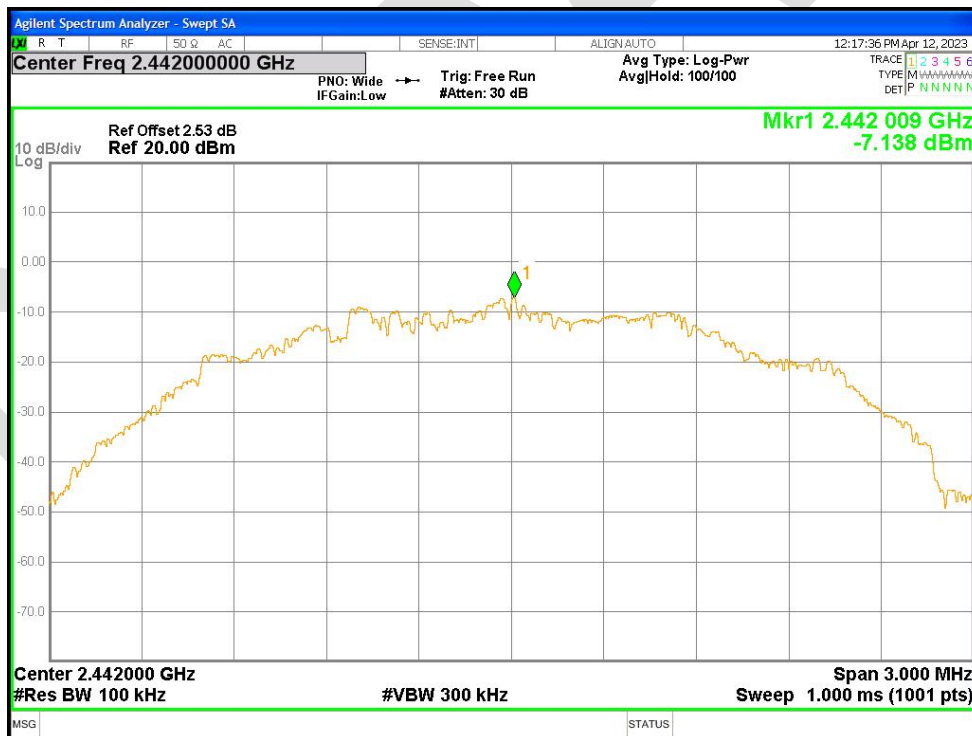
Tx. Spurious NVNT BLE 2M 2442MHz Ant1 Emission

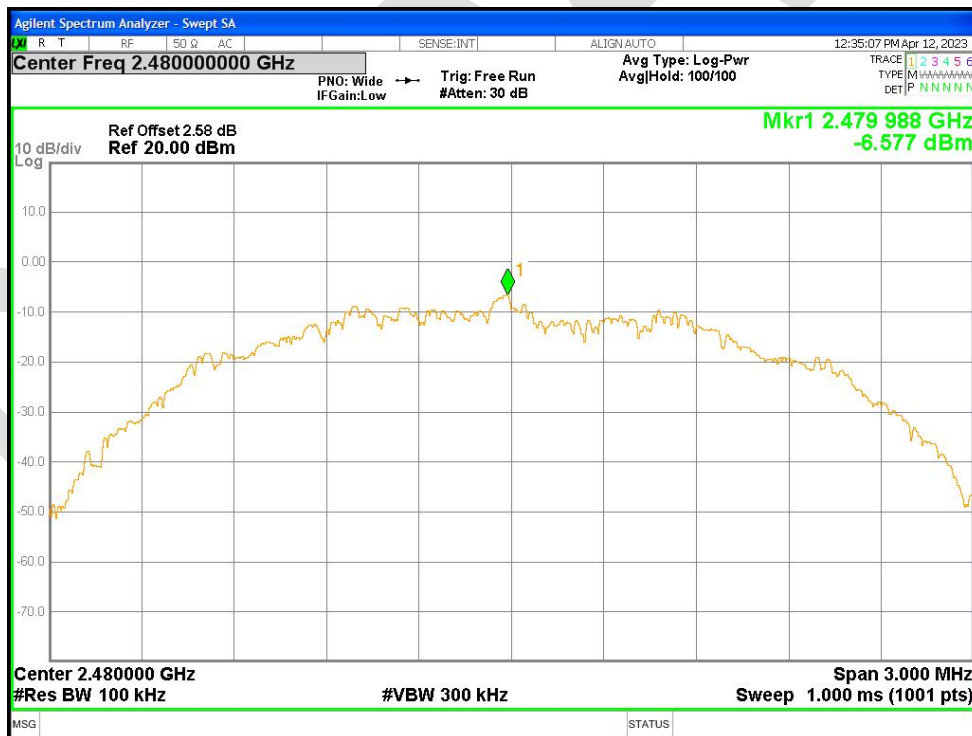
Tx. Spurious NVNT BLE 2M 2480MHz Ant1 Emission

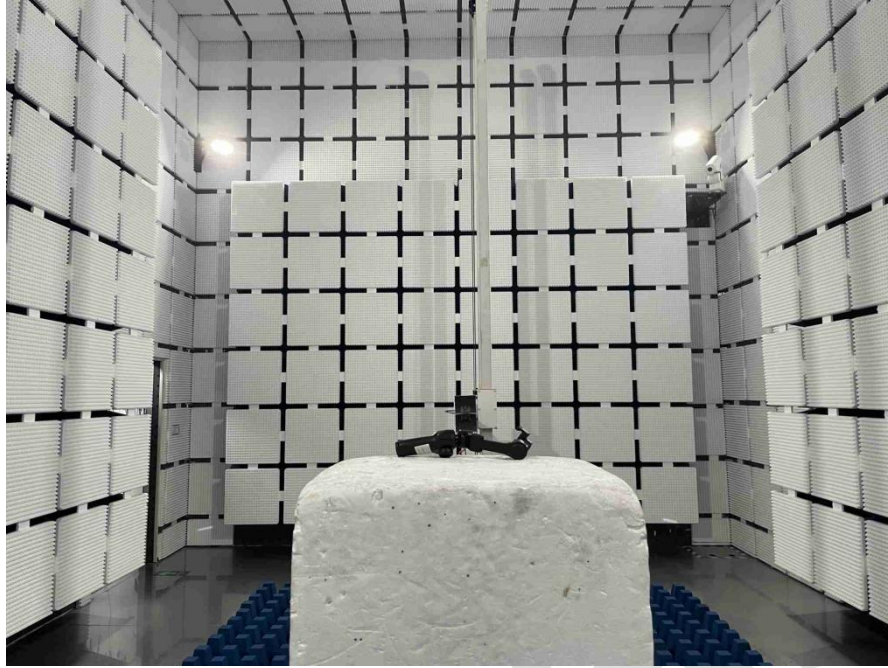
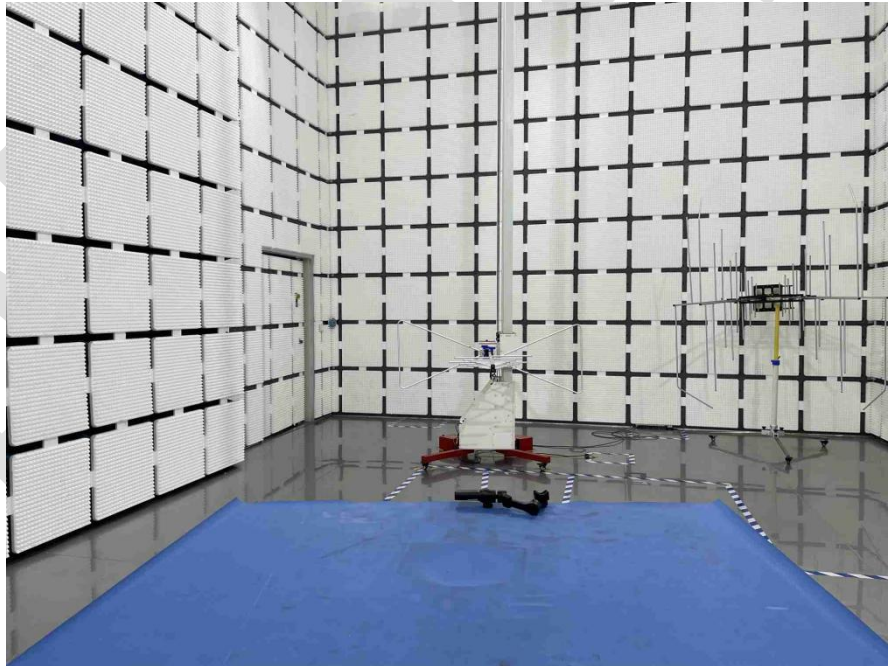
Radiated Spurious Emissions

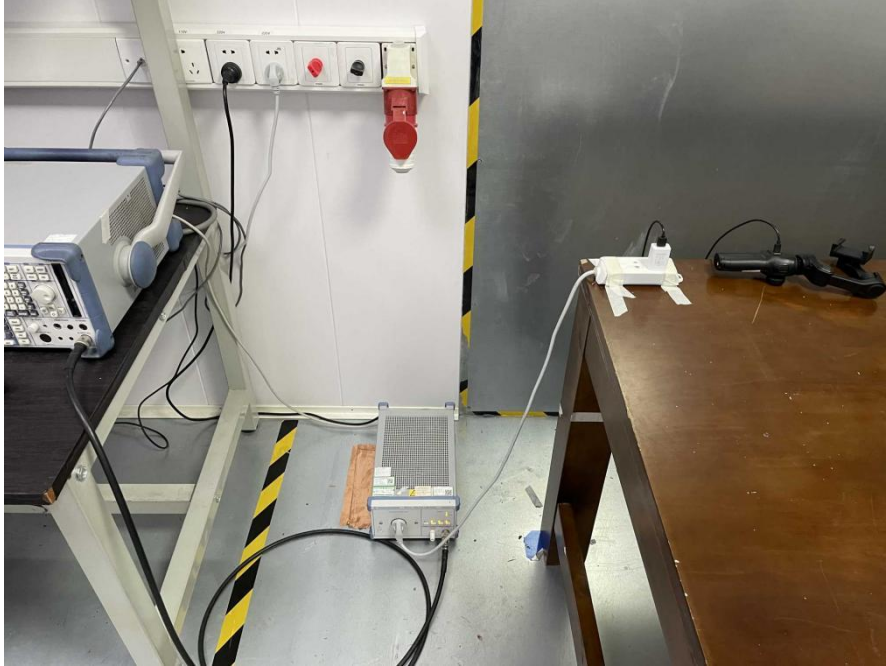
Conducted Emissions at AC Power Line (150kHz-30MHz)
