## Appendix E: Band edge measurements

Appendix F: Conducted Spurious Emission  
Test Result

Appendix G: Duty Cycle  
Test Result

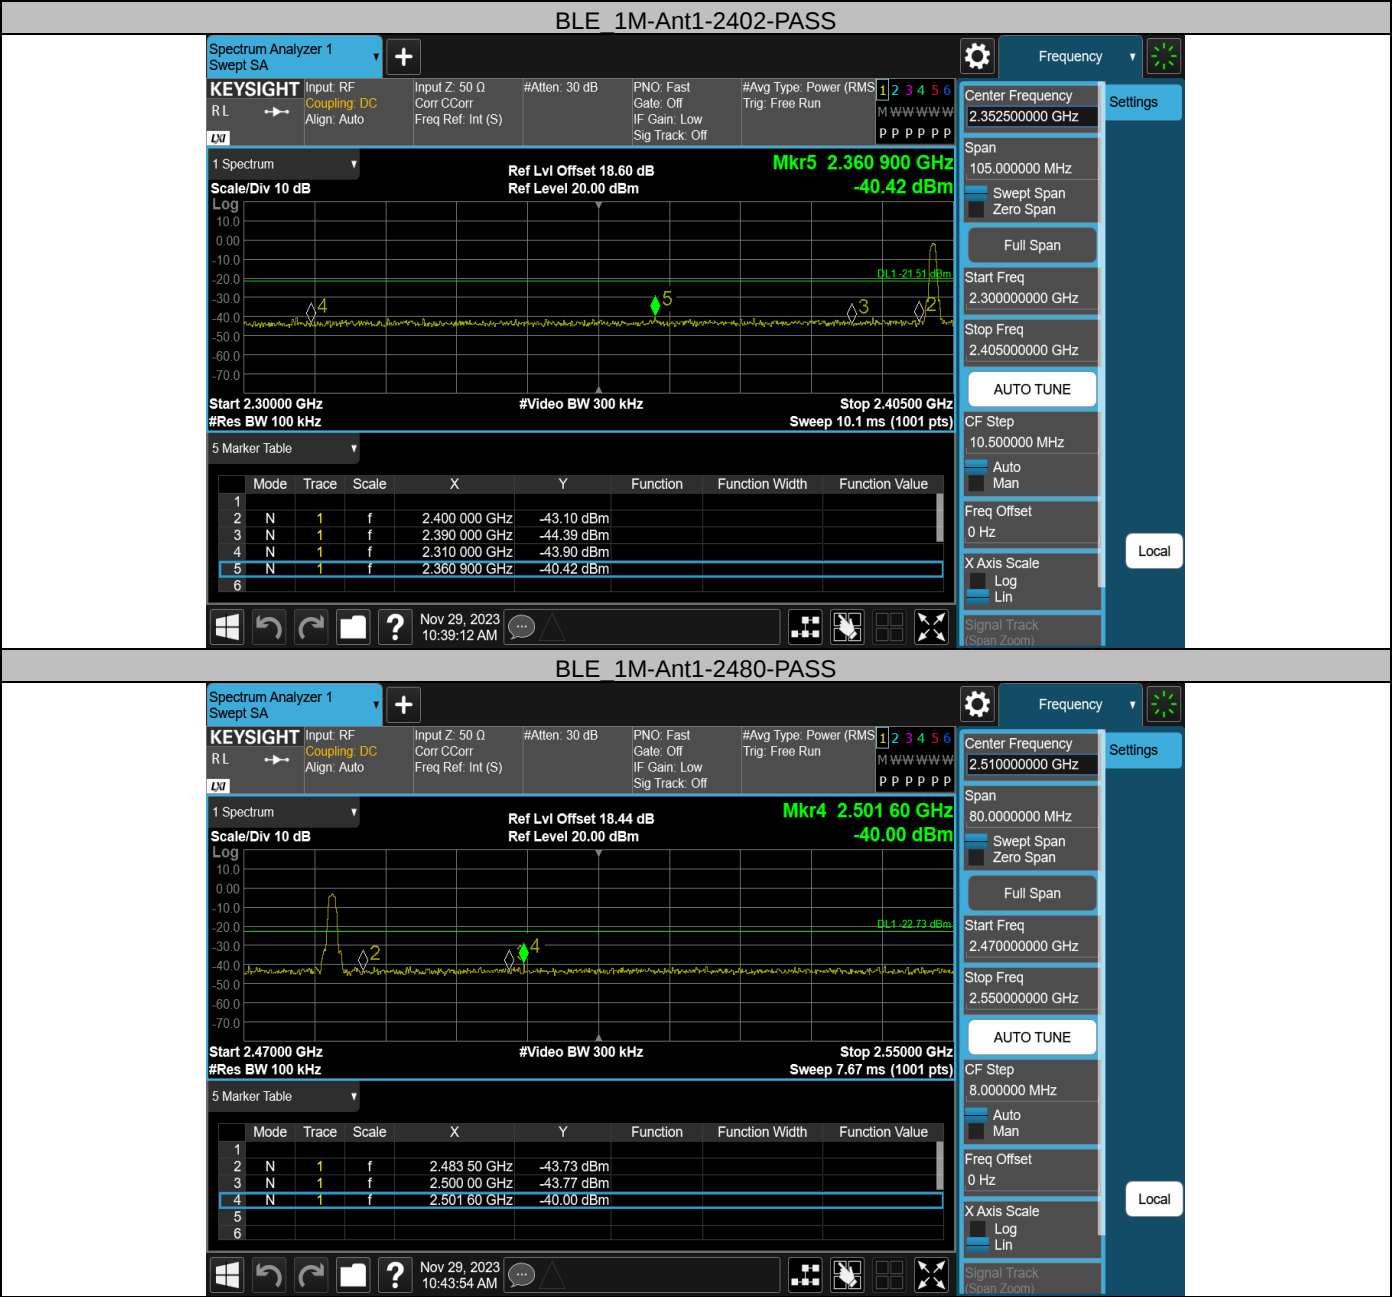
Test Graphs

| TestMode | Antenna | ChName | Frequency[MHz] | RefLevel[dBm] | Result[dBm] | Limit[dBm] | Verdict |
|---|---|---|---|---|---|---|---|
| BLE_1M | Ant1 | Low | 2402 | -1.51 | -40.42 | $\leq -21.51$ | PASS |
| BLE_1M | Ant1 | High | 2480 | -2.73 | -40 | $\leq -22.73$ | PASS |

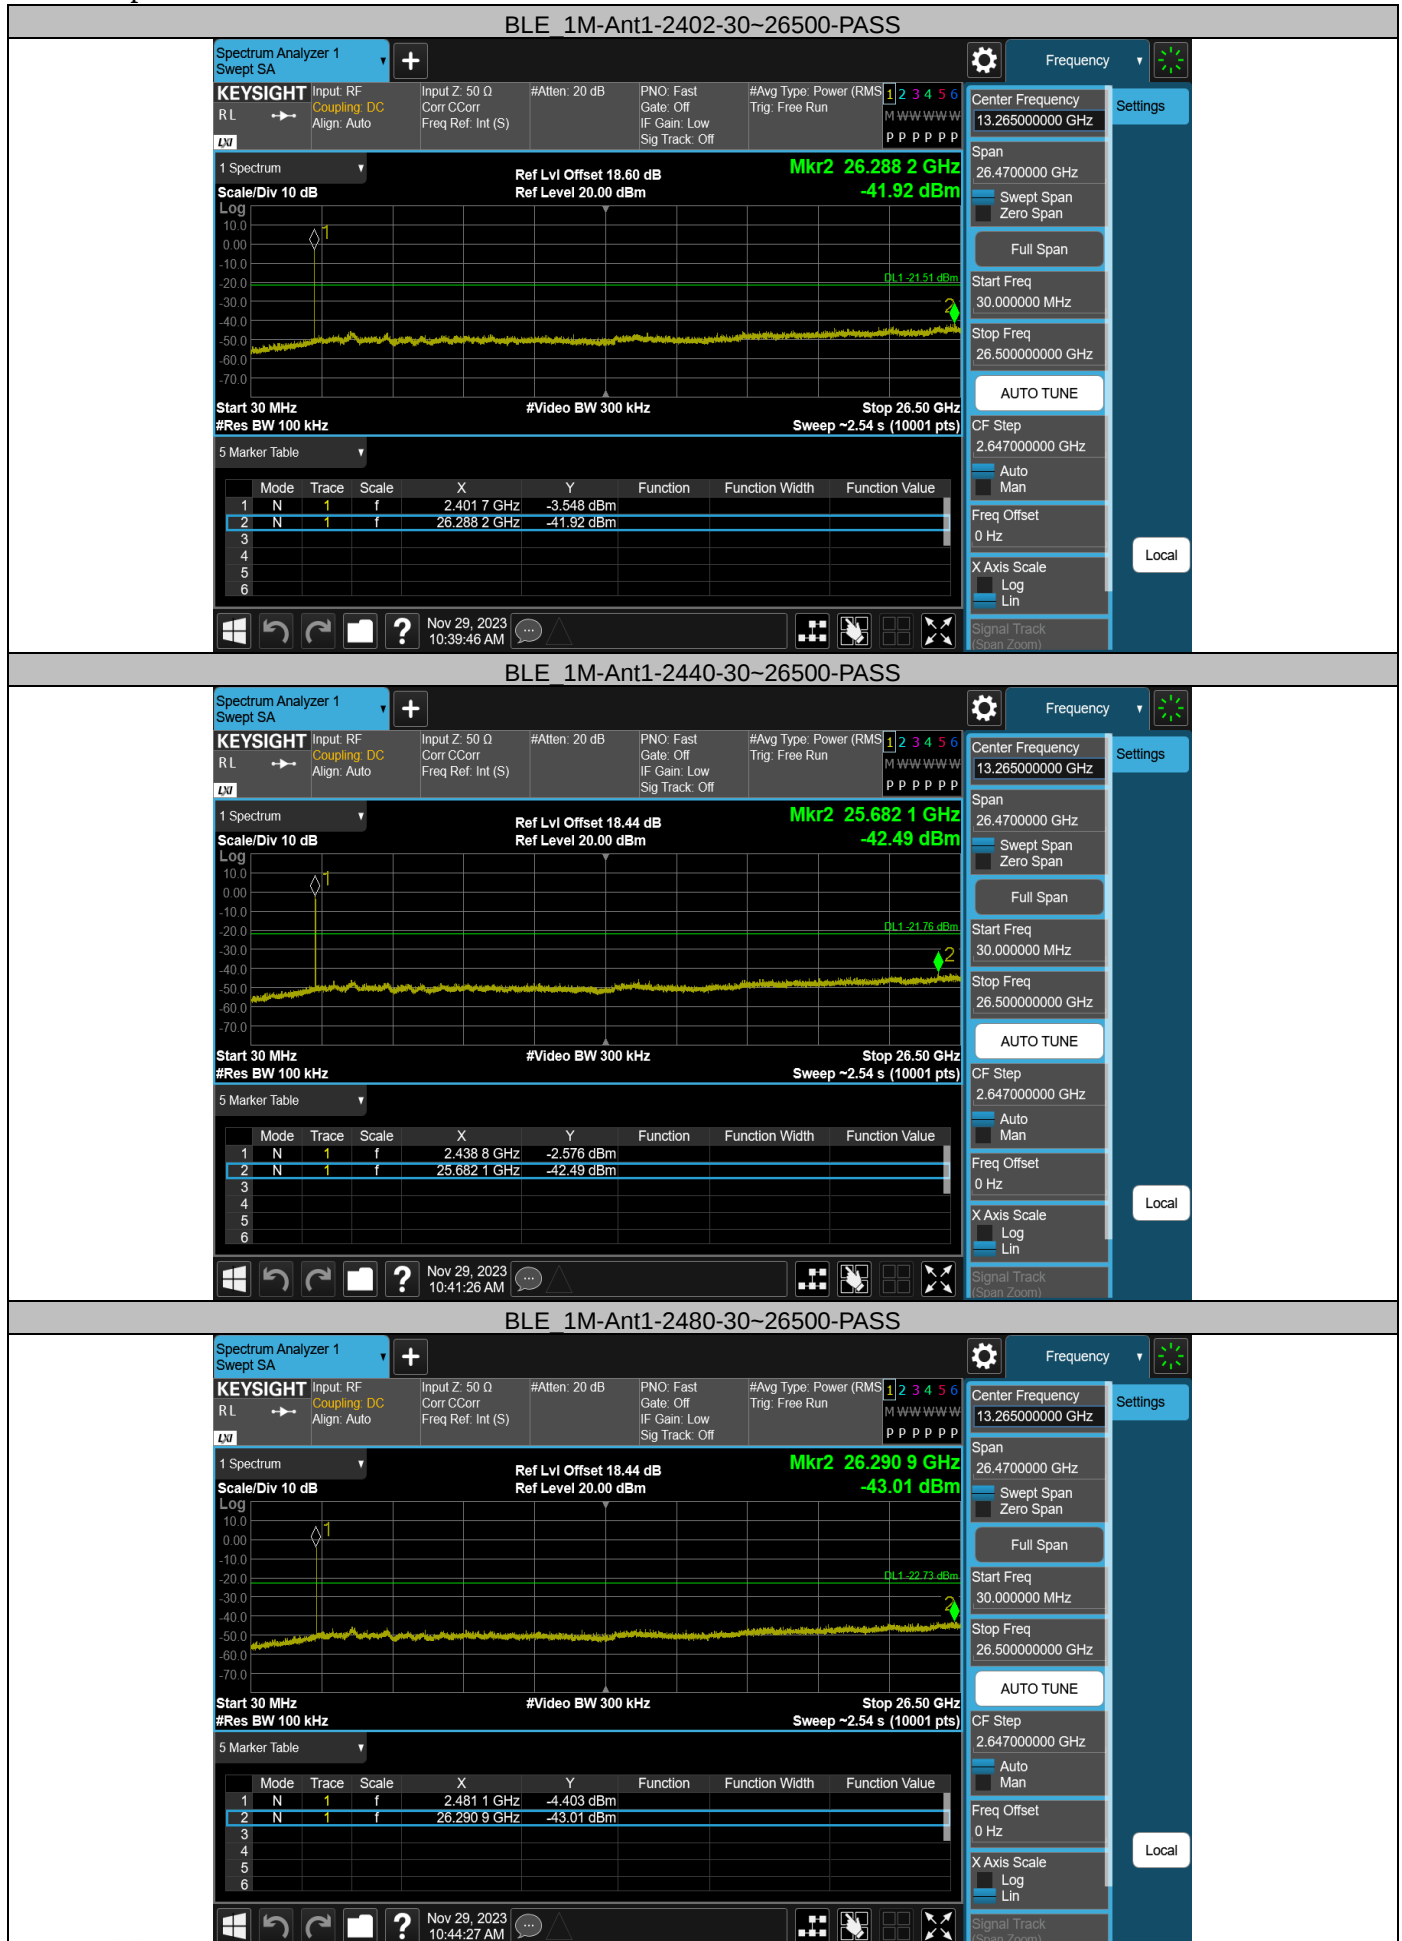
## Test Graphs

| TestMode | Antenna | Frequency[MHz] | FreqRange<br>[MHz] | RefLevel<br>[dBm] | Result[dBm] | Limit[dBm] | Verdict |
|---|---|---|---|---|---|---|---|
| BLE_1M | Ant1 | 2402 | 30~26500 | -1.51 | -41.92 | ≤-21.51 | PASS |
| BLE_1M | Ant1 | 2440 | 30~26500 | -1.76 | -42.49 | ≤-21.76 | PASS |
| BLE_1M | Ant1 | 2480 | 30~26500 | -2.73 | -43.01 | ≤-22.73 | PASS |

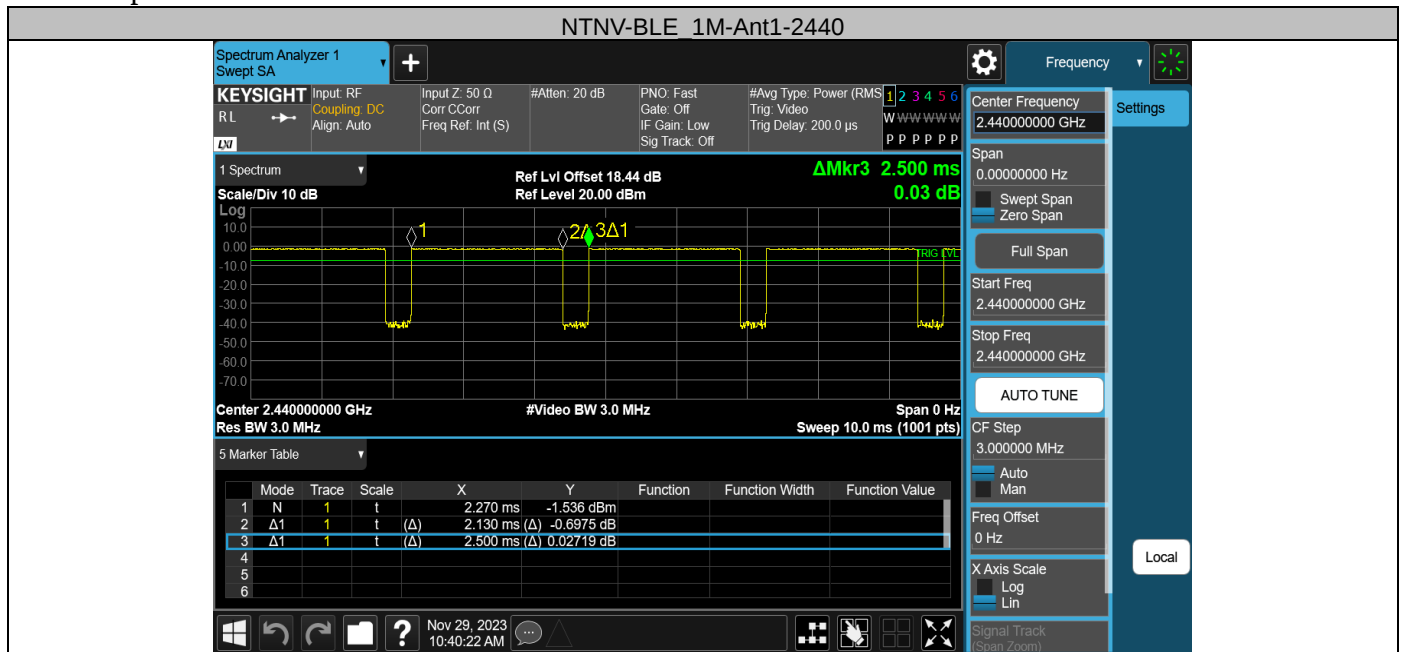
## Test Graphs

| TestMode | Antenna | Frequency[MHz] | ON Time<br>[ms] | Period<br>[ms] | Duty Cycle<br>[%] | Duty Cycle<br>Factor[dB] |
|---|---|---|---|---|---|---|
| BLE 1M | Ant1 | 2440 | 2.13 | 2.50 | 85.20 | 0.70 |
