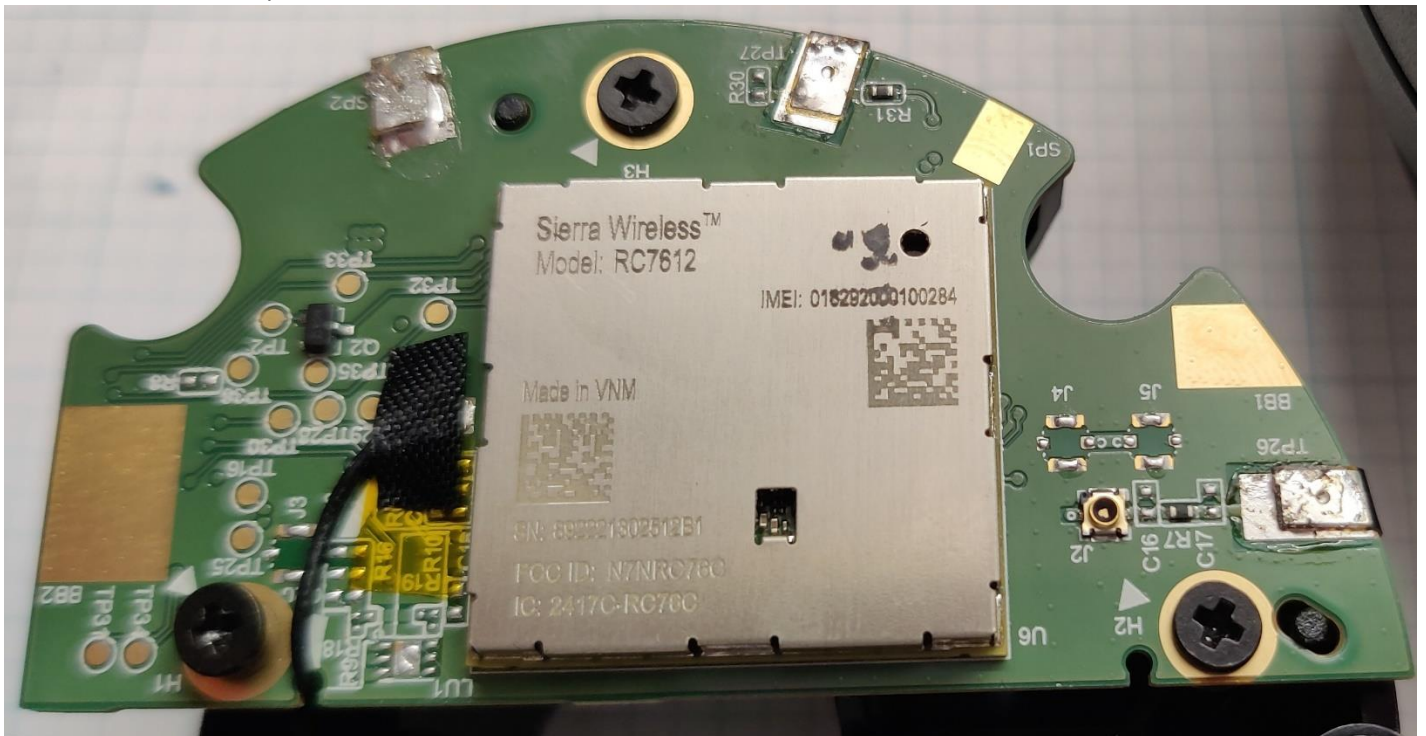
03 - LTE board close-up, front

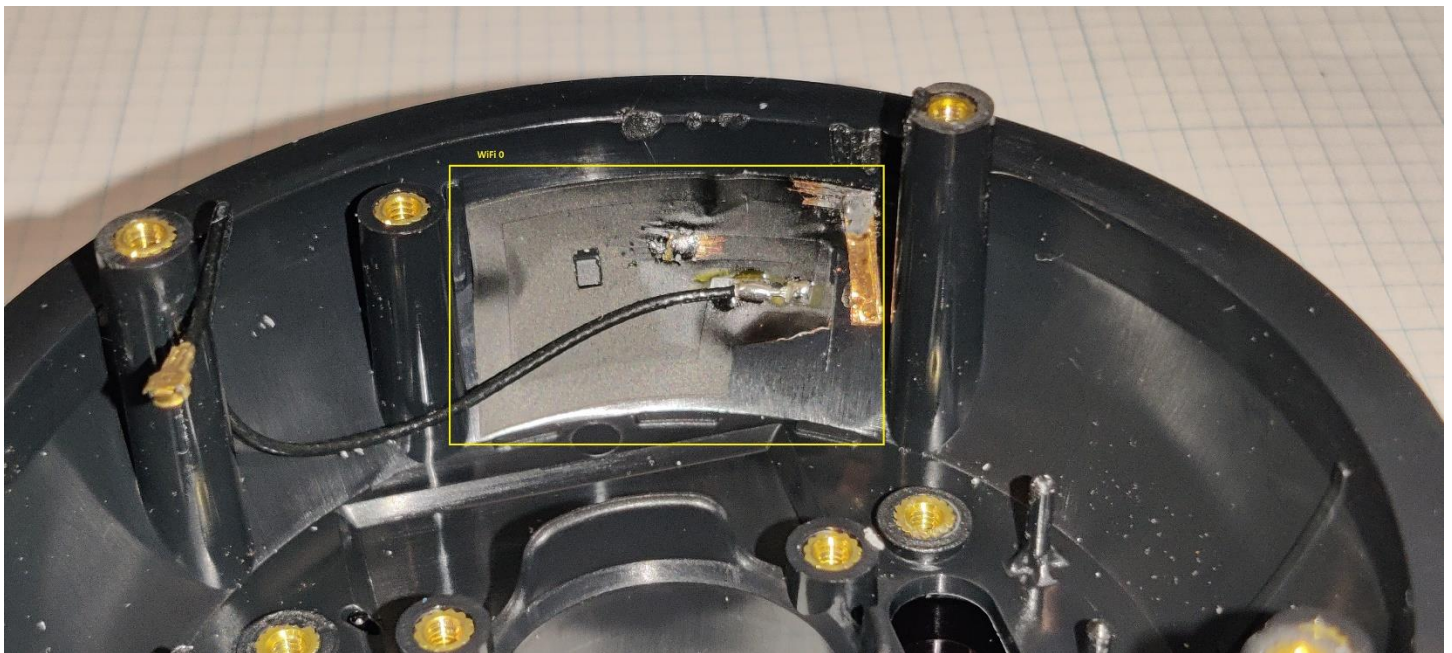
16c - Rear and antenna carrier. WiFi 0 highlighted
