APPENDIX A: PHOTOGRAPHS OF TEST SETUP

APPENDIX B: PHOTOGRAPHS OF EUT

Reference to the test report No. BLA-EMC-202304-A3201

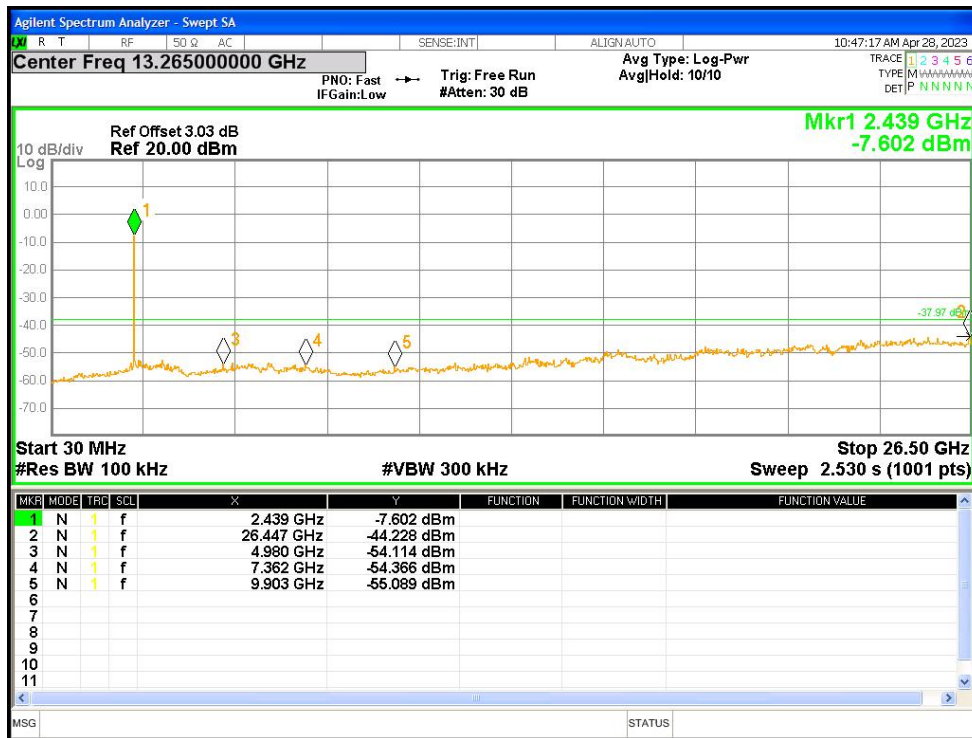
Tx. Spurious NVNT n20 2462MHz Ant1 Ref
