APPENDIX A: PHOTOGRAPHS OF TEST SETUP

APPENDIX B: PHOTOGRAPHS OF EUT

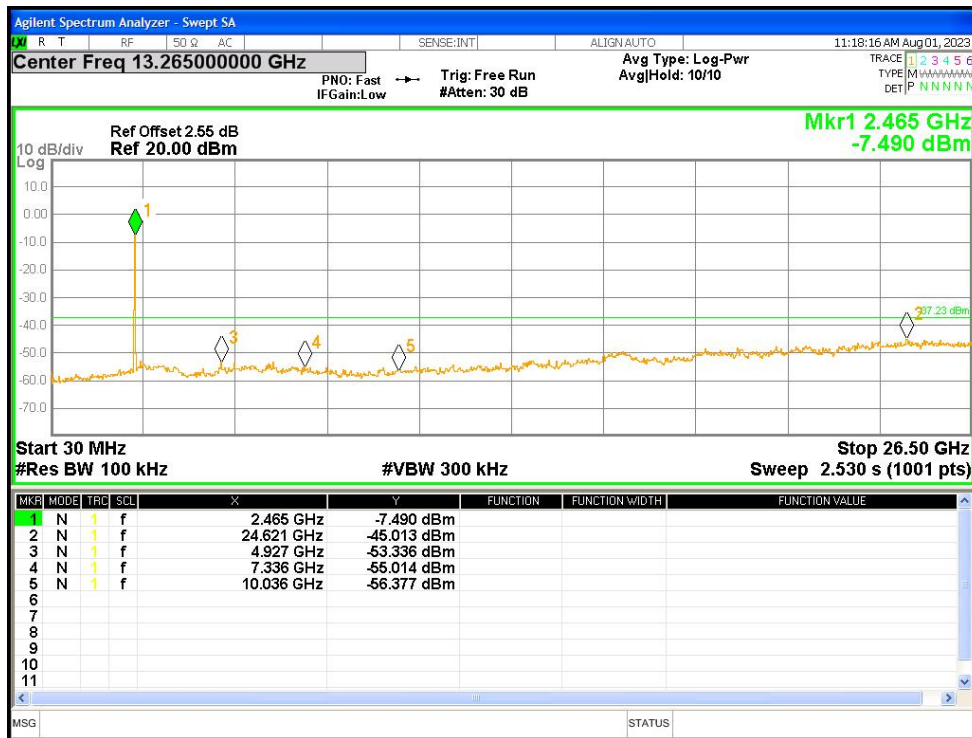
Tx. Spurious NVNT n40 2422MHz Ant1 Ref

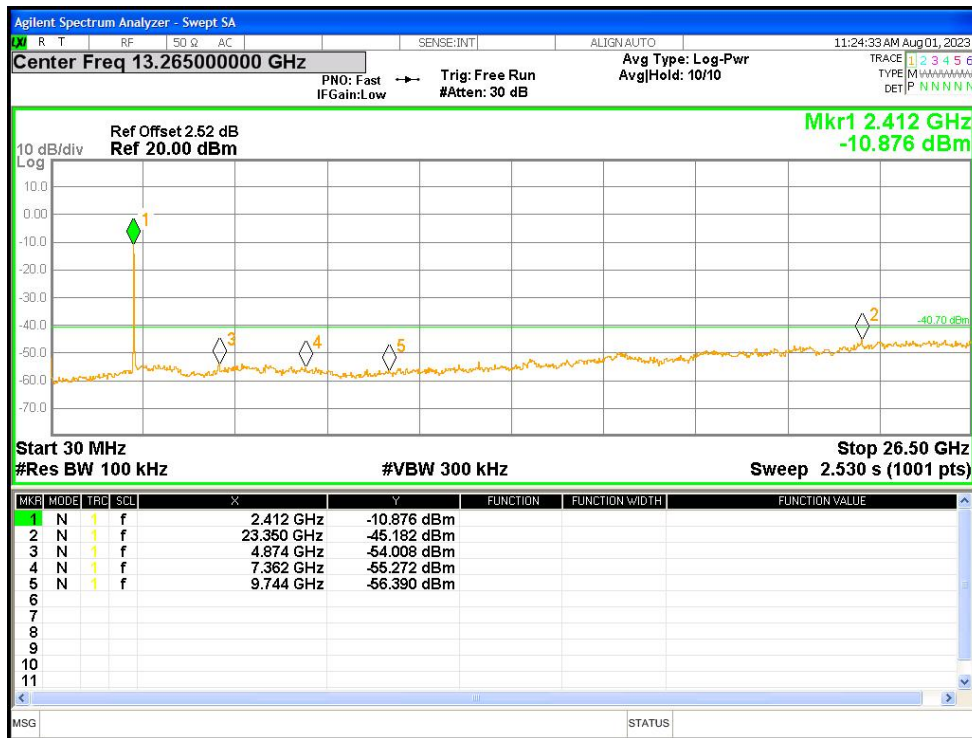
Tx. Spurious NVNT n40 2437MHz Ant1 Ref

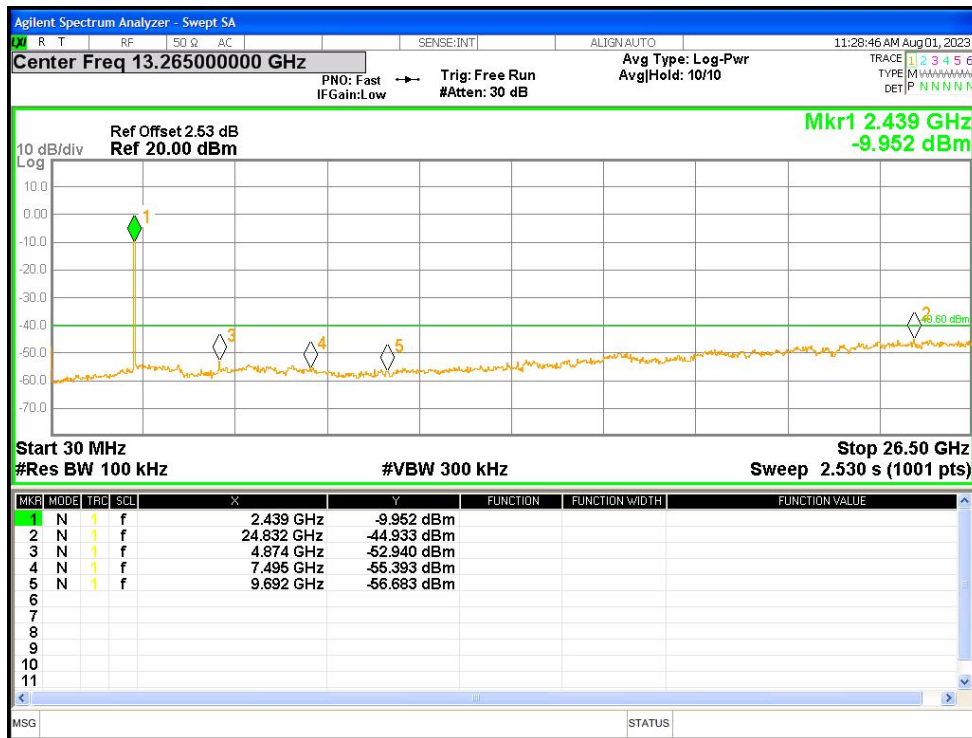
Tx. Spurious NVNT n40 2452MHz Ant1 Ref

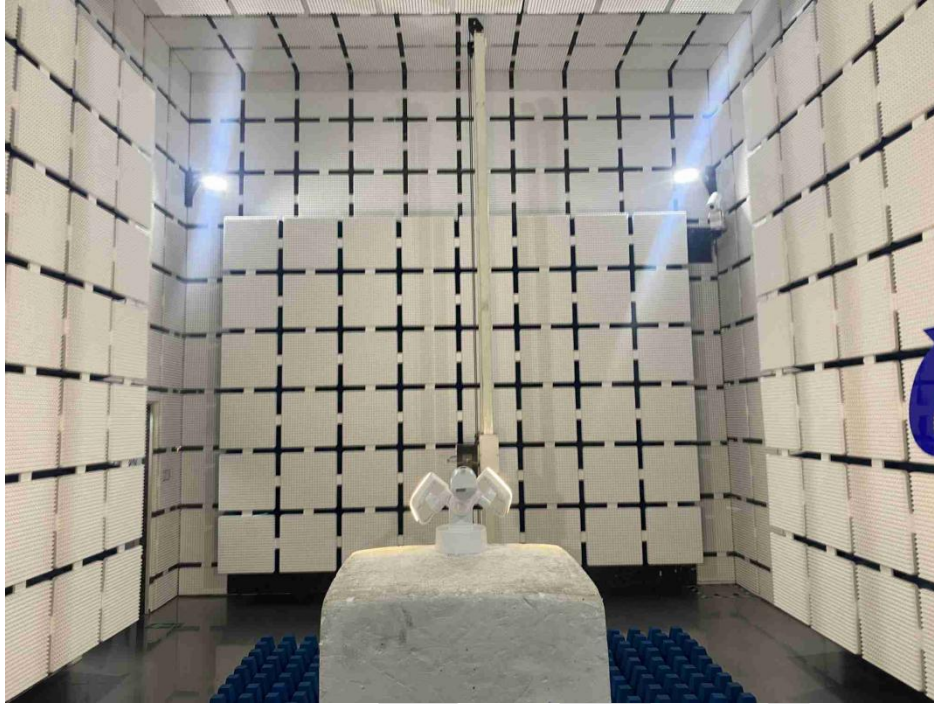
Radiated Spurious Emissions

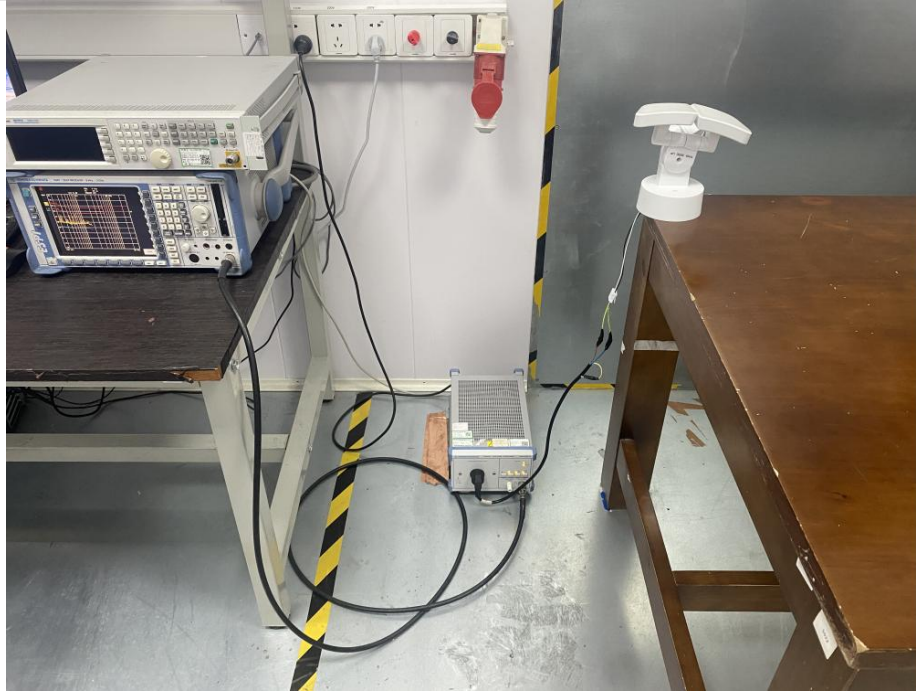
Conducted Emissions at AC Power Line (150kHz-30MHz)
