## APPENDIX A: PHOTOGRAPHS OF TEST SETUP

### APPENDIX B: PHOTOGRAPHS OF EUT

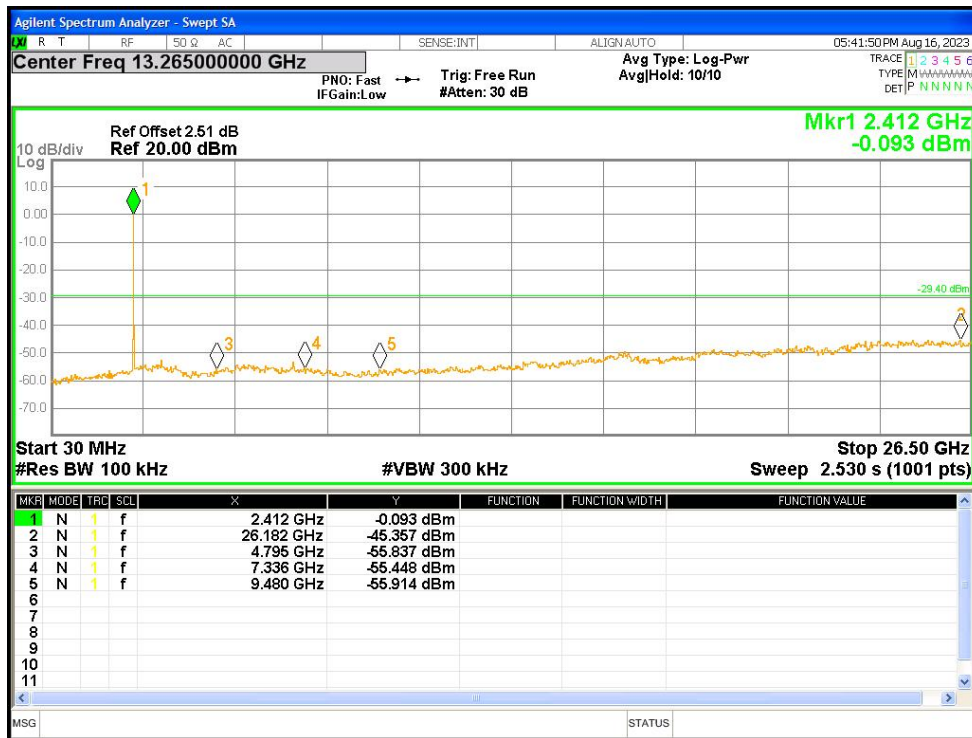
Tx. Spurious NVNT n20 2437MHz Ant1 Ref

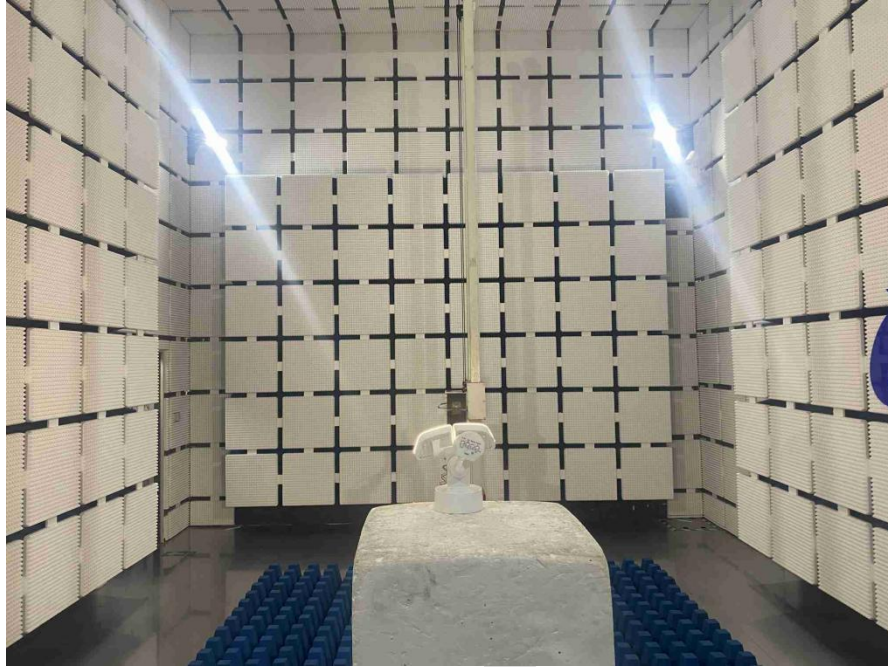
### Radiated Spurious Emissions
